# SACRIFICIAL ANODE VHS-8339 – ZN ALLOY – MODERN TIMES

**Artefact name** Sacrificial anode VHS-8339

**Authors** Marianne. Senn (Empa, Dübendorf, Zurich, Switzerland) & Christian. Degrigny (HE-Arc CR, Neuchâtel, Neuchâtel, Switzerland)

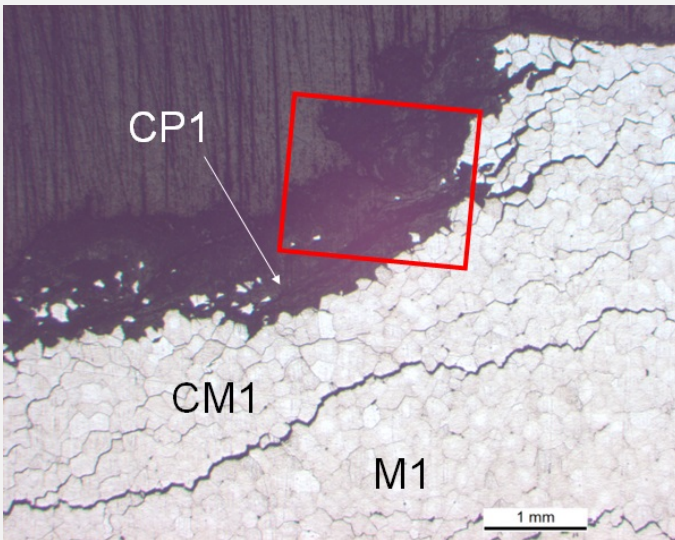
The remaining metal is an almost pure zinc alloy (Table 1). The oxygen content is not from the original alloy, but is due to secondary corrosion. The metal grains are visible without etching and present a polygonal structure (Figs. 4 and 5). The structure is recrystallized after annealing. The recrystallization of zinc alloys begins at room temperature.

Fig. 4: Micrograph of the metal sample from Fig. 3 (reversed picture, detail), unetched, bright field. Extensive intergranular corrosion is visible. The rectangle marks Fig. 6,

Extensive intergranular corrosion / cracking has developed in the metal structure (Figs. 4, 5). The metal is covered by a corrosion crust that is hardly visible in bright field and which contains remnant metal (Fig. 4). On most of the sample the corrosion crust is uniform. In areas we see cracks (Fig. 6) appearing as brown lines separating the corrosion crust (Fig. 7). In bright field the corrosion crust appears grey containing dark-grey zones (Fig. 6). Under polarized light, the corrosion crust appears white with darker parts including remnant metal (Fig. 7). It contains Zn and O as well as S along some cracks (Table 2 and Fig. 8).
