# SACRIFICIAL ANODE VHS-8339 – ZN ALLOY – MODERN TIMES

**Artefact name** Sacrificial anode VHS-8339

**Authors** Marianne. Senn (Empa, Dübendorf, Zurich, Switzerland) & Christian. Degryny (HE-Arc CR, Neuchâtel, Neuchâtel, Switzerland)

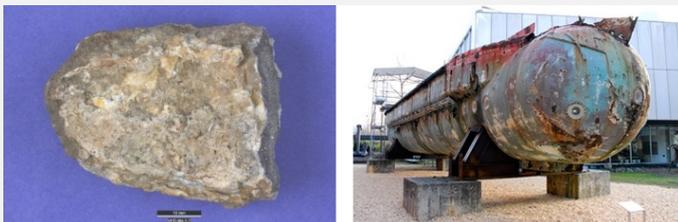
Fig. 1: Sacrificial anode (left) from submarine "Mesoscaph" (right) ([www.verkehrshaus.ch](http://www.verkehrshaus.ch)),

<b>Description of the artefact</b>	The artefact could be a weight or sacrificial anode of a submarine (Fig. 1). It is surrounded by a whitish brown-grey corrosion crust. The broken metal has a greyish shiny colour. Dimensions: L = 4.9cm ; WT = 95g.
<b>Type of artefact</b>	Submarine part
<b>Origin</b>	Submarine "Mesoscaph" from Auguste Piccard
<b>Recovering date</b>	The sacrificial anodes (?) might have been added when the submarine was used in the sea.
<b>Chronology category</b>	Modern Times
<b>chronology tpq</b>	<input type="text" value="1970"/> A.D. ▾
<b>chronology taq</b>	<input type="text" value="1974"/> A.D. ▾
<b>Chronology comment</b>	
<b>Burial conditions / environment</b>	Outdoor atmosphere
<b>Artefact location</b>	Swiss Museum of Transport, Luzern, Lucerne
<b>Owner</b>	Swiss Museum of Transport, Luzern, Lucerne

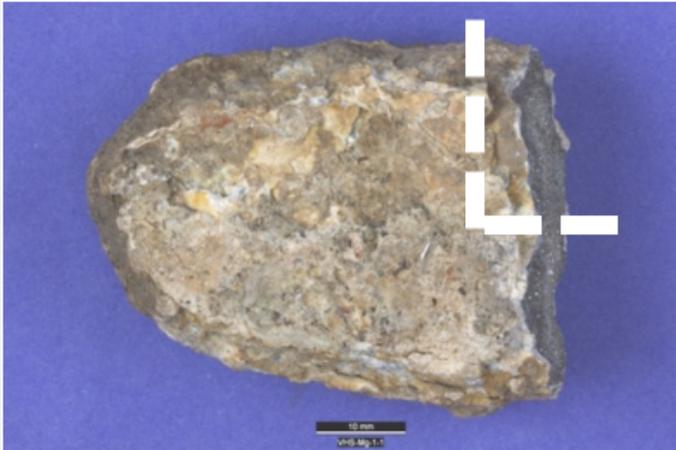
Fig. 2: Location of sampling area,

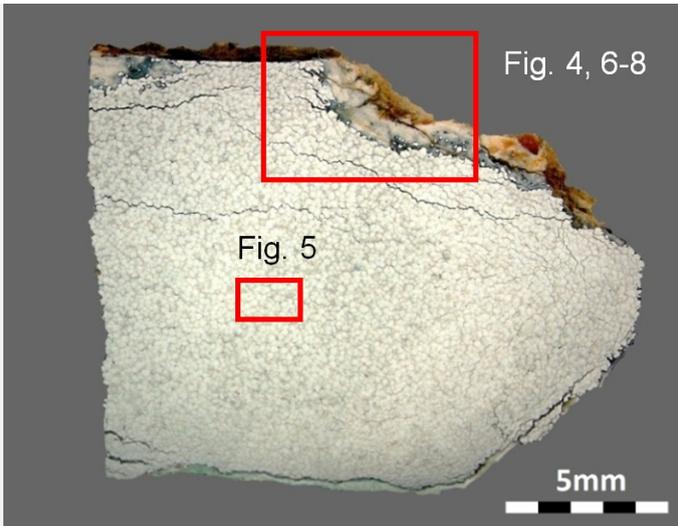
Fig. 3: Micrograph of the cross-section of the fragment sampled from the sacrificial anode showing the location of Figs. 4 to 8,

<b>Description of sample</b>	The sample (Fig. 3) shows a cross-section from the fragment of the sacrificial anode (Fig. 2). It has a silvery appearance. The thickness of the corrosion crust is variable. Dimensions: L = 17mm; W = 14mm.
<b>Alloy</b>	Zn Alloy
<b>Technology</b>	Cast and annealed
<b>Lab number of sample</b>	VHS-Mq-1
<b>Sample location</b>	HE-Arc CR, Neuchâtel, Neuchâtel
<b>Responsible institution</b>	Swiss Museum of Transport, Luzern, Lucerne
<b>Date and aim of sampling</b>	07/09/2009 metallography

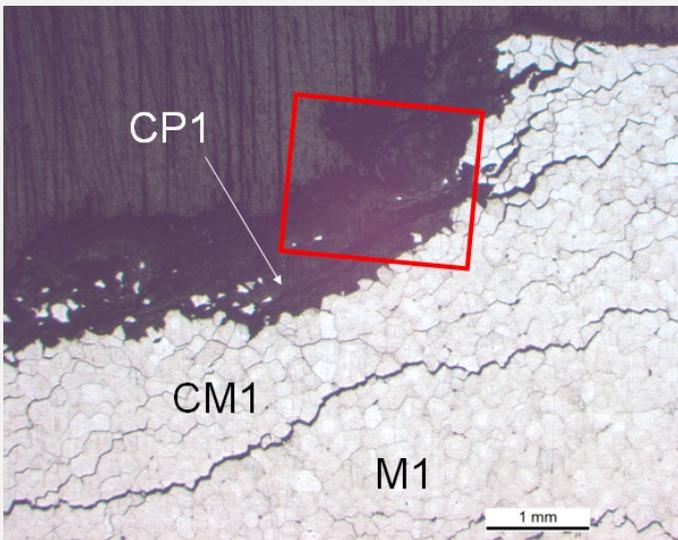
The remaining metal is an almost pure zinc alloy (Table 1). The oxygen content is not from the original alloy, but is due to secondary corrosion. The metal grains are visible without etching and present a polygonal structure (Figs. 4 and 5). The structure is recrystallised after annealing. The recrystallization of zinc alloys begins at room temperature.

Fig. 4: Micrograph of the metal sample from Fig. 3 (reversed picture, detail), unetched, bright field. Extensive intergranular corrosion is visible. The rectangle marks Fig. 6,

Extensive intergranular corrosion / cracking has developed in the metal structure (Figs. 4, 5). The metal is covered by a corrosion crust that is hardly visible in bright field and which contains remnant metal (Fig. 4). On most of the sample the corrosion crust is uniform. In areas we see cracks (Fig. 6) appearing as brown lines separating the corrosion crust (Fig. 7). In bright field the corrosion crust appears grey containing dark-grey zones (Fig. 6). Under polarized light, the corrosion crust appears white with darker parts including remnant metal (Fig. 7). It contains Zn and O as well as S along some cracks (Table 2 and Fig. 8).

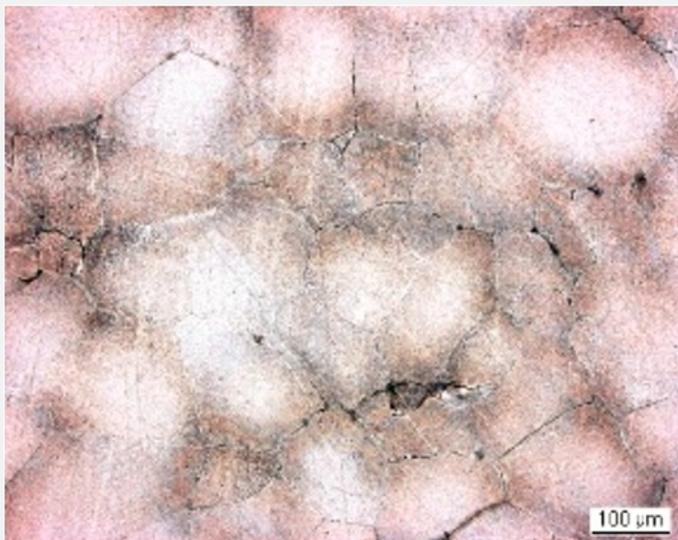
Fig. 5: Micrograph of the metal sample from Fig. 3 (detail), etched,

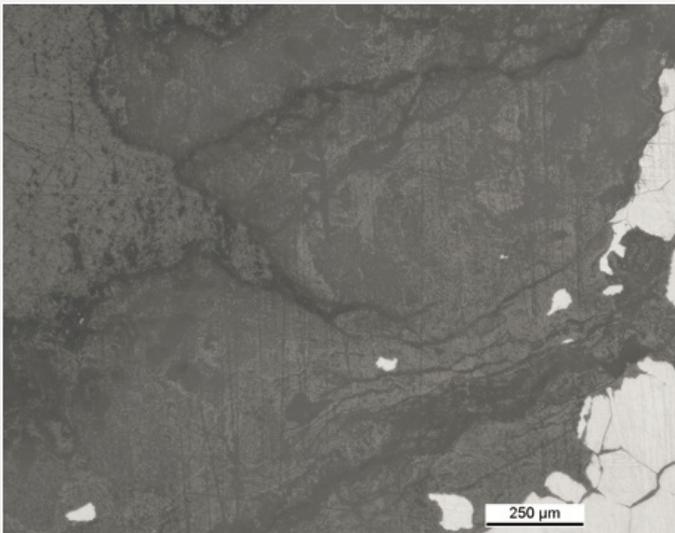
Fig. 6: Micrograph showing the metal - corrosion products interface from Fig. 5 (detail), unetched, bright field,

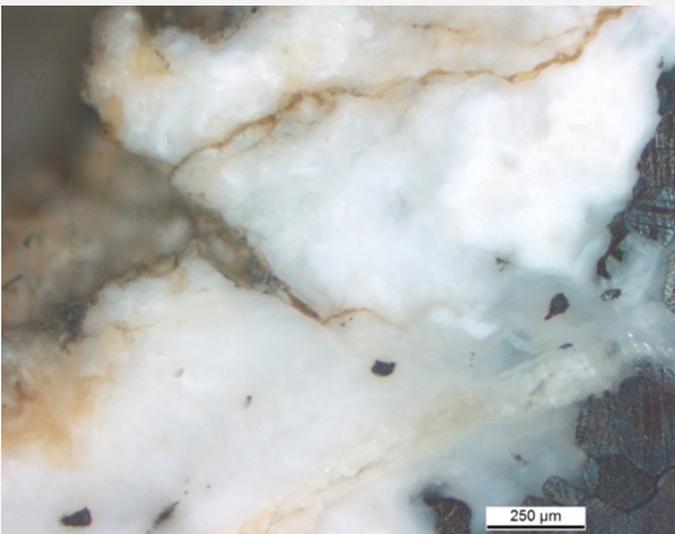
Fig. 7: Micrograph (same as Fig. 6) corresponding to the stratigraphy of Fig. 4, unetched, polarised light. We observe in dark-grey the metal, in white the corrosion crust separated by brown cracks including remnant metal,

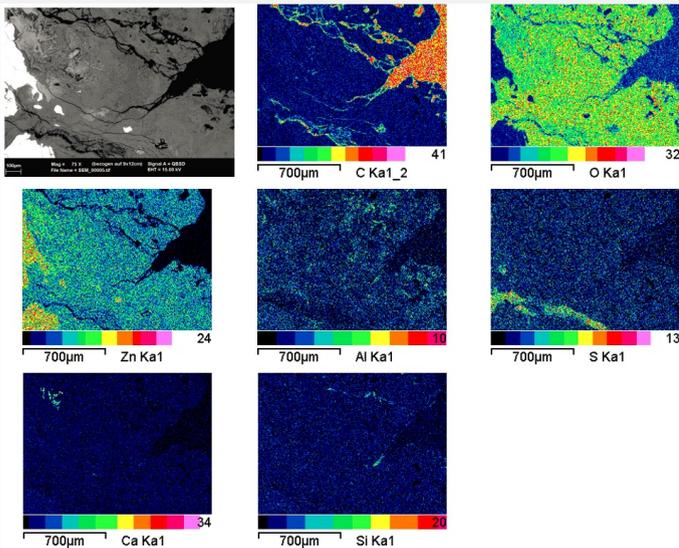
Table 2. Chemical composition (mass %) of the corrosion layer from Figs. 6 and 8. Method of analysis: SEM/EDS, Laboratory of Analytical Chemistry, Empa.

Fig. 8: SEM image, BSE-mode, and elemental chemical distribution of most of the area of Fig. 6 (reversed picture). Method of examination: SEM/EDS, Laboratory of Analytical Chemistry, Empa,
