ARMATURE FROM A CLOCK MOVEMENT MIH IV-212 – ZN AL SN CU ALLOY – MODERN TIMES

Artefact name Armature from a clock movement MIH IV-212

Authors Marianne. Senn (Empa, Dübendorf, Zurich, Switzerland) & Christian. Degrygn (HE-Arc CR, Neuchâtel, Neuchâtel, Switzerland)

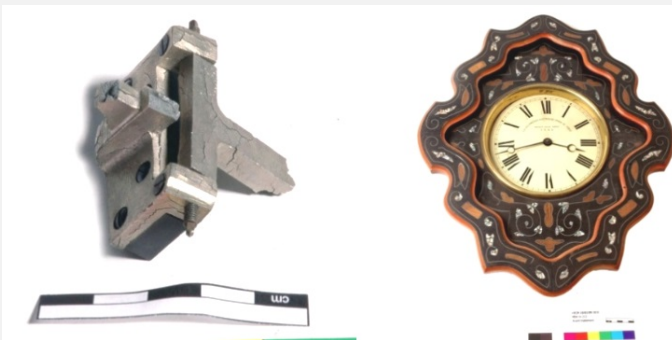
Fig. 1: Broken armature (left) from the clock movement of a wooden wall clock (right) (after Seematter 2009),

Description of the artefact	Armature from the clock movement of a wooden wall clock with electric movement, broken in two elements (Fig. 1 and Fig. 2) with a heavily cracked surface.
Type of artefact	Horological object
Origin	Wooden wall clock
Recovering date	1902-1904
Chronology category	Modern Times
chronology tpq	<input type="text" value="1902"/> A.D. ▾
chronology taq	<input type="text" value="1904"/> A.D. ▾
Chronology comment	
Burial conditions / environment	Indoor atmosphere
