ARMATURE FROM A CLOCK MOVEMENT MIH IV-212 – ZN AL SN CU ALLOY – MODERN TIMES

Artefact name	Armature from a clock movement MIH IV-212
Authors	Marianne. Senn (Empa, Dübendorf, Zurich, Switzerland) & Christian. Degriigny (HE-Arc CR, Neuchâtel, Neuchâtel, Switzerland)
Url	/artefacts/905/

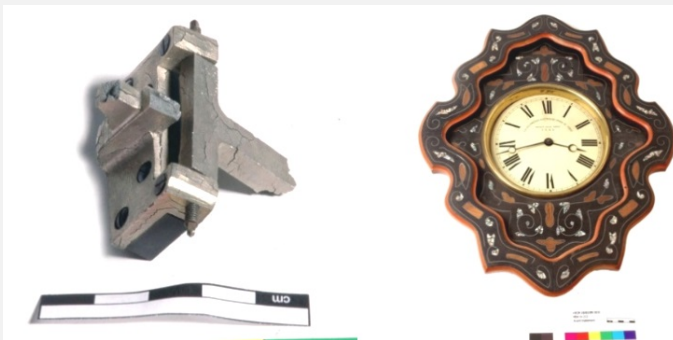
Fig. 1: Broken armature (left) from the clock movement of a wooden wall clock (right) (after Seematter 2009),

Description of the artefact	Armature from the clock movement of a wooden wall clock with electric movement, broken in two elements (Fig. 1 and Fig. 2) with a heavily cracked surface.
Type of artefact	Horological object
Origin	Wooden wall clock
Recovering date	1902-1904
Chronology category	Modern Times
chronology tpq	<input type="text" value="1902"/> A.D. ∨
chronology taq	<input type="text" value="1904"/> A.D. ∨
Chronology comment	
Burial conditions / environment	Indoor atmosphere

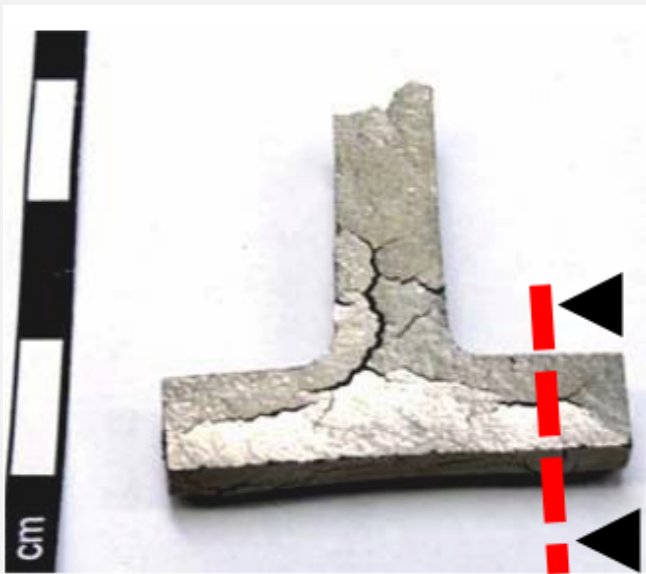
Fig. 2: Location of sampling area on one of the two broken elements of the armature,

Description of sample	This sample is the complete cross-section from one of the two broken elements of the armature (Fig. 2). The metal has large cracks radiating from the centre to the outside which have deformed the armature (Fig. 3).
Alloy	Zn Al Sn Cu Alloy
Technology	As-cast
Lab number of sample	MIH-VI-212
Sample location	HE-Arc CR, Neuchâtel, Neuchâtel
Responsible institution	International museum of horology (IMH), La Chaux-de-Fonds, Neuchâtel
Date and aim of sampling	2009, metal analysis

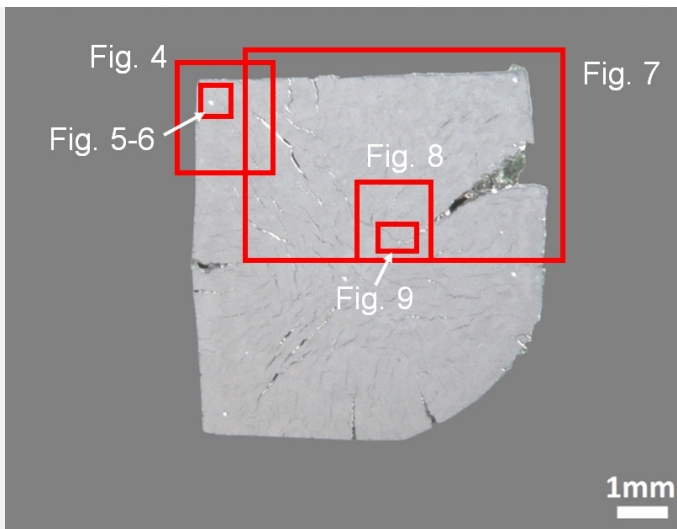
Fig. 3: Micrograph of the cross-section of the fragment sampled from the armature showing the location of Figs. 4 to 9,

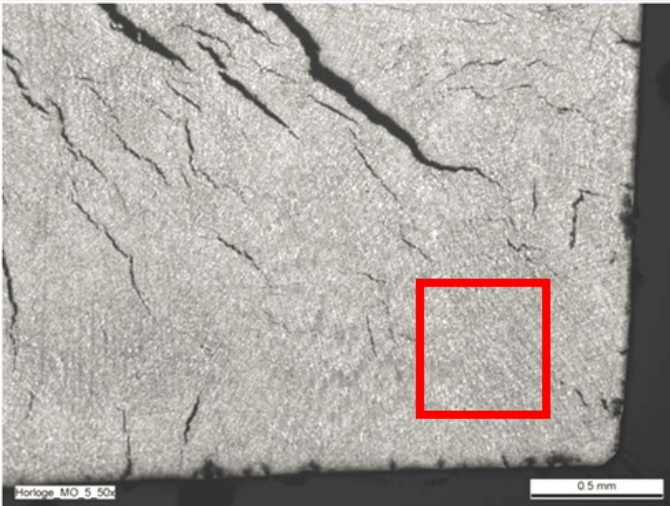
The metal is a Zn-Al-Sn-Cu alloy (Table 1) with an average hardness of HV1 105. A fine dendritic structure is observed (Fig. 4) which consists of clearly separated Zn, Al-Cu and Sn-rich phases (Figs. 5 and 6). Pb is associated with Sn but also forms tiny nodules.

Fig. 4: Micrograph of the metal sample from Fig. 3 (inverted picture, rotated by 270°, detail), unetched, bright field. A dendritic structure is visible. The micrograph of Fig. 5 is marked by a square,

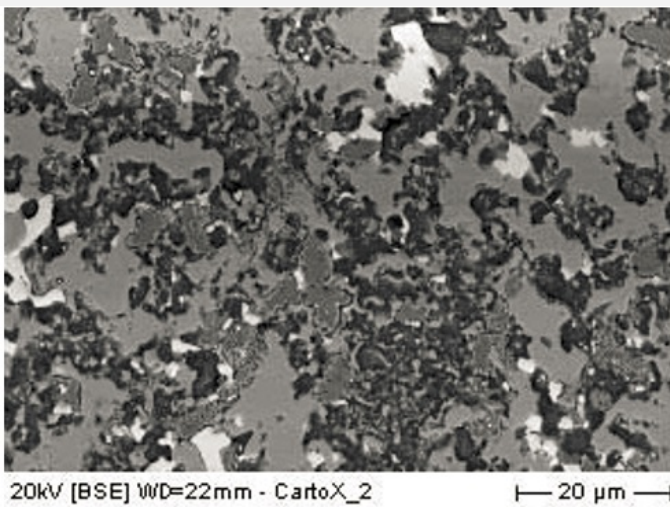
Fig. 5: SEM image, BSE-mode, detail from Fig. 4 (detail), unetched, bright field. Three phases appear: in light-grey the Zn-rich phase, in dark-grey the Al and Cu-rich phase and in white the Sn-rich phase,

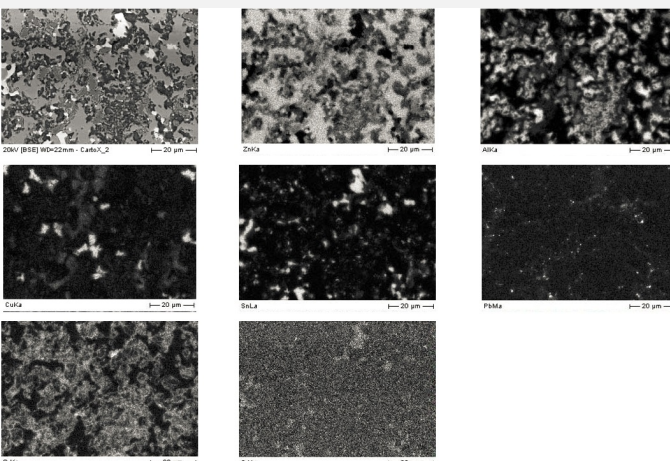
Fig. 6: SEM image, BSE-mode, and elemental chemical distribution of the selected area from Fig. 5. Method of examination: SEM/EDS, Lab of Electronic Microscopy and microanalysis, IMA (Néode), HEI Arc,

The Zn-rich phase is heavily oxidised internally (Fig. 6). The corrosion has developed throughout the entire metal body, generating cracks (Figs. 7 and 8). The cracks are Zn, O and C-rich (Fig. 9) and could be composed of zinc carbonate.

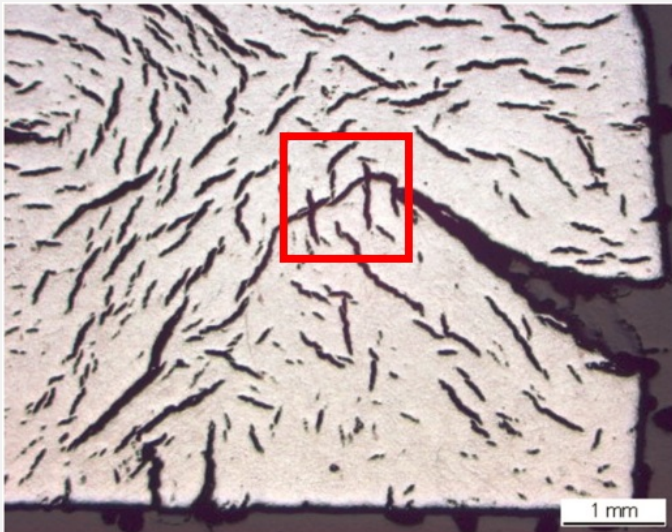
Fig. 7: Micrograph showing the metal - "corrosion products" interface from Fig. 3 (reversed picture, detail), unetched, bright field,

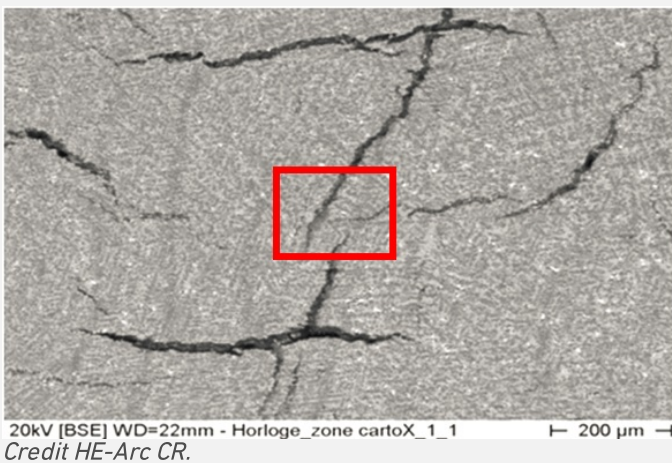
Fig. 8: Micrograph of the metal sample, detail from Fig. 7 (reversed and rotated by 90°), unetched, bright field. A dendritic structure is visible. The area selected for elementary mapping (Fig. 9) is marked by a rectangle. Can be compared to the stratigraphy representation of Fig. 10,

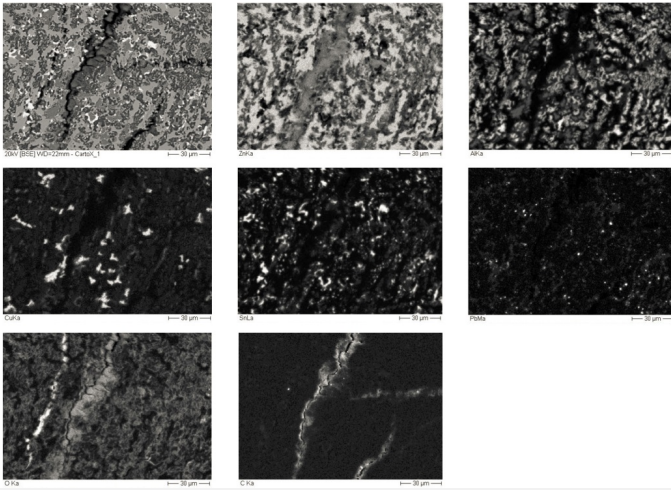
Fig. 9: SEM image, BSE-mode, and elemental chemical distribution of the selected area from Fig. 8 (detail). Method of examination: SEM/EDX, Lab of Electronic Microscopy and microanalysis, IMA (Néode), HEI Arc,

Corrosion form Internal cracking
Corrosion type zinc pest
