# ARMATURE FROM A CLOCK MOVEMENT MIH IV-212 – ZN AL SN CU ALLOY – MODERN TIMES

| Artefact name | Armature from a clock movement MIH IV-212 |
| Authors | Marianne. Senn (Empa, Dübendorf, Zurich, Switzerland) & Christian. Degriigny (HE-Arc CR, Neuchâtel, Neuchâtel, Switzerland) |

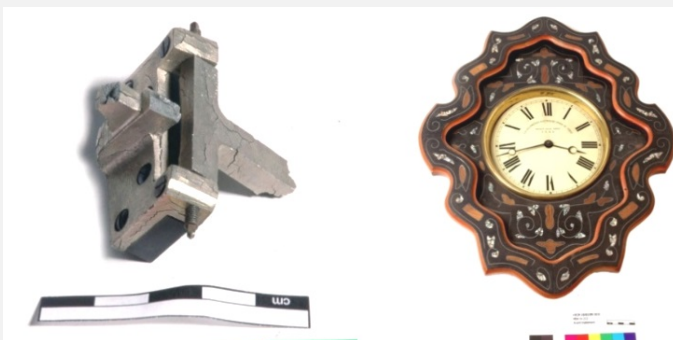
Fig. 1: Broken armature (left) from the clock movement of a wooden wall clock (right) (after Seematter 2009),

| Description of the artefact | Armature from the clock movement of a wooden wall clock with electric movement, broken in two elements (Fig. 1 and Fig. 2) with a heavily cracked surface. | |

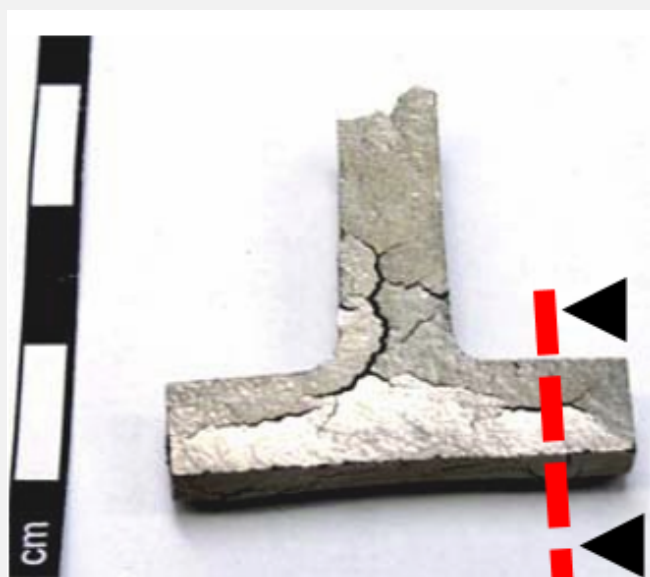
Fig. 2: Location of sampling area on one of the two broken elements of the armature,

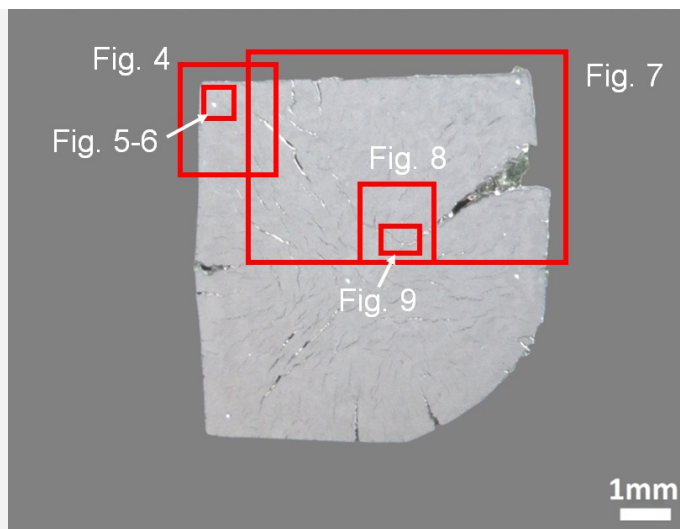
Fig. 3: Micrograph of the cross-section of the fragment sampled from the armature showing the location of Figs. 4 to 9,

| <b>Description of sample</b> | This sample is the complete cross-section from one of the two broken elements of the armature (Fig. 2). The metal has large cracks radiating from the centre to the outside which have deformed the armature (Fig. 3). |

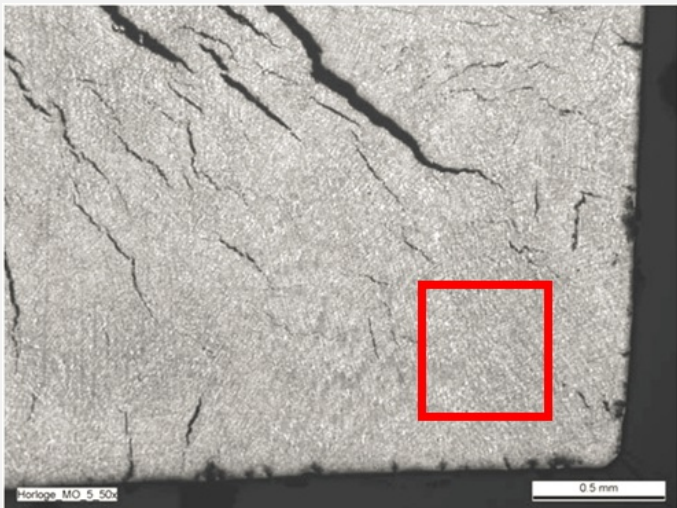
The metal is a Zn-Al-Sn-Cu alloy (Table 1) with an average hardness of HV1 105. A fine dendritic structure is observed (Fig. 4) which consists of clearly separated Zn, Al-Cu and Sn-rich phases (Figs. 5 and 6). Pb is associated with Sn but also forms tiny nodules.

Fig. 4: Micrograph of the metal sample from Fig. 3 (inverted picture, rotated by 270°, detail), unetched, bright field. A dendritic structure is visible. The micrograph of Fig. 5 is marked by a square,

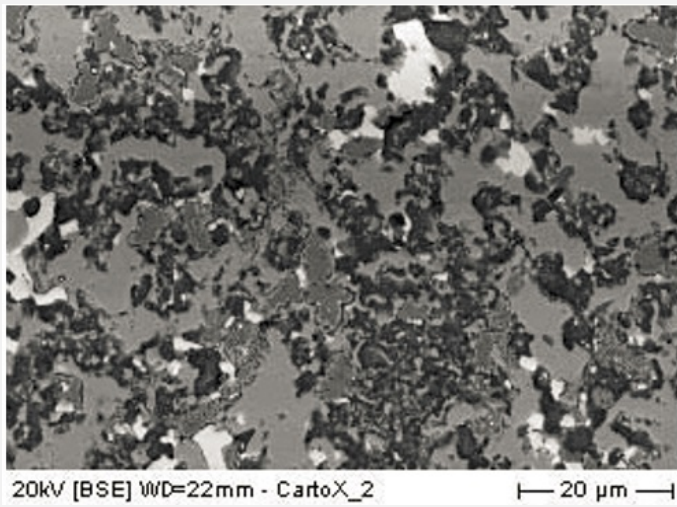
Fig. 5: SEM image, BSE-mode, detail from Fig. 4 (detail), unetched, bright field. Three phases appear: in light-grey the Zn-rich phase, in dark-grey the Al and Cu-rich phase and in white the Sn-rich phase,

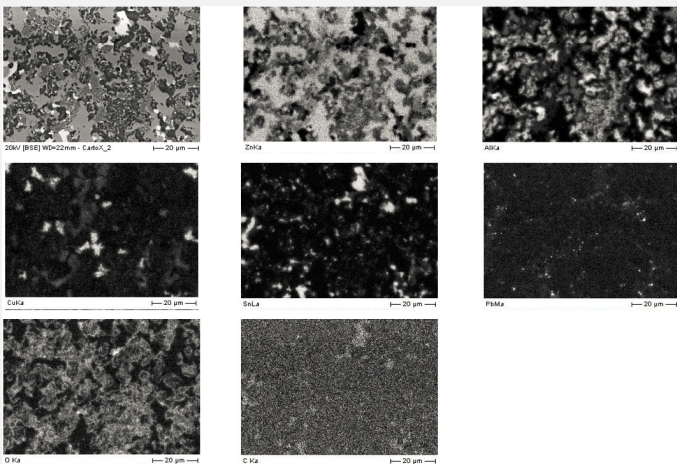
Fig. 6: SEM image, BSE-mode, and elemental chemical distribution of the selected area from Fig. 5. Method of examination: SEM/EDS, Lab of Electronic Microscopy and microanalysis, IMA (Néode), HEI Arc,

The Zn-rich phase is heavily oxidised internally (Fig. 6). The corrosion has developed throughout the entire metal body, generating cracks (Figs. 7 and 8). The cracks are Zn, O and C-rich (Fig. 9) and could be composed of zinc carbonate.

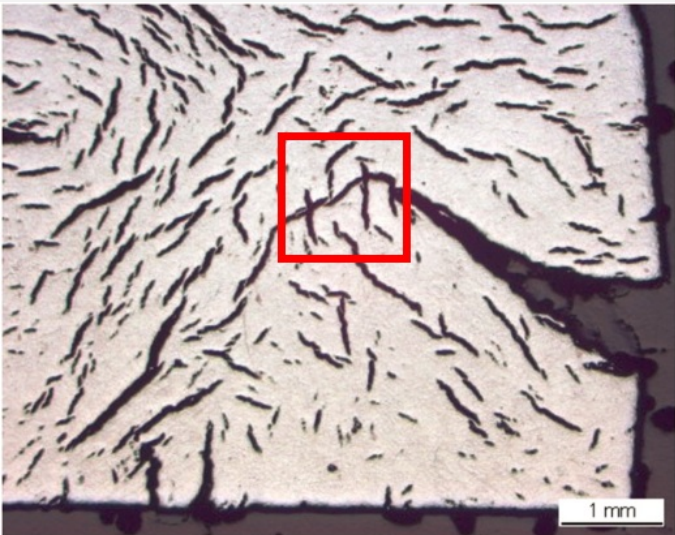
Fig. 7: Micrograph showing the metal - "corrosion products" interface from Fig. 3 (reversed picture, detail), unetched, bright field,

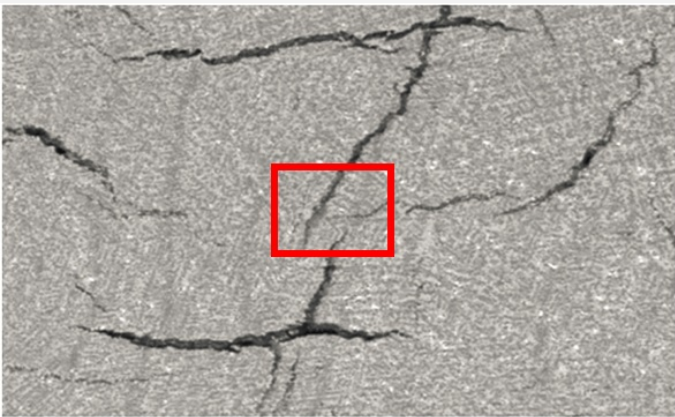
Fig. 8: Micrograph of the metal sample, detail from Fig. 7 (reversed and rotated by 90°), unetched, bright field. A dendritic structure is visible. The area selected for elementary mapping (Fig. 9) is marked by a rectangle. Can be compared to the stratigraphy representation of Fig. 10,

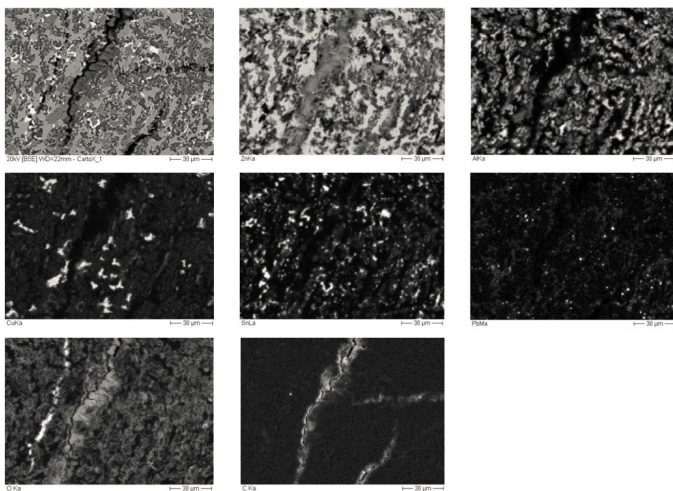
Fig. 9: SEM image, BSE-mode, and elemental chemical distribution of the selected area from Fig. 8 (detail). Method of examination: SEM/EDX, Lab of Electronic Microscopy and microanalysis, IMA (Néode), HEI Arc,
