SHOE NAIL 2637 1370.B. – HYPOEUTECTOID STEEL – ROMAN TIMES – SWITZERLAND

Artefact name	Shoe nail 2637 1370.B.
Authors	Christian. Degriigny (HE-Arc CR, Neuchâtel, Neuchâtel, Switzerland) & Valentin. Boissonnas (HE-Arc CR, Neuchâtel, Neuchâtel, Switzerland) & Vincent Chappuis. (HE-Arc CR, Neuchâtel, Neuchâtel, Switzerland)
Url	/artefacts/907/

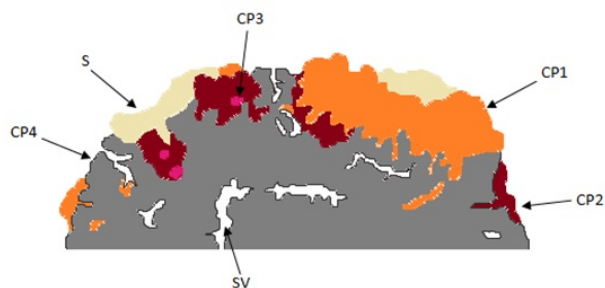
S = compact sand-clay soil.
 CP1 = powdery soil, orange-coloured by corrosion products.
 CP2 = dark-red corrosion crust, breaks into bits.
 CP3 = vivid pink-red and globular corrosion products.
 CP4 = dark grey to black and very hard corrosion products, results in a dark-orange powder when scratched.
 SV = structural void near the center of the cross section, seems to draw a square shape.

Fig. 3: Preliminary stratigraphy of the corrosion layers based on the observation of a broken nail,

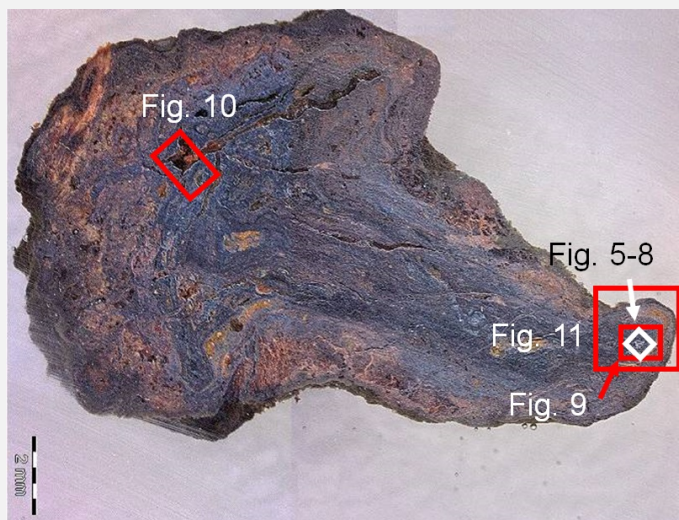
Fig. 4: Micrograph of the cross-section of the nail showing the location of figs. 5 to 11,

Description of sample	A longitudinal cut through the nail (Fig. 4). Dimensions: L = 16.4mm; W = about 12.0mm.
Alloy	Hypoeutectoid steel
Technology	Forged
Lab number of sample	HE-Arc CR 1457-S1.
Sample location	HE-Arc CR, Neuchâtel, Neuchâtel
Responsible institution	HE-Arc CR, Neuchâtel, Neuchâtel

The metal is heavily corroded and the thickness of the corrosion crust is irregular, varying from 0.8 to 3.8mm, with an average of about 2mm. The corrosion has replaced most of the metal (Fig. 4). Between corrosion layers the limit of the original structure is visible. Some leather fibers seem to be preserved as pseudomorphic structures in voids of the metal core (POM1, Figs. 9 and 10). The carbon mapping (Fig.11) shows the presence of carbon in these areas. This can also be due to the penetration of the mounting resin in the cracks.

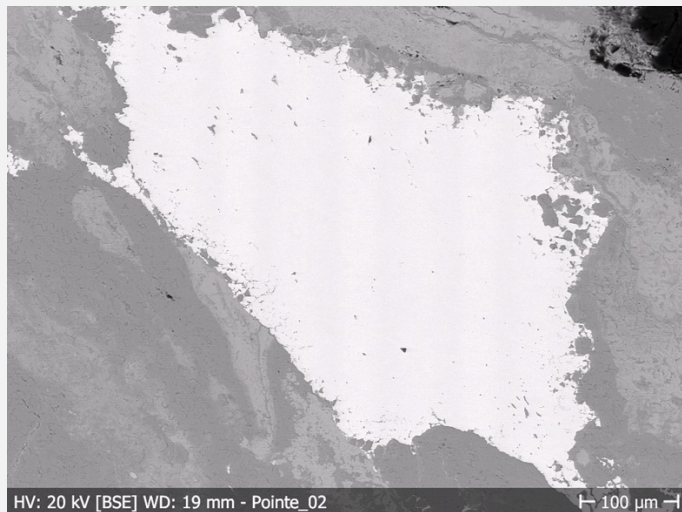
The remaining metal is an hypoeutectoid steel (Fig. 5 and 6), containing Fe, Si and O slags inclusions (possibly fayalite FeO, SiO_2), and consisting of less than 1% of the total volume of the highly mineralized nail. After Nital etching, it shows intergranular corrosion on one of its sides (Figs. 7 and 8).

Fig. 5: SEM, BSE-mode picture of remaining metal from cross-section of Fig. 4,

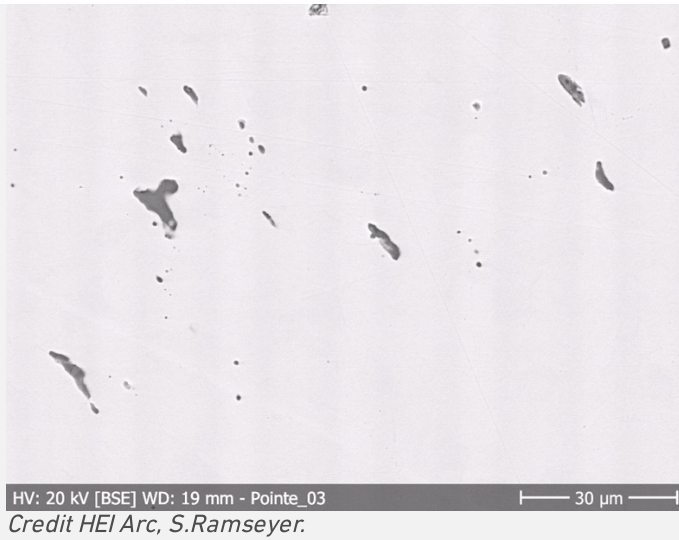
Fig. 6: SEM, BSE-mode picture of inclusions in remaining metal (detail of Fig. 5),

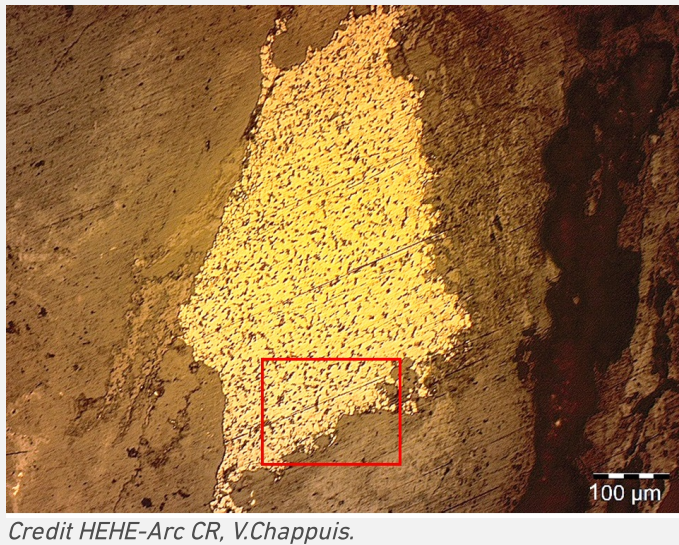
Fig. 7: Micrograph of the metal sample from Fig. 5 (detail, rotated 90°), Nital etched, bright field, with indication of Fig. 8 (red rectangle)

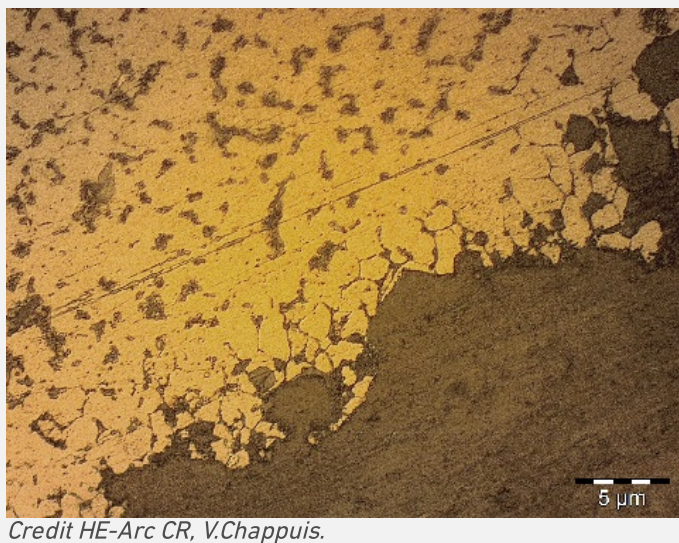
Fig. 8: Micrograph of the selected area of Fig. 7, Nital etched with no clear grain structure, bright field, Intergranular corrosion and grey phase (perlite?) are observed,

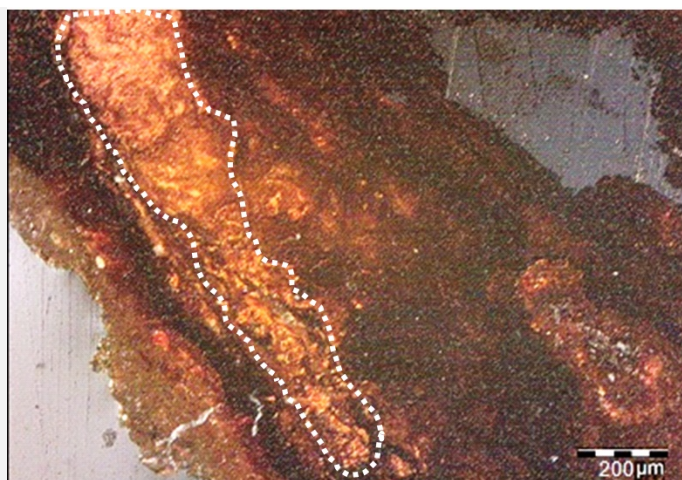
Fig. 9: Micrograph of the metal sample from Fig. 4, bright field. The delimited zone shows what could be leather pseudomorphic fibers filling a void,

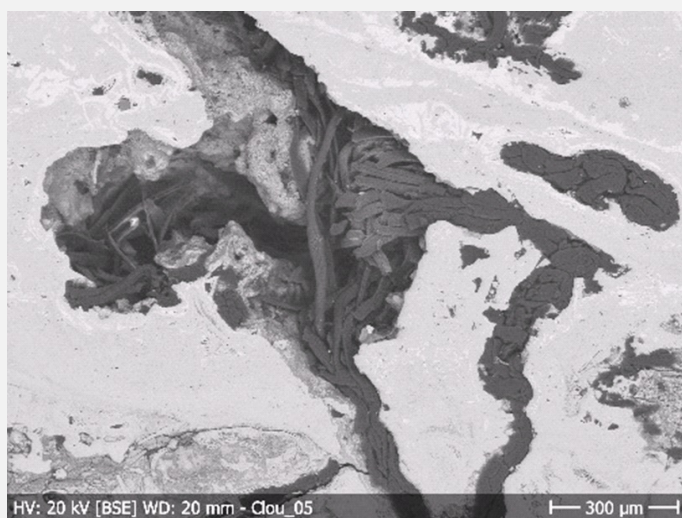
Fig. 10: SEM - BSE-mode picture of another void filled with fibers in the head of the nail (see Fig. 4),

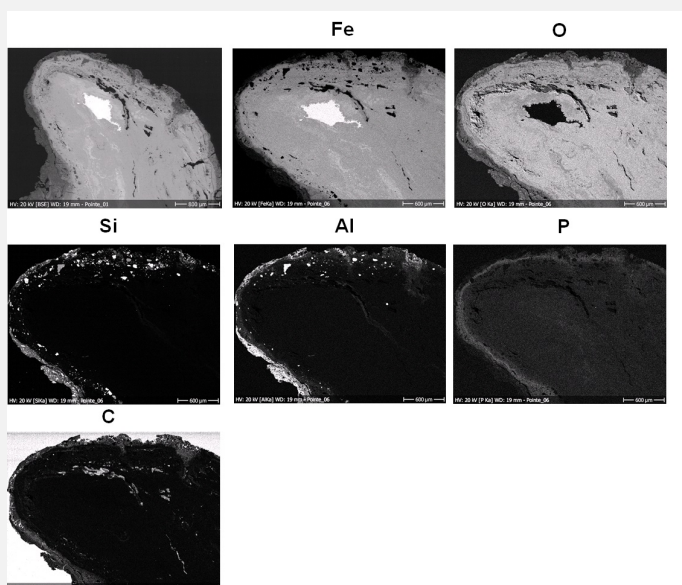
Si, Al, P and K can be considered external markers, helping to determine the limit of the original surface (Fig. 11 and Table 1). The outer layer of corrosion products (CP1-3) ranges from dark grey to orange in bright field and contains less O and Fe on its borders than the inner layer (CP4-5, Figs. 4 and 11, Table 1). The SEM pictures show a marbling appearance of the inner corrosion layer (CP5). Cl and S do not seem to be present in the sampled nail.

Fig. 11: Elemental chemical distribution of the selected area from Fig. 4 (90° counter-clockwise rotated). SEM-EDS,

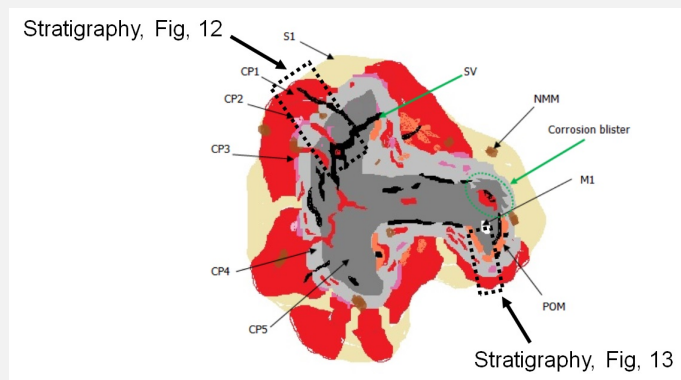
The schematic representation of corrosion layers of Fig. 3 integrating additional information based on the analyses carried out is given in Fig. 14. The following strata were identified:

S1 = sand-clay soil, compact, cemented when dry, powdery when abraded, very thin particle size (usually about and less than 0.1mm). Undefined thickness (soil).

CP1 = powdery orange (loosely coherent) and matte corrosion crust, sometimes forming humps. Partially mixed with S1 and POM layers (diffused interfaces). 1 to 5 millimeters thick.

CP2 = vivid red or pink dots, more brittle than powdery (loose cohesion) and mostly matte, only two or three observed, always above CP3 interfaces. Usually 1 mm spheric diameter.

CP3 = dark reddish corrosion product, forming smooth, matte and brittle layers that are parallel to CP4, with a clean and regular interface. The corrosion products are generally hard, but sometimes break up into grains, resulting in a more irregular interface. The layer is approximately 0.5mm thick.

CP4 = dark grey to black corrosion product, smooth with pseudo-metallic reflection (a bit glossy), very hard, when scratched results in orange powder, with somewhat irregular shape and thickness (ranging from 0.3 to 2mm).

CP5 = dark grey to black corrosion product, generally a bit darker than CP4. Smooth with pseudo-metallic reflection, even harder than CP4 and when scratched it turns into an orange coloured powder. Irregular interface regarding CP4. Clear transition and somewhat parallel from CP4 to CP5. As regards its thickness, it fills the remaining volume.

POM = mostly powdery and grain-like material, ranging from orange to dark brown in colour, somewhat glossy and similar to crystals when illuminated. A few fiber-like zones are present, which are more satin than glossy. They are dark brown to charcoal black, very brittle and break into a powdery and grain-like material. POM is located above or close to CP3 and CP4 layers, sometimes mixed into S1 or CP1 layers with a diffused interface. Overall, the stratum is approximately 0.2-0.3mm thick.

SV = structural void, present as fissures that either pass through the different layers, or are present at corrosion interfaces, especially at the CP4/CP5 interface. The void is 0.1 to 0.3mm thick and partially filled with POM in the outer layers.

Fig. 14: Improved stratigraphic representation of the nail from visual observations and analyses and visualization of the two stratigraphies of Figs, 12 and 13,
