# SHOE NAIL 2637 1370.B. – HYPOEUTECTOID STEEL – ROMAN TIMES – SWITZERLAND

Artefact name	Shoe nail 2637 1370.B.
Authors	Christian. Degriigny (HE-Arc CR, Neuchâtel, Neuchâtel, Switzerland) & Valentin. Boissonnas (HE-Arc CR, Neuchâtel, Neuchâtel, Switzerland) & Vincent Chappuis. (HE-Arc CR, Neuchâtel, Neuchâtel, Switzerland)
Url	/artefacts/907/

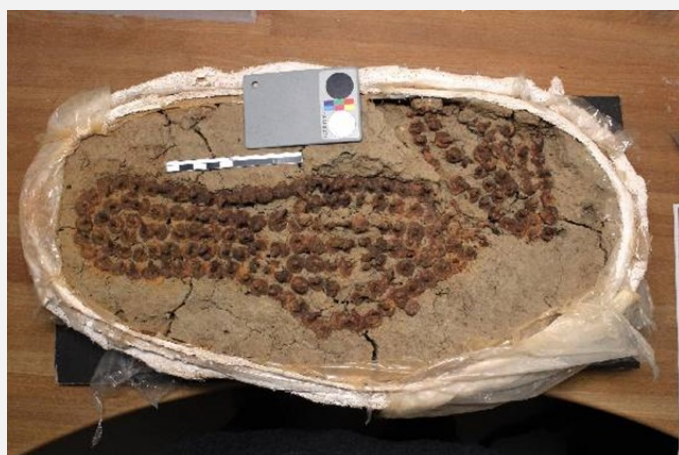
Fig. 1: A Roman shoe nail from a block taken from an excavation site before conservation,

Description of the artefact	A Roman shoe nail from a block taken from an excavation site (Fig. 1) covered with a thick corrosion crust. The forged nails were hammered into the leather soles on a bucking tool. Average dimensions of the shoe nails: L = about 14mm; diamter = 11mm; W = up to 0.8g.		
Type of artefact	Shoe nail		
Origin	Hofstetterfeld, near Roman Necropolis, Sursee, Lucerne, Switzerland		
Recovering date	Unknown		
Chronology category	Roman Times		
chronology tpq	50	A.D. ▼	
chronology taq	100	A.D. ▼

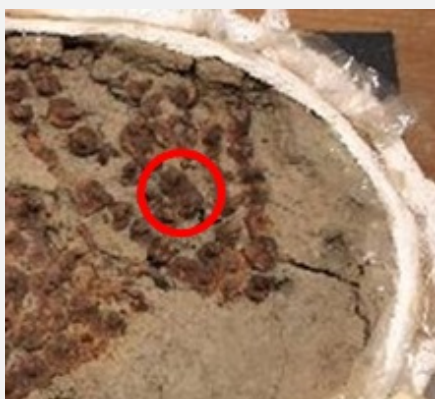
Fig. 2: Incomplete shoe from which the nail was sampled (in red circle),

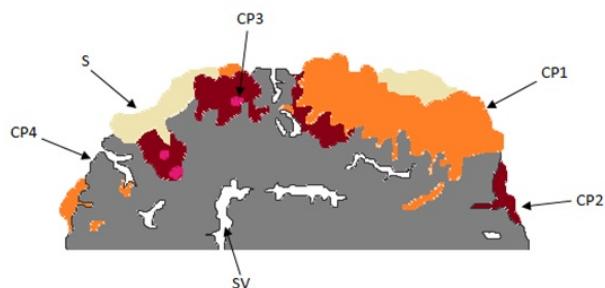
Fig. 3: Preliminary stratigraphy of the corrosion layers based on the observation of a broken nail,

S = compact sand-clay soil.  
 CP1 = powdery soil, orange-coloured by corrosion products.  
 CP2 = dark-red corrosion crust, breaks into bits.  
 CP3 = vivid pink-red and globular corrosion products.  
 CP4 = dark grey to black and very hard corrosion products, results in an dark-orange powder when scratched.  
 SV = structural void near the center of the cross section, seems to draw a square shape.

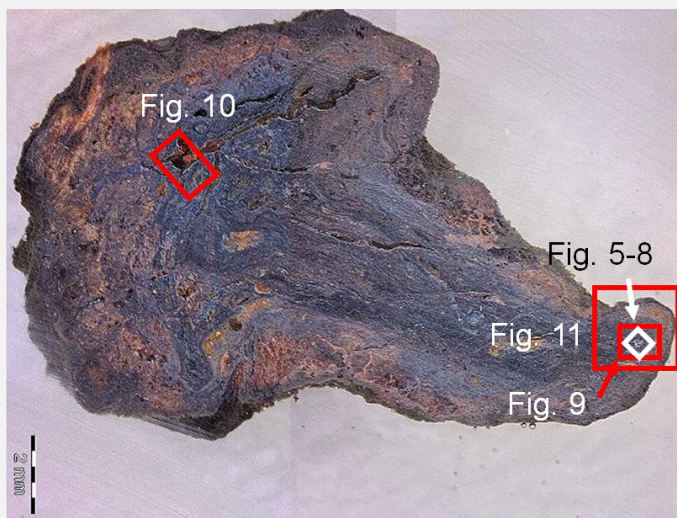
Fig. 4: Micrograph of the cross-section of the nail showing the location of figs. 5 to 11,

<b>Description of sample</b>	A longitudinal cut through the nail (Fig. 4). Dimensions: L = 16.4mm; W = about 12.0mm.
<b>Alloy</b>	Hypoeutectoid steel
<b>Technology</b>	Forged
<b>Lab number of sample</b>	HE-Arc CR 1457-S1.
<b>Sample location</b>	HE-Arc CR, Neuchâtel, Neuchâtel
<b>Responsible institution</b>	HE-Arc CR, Neuchâtel, Neuchâtel

The metal is heavily corroded and the thickness of the corrosion crust is irregular, varying from 0.8 to 3.8mm, with an average of about 2mm. The corrosion has replaced most of the metal (Fig. 4). Between corrosion layers the limit of the original structure is visible. Some leather fibers seem to be preserved as pseudomorphic structures in voids of the metal core (POM1, Figs. 9 and 10). The carbon mapping (Fig.11) shows the presence of carbon in these areas. This can also be due to the penetration of the mounting resin in the cracks.

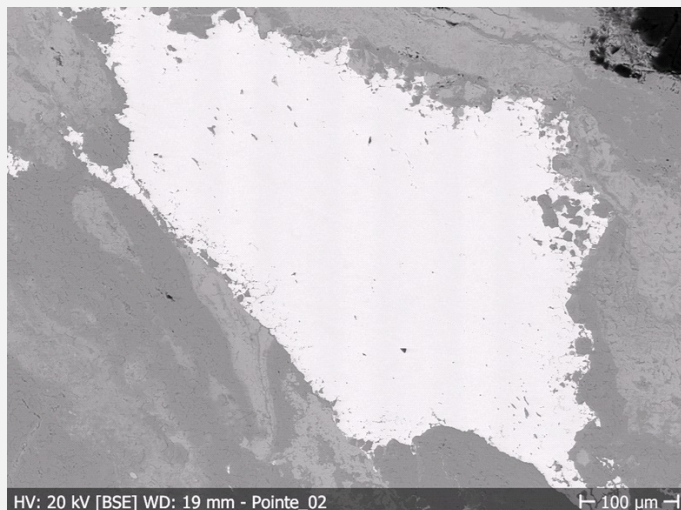
The remaining metal is an hypoeutectoid steel (Fig. 5 and 6), containing Fe, Si and O slags inclusions (possibly fayalite  $\text{FeO}, \text{SiO}_2$ ), and consisting of less than 1% of the total volume of the highly mineralized nail. After Nital etching, it shows intergranular corrosion on one of its sides (Figs. 7 and 8).

Fig. 5: SEM, BSE-mode picture of remaining metal from cross-section of Fig. 4,

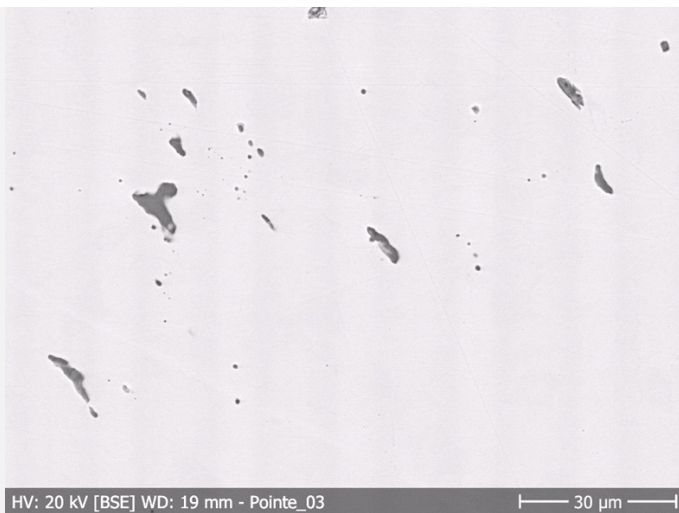
Fig. 6: SEM, BSE-mode picture of inclusions in remaining metal (detail of Fig. 5),

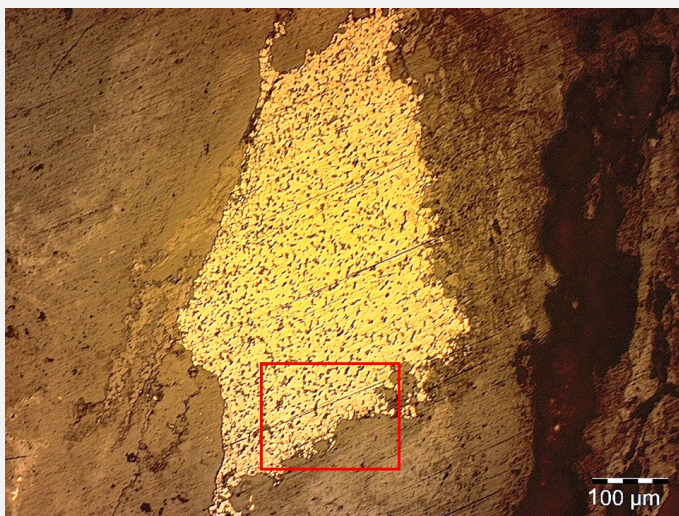
Fig. 7: Micrograph of the metal sample from Fig. 5 (detail, rotated 90°), Nital etched, bright field, with indication of Fig. 8 (red rectangle)

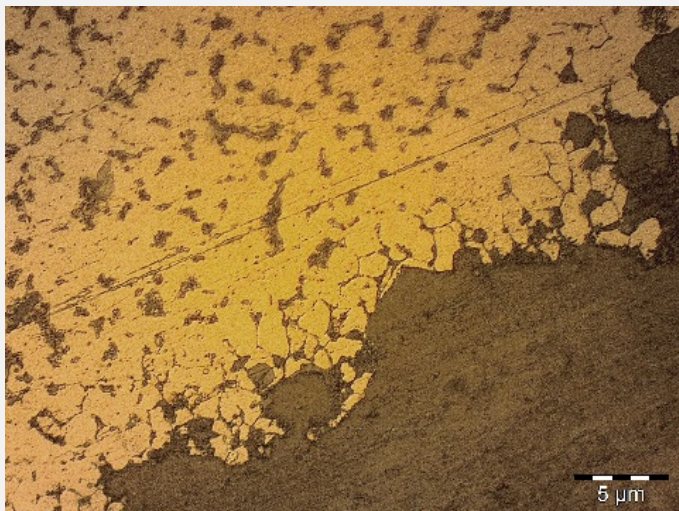
Fig. 8: Micrograph of the selected area of Fig. 7, Nital etched with no clear grain structure, bright field, Intergranular corrosion and grey phase (perlite?) are observed,

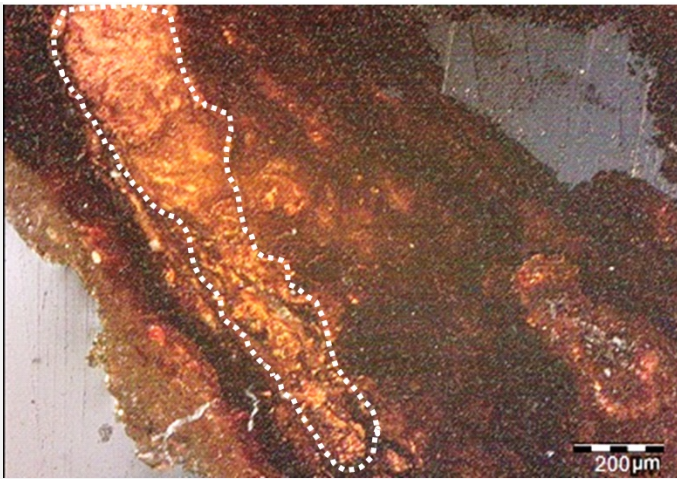
Fig. 9: Micrograph of the metal sample from Fig. 4, bright field. The delimited zone shows what could be leather pseudomorphic fibers filling a void,

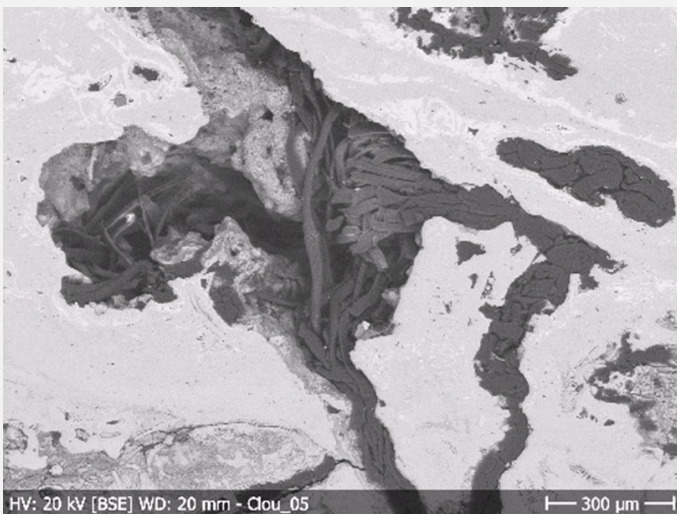
Fig. 10: SEM - BSE-mode picture of another void filled with fibers in the head of the nail (see Fig. 4),

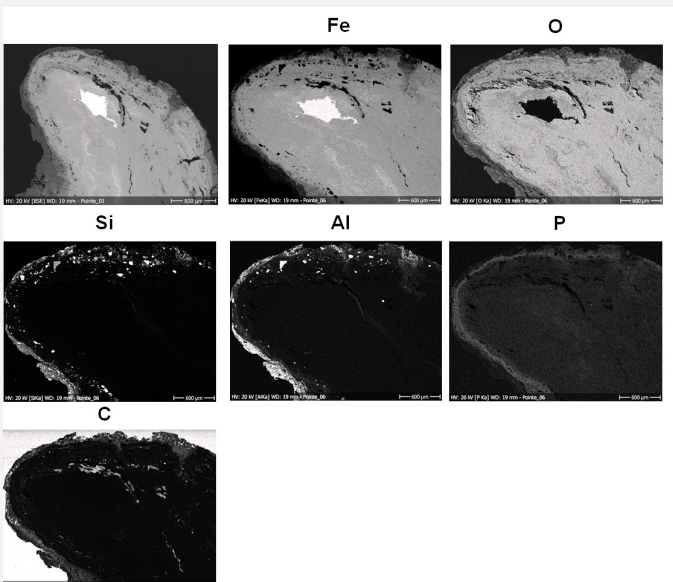
Si, Al, P and K can be considered external markers, helping to determine the limit of the original surface (Fig. 11 and Table 1). The outer layer of corrosion products (CP1-3) ranges from dark grey to orange in bright field and contains less O and Fe on its borders than the inner layer (CP4-5, Figs. 4 and 11, Table 1). The SEM pictures show a marbling appearance of the inner corrosion layer (CP5). Cl and S do not seem to be present in the sampled nail.

Fig. 11: Elemental chemical distribution of the selected area from Fig. 4 (90° counter-clockwise rotated). SEM-EDS,

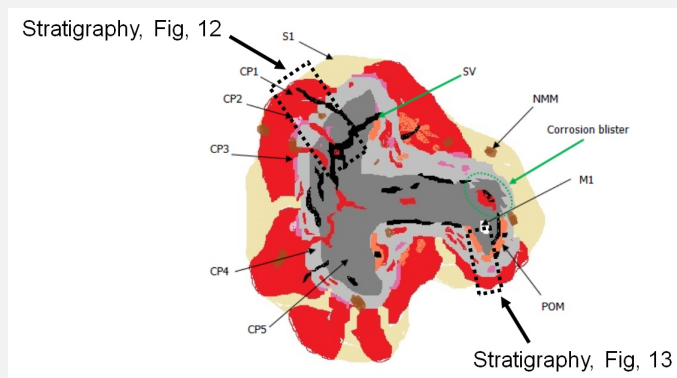
The schematic representation of corrosion layers of Fig. 3 integrating additional information based on the analyses carried out is given in Fig. 14. The following strata were identified:

S1 = sand-clay soil, compact, cemented when dry, powdery when abraded, very thin particle size (usually about and less than 0.1mm). Undefined thickness (soil).

CP1 = powdery orange (loosely coherent) and matte corrosion crust, sometimes forming humps. Partially mixed with S1 and POM layers (diffused interfaces). 1 to 5 millimeters thick.

CP2 = vivid red or pink dots, more brittle than powdery (loose cohesion) and mostly matte, only two or three observed, always above CP3 interfaces. Usually 1 mm spheric diameter.

CP3 = dark reddish corrosion product, forming smooth, matte and brittle layers that are parallel to CP4, with a clean and regular interface. The corrosion products are generally hard, but sometimes break up into grains, resulting in a more irregular interface. The layer is approximately 0.5mm thick.

CP4 = dark grey to black corrosion product, smooth with pseudo-metallic reflection (a bit glossy), very hard, when scratched results in orange powder, with somewhat irregular shape and thickness (ranging from 0.3 to 2mm).

CP5 = dark grey to black corrosion product, generally a bit darker than CP4. Smooth with pseudo-metallic reflection, even harder than CP4 and when scratched it turns into an orange coloured powder. Irregular interface regarding CP4. Clear transition and somewhat parallel from CP4 to CP5. As regards its thickness, it fills the remaining volume.

POM = mostly powdery and grain-like material, ranging from orange to dark brown in colour, somewhat glossy and similar to crystals when illuminated. A few fiber-like zones are present, which are more satin than glossy. They are dark brown to charcoal black, very brittle and break into a powdery and grain-like material. POM is located above or close to CP3 and CP4 layers, sometimes mixed into S1 or CP1 layers with a diffused interface. Overall, the stratum is approximately 0.2-0.3mm thick.

SV = structural void, present as fissures that either pass through the different layers, or are present at corrosion interfaces, especially at the CP4/CP5 interface. The void is 0.1 to 0.3mm thick and partially filled with POM in the outer layers.

Fig. 14: Improved stratigraphic representation of the nail from visual observations and analyses and visualization of the two stratigraphies of Figs, 12 and 13,
