SHOE NAIL 2637 1370.B. - HYPOEUTECTOID STEEL - ROMAN TIMES - SWITZERLAND

Artefact name Shoe nail 2637 1370.B.

Authors Christian. Degriigny (HE-Arc CR, Neuchâtel, Neuchâtel, Switzerland) & Valentin. Boissonnas (HE-Arc CR, Neuchâtel, Neuchâtel, Switzerland) & Vincent Chappuis. (HE-Arc CR, Neuchâtel, Neuchâtel, Switzerland)

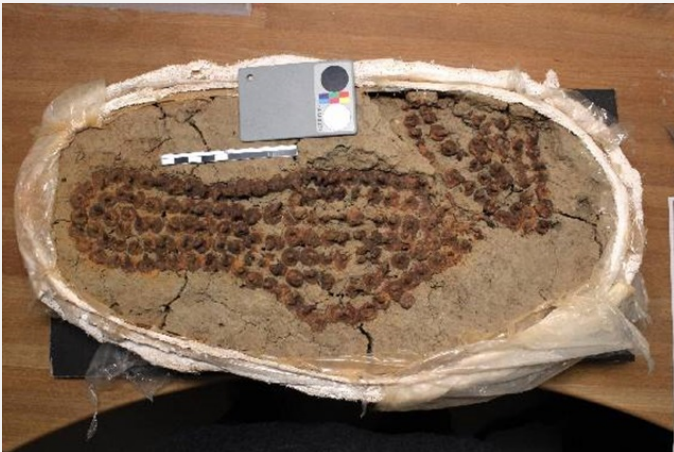
Fig. 1: A Roman shoe nail from a block taken from an excavation site before conservation,

Description of the artefact	A Roman shoe nail from a block taken from an excavation site (Fig. 1) covered with a thick corrosion crust. The forged nails were hammered into the leather soles on a bucking tool. Average dimensions of the shoe nails: L = about 14mm; diamter = 11mm; W = up to 0.8g.
Type of artefact	Shoe nail
Origin	Hofstetterfeld, near Roman Necropolis, Sursee, Lucerne, Switzerland
Recovering date	Unknown
Chronology category	Roman Times
chronology tpq	<input type="text" value="50"/> A.D. ∨
chronology taq	<input type="text" value="100"/> A.D. ∨

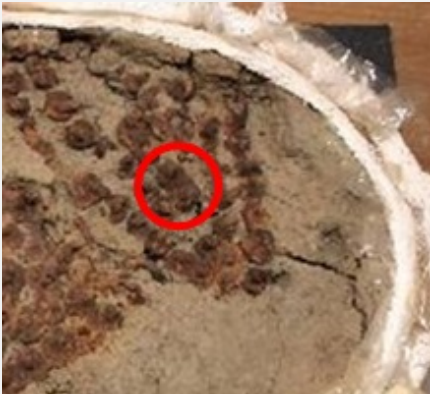
Fig. 2: Incomplete shoe from which the nail was sampled (in red circle),

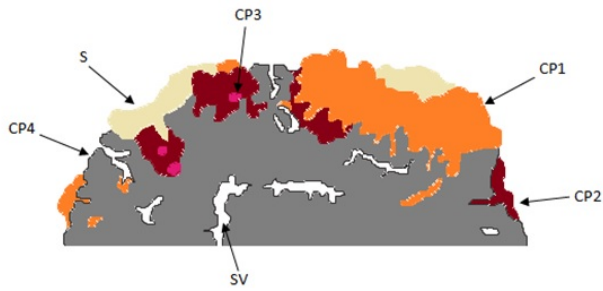
Fig. 3: Preliminary stratigraphy of the corrosion layers based on the observation of a broken nail,

S = compact sand-clay soil.
 CP1 = powdery soil, orange-coloured by corrosion products.
 CP2 = dark-red corrosion crust, breaks into bits.
 CP3 = vivid pink-red and globular corrosion products.
 CP4 = dark grey to black and very hard corrosion products, results in an dark-orange powder when scratched.
 SV = structural void near the center of the cross section, seems to draw a square shape.

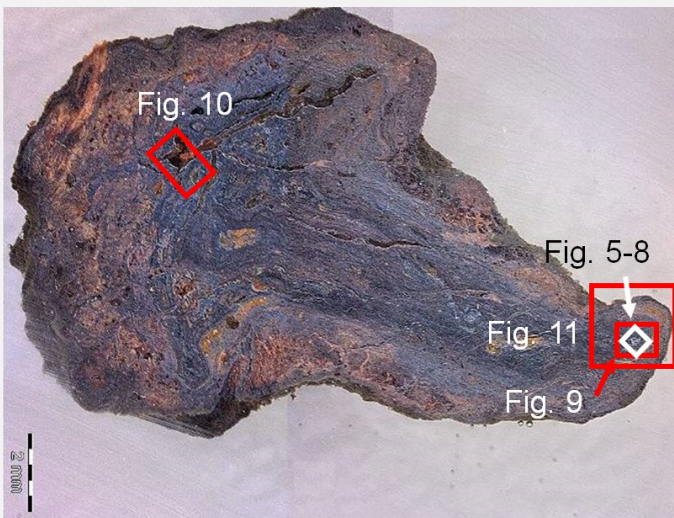
Fig. 4: Micrograph of the cross-section of the nail showing the location of figs. 5 to 11,

Description of sample	A longitudinal cut through the nail (Fig. 4). Dimensions: L = 16.4mm; W = about 12.0mm.
Alloy	Hypoeutectoid steel
Technology	Forged
Lab number of sample	HE-Arc CR 1457-S1.
Sample location	HE-Arc CR, Neuchâtel, Neuchâtel
Responsible institution	HE-Arc CR, Neuchâtel, Neuchâtel

The metal is heavily corroded and the thickness of the corrosion crust is irregular, varying from 0.8 to 3.8mm, with an average of about 2mm. The corrosion has replaced most of the metal (Fig. 4). Between corrosion layers the limit of the original structure is visible. Some leather fibers seem to be preserved as pseudomorphic structures in voids of the metal core (POM1, Figs. 9 and 10). The carbon mapping (Fig.11) shows the presence of carbon in these areas. This can also be due to the penetration of the mounting resin in the cracks.

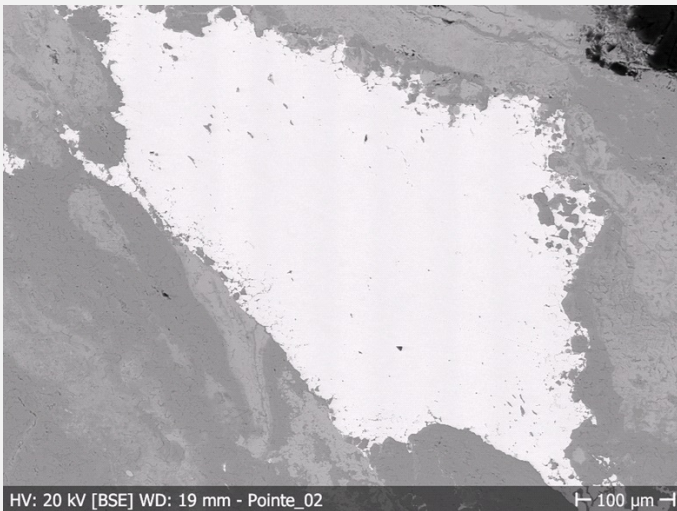
The remaining metal is an hypoeutectoid steel (Fig. 5 and 6), containing Fe, Si and O slags inclusions (possibly fayalite FeO, SiO_2), and consisting of less than 1% of the total volume of the highly mineralized nail. After Nital etching, it shows intergranular corrosion on one of its sides (Figs. 7 and 8).

Fig. 5: SEM, BSE-mode picture of remaining metal from cross-section of Fig. 4,

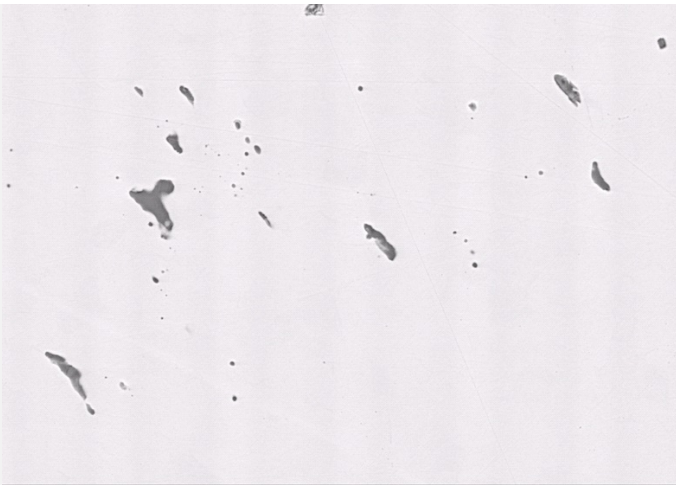
Fig. 6: SEM, BSE-mode picture of inclusions in remaining metal (detail of Fig. 5),

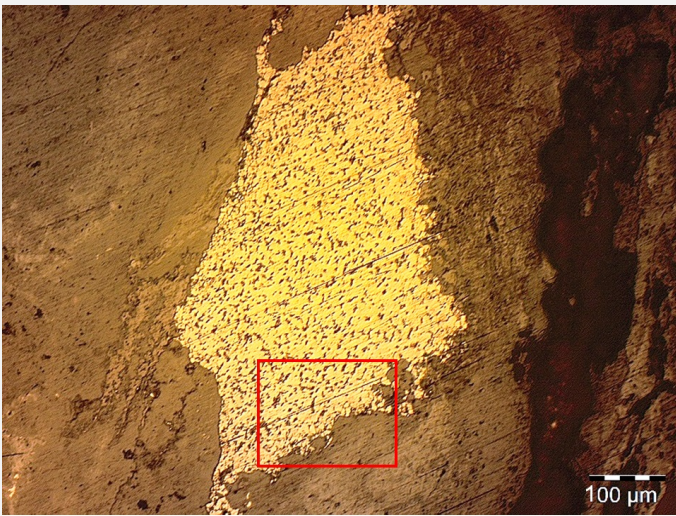
Fig. 7: Micrograph of the metal sample from Fig. 5 (detail, rotated 90°), Nital etched, bright field, with indication of Fig. 8 (red rectangle)

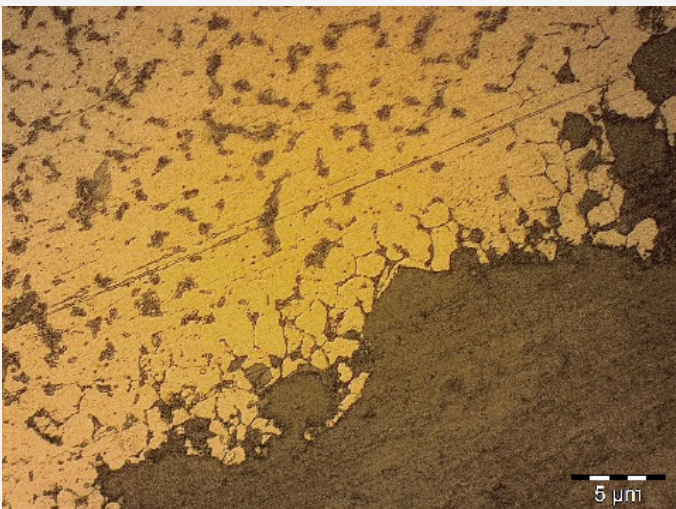
Fig. 8: Micrograph of the selected area of Fig. 7, Nital etched with no clear grain structure, bright field, Intergranular corrosion and grey phase (perlite?) are observed,

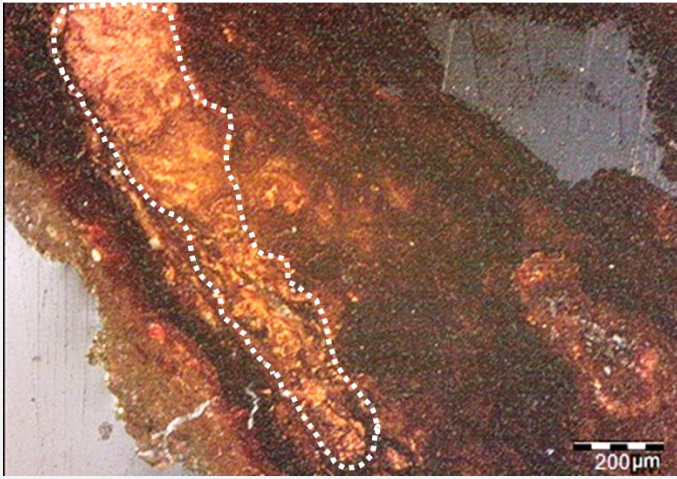
Fig. 9: Micrograph of the metal sample from Fig. 4, bright field. The delimited zone shows what could be leather pseudomorphic fibers filling a void,

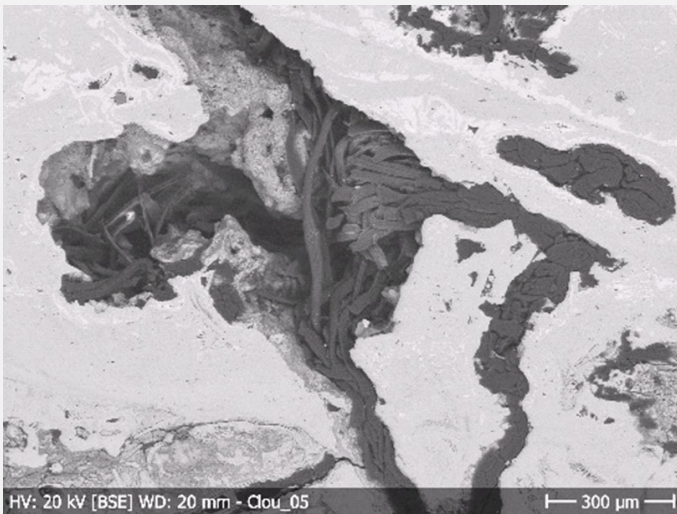
Fig. 10: SEM - BSE-mode picture of another void filled with fibers in the head of the nail (see Fig. 4),

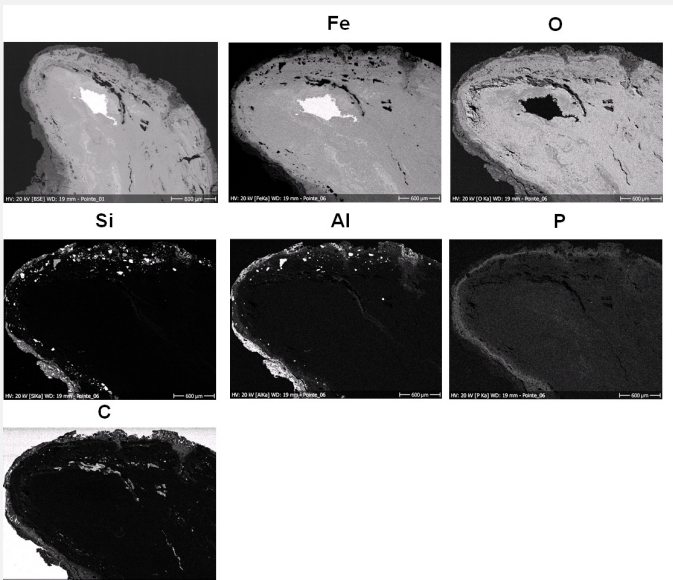
Si, Al, P and K can be considered external markers, helping to determine the limit of the original surface (Fig. 11 and Table 1). The outer layer of corrosion products (CP1-3) ranges from dark grey to orange in bright field and contains less O and Fe on its borders than the inner layer (CP4-5, Figs. 4 and 11, Table 1). The SEM pictures show a marbling appearance of the inner corrosion layer (CP5). Cl and S do not seem to be present in the sampled nail.

Fig. 11: Elemental chemical distribution of the selected area from Fig. 4 (90° counter-clockwise rotated). SEM-EDS,

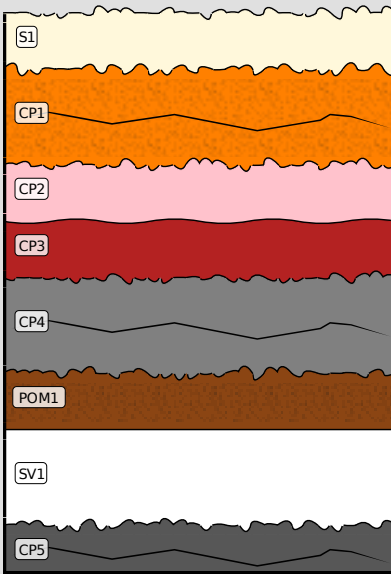
Fig. 12: Stratigraphic representation of the nail in cross-section (dark field) using the MiCorr application. The characteristics of the strata are only accessible by clicking on the drawing that redirects you to the search tool by stratigraphy representation. This representation can be compared to Fig. 14, Credit HE-Arc CR, V.Chappuis.

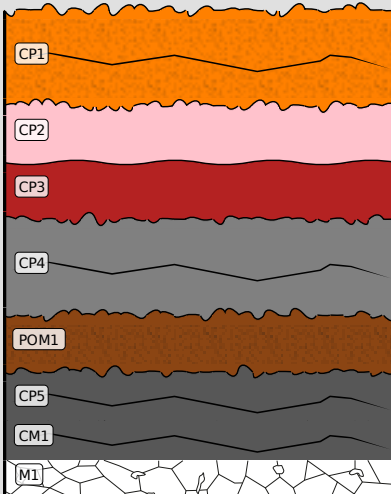
Fig. 13: Stratigraphic representation of the nail in cross-section (dark field) using the MiCorr application. The characteristics of the strata are only accessible by clicking on the drawing that redirects you to the search tool by stratigraphy representation. This representation can be compared to Fig. 14, Credit HE-Arc CR, V.Chappuis.
