# SHOE NAIL 2637 1370.B. - HYPOEUTECTOID STEEL - ROMAN TIMES - SWITZERLAND

**Artefact name** Shoe nail 2637 1370.B.

**Authors** Christian. Degrigny (HE-Arc CR, Neuchâtel, Neuchâtel, Switzerland) & Valentin. Boissonnas (HE-Arc CR, Neuchâtel, Neuchâtel, Switzerland) & Vincent Chappuis. (HE-Arc CR, Neuchâtel, Neuchâtel, Switzerland)

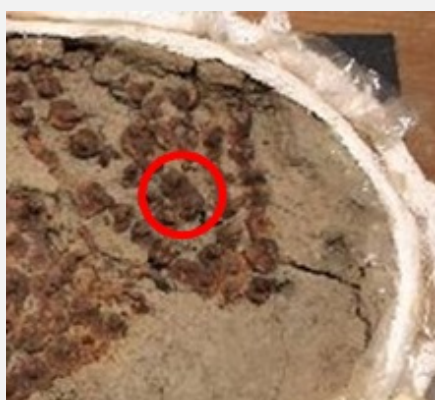
Fig. 2: Incomplete shoe from which the nail was sampled (in red circle),

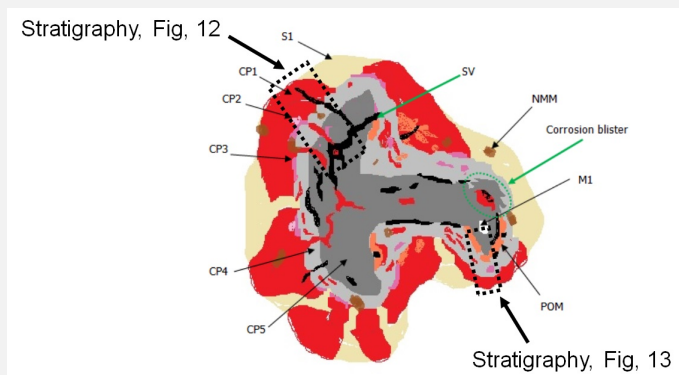
The schematic representation of corrosion layers of Fig. 3 integrating additional information based on the analyses carried out is given in Fig. 14. The following strata were identified:

S1 = sand-clay soil, compact, cemented when dry, powdery when abraded, very thin particle size (usually about and less than 0.1mm). Undefined thickness (soil).

CP1 = powdery orange (loosely coherent) and matte corrosion crust, sometimes forming humps. Partially mixed with S1 and POM layers (diffused interfaces). 1 to 5 millimeters thick.

CP2 = vivid red or pink dots, more brittle than powdery (loose cohesion) and mostly matte, only two or three observed, always above CP3 interfaces. Usually 1 mm spheric diameter.

CP3 = dark reddish corrosion product, forming smooth, matte and brittle layers that are parallel to CP4, with a clean and regular interface. The corrosion products are generally hard, but sometimes break up into grains, resulting in a more irregular interface. The layer is approximately 0.5mm thick.

CP4 = dark grey to black corrosion product, smooth with pseudo-metallic reflection (a bit glossy), very hard, when scratched results in orange powder, with somewhat irregular shape and thickness (ranging from 0.3 to 2mm).

CP5 = dark grey to black corrosion product, generally a bit darker than CP4. Smooth with pseudo-metallic reflection, even harder than CP4 and when scratched it turns into an orange coloured powder. Irregular interface regarding CP4. Clear transition and somewhat parallel from CP4 to CP5. As regards its thickness, it fills the remaining volume.

NMM = silica and calcareous inclusions.

POM = mostly powdery and grain-like material, ranging from orange to dark brown in colour, somewhat glossy and similar to crystals when illuminated. A few fiber-like zones are present, which are more satin than glossy. They are dark brown to charcoal black, very brittle and break into a powdery and grain-like material. POM is located above or close to CP3 and CP4 layers, sometimes mixed into S1 or CP1 layers with a diffused interface. Overall, the stratum is approximately 0.2-0.3mm thick.

SV = structural void, present as fissures that either pass through the different layers, or are present at corrosion interfaces, especially at the CP4/CP5 interface. The void is 0.1 to 0.3mm thick and partially filled with POM in the outer layers.

M1 = glossy with metallic reflection.

Fig. 14: Improved stratigraphic representation of the nail from visual observations and analyses and visualization of the two stratigraphies of Figs, 12 and 13,
