COFFEE FILTER – AL ALLOY – MODERN TIMES – FRANCE

Artefact name Coffee filter

Authors Christian. Degriigny (HE-Arc CR, Neuchâtel, Neuchâtel, Switzerland)

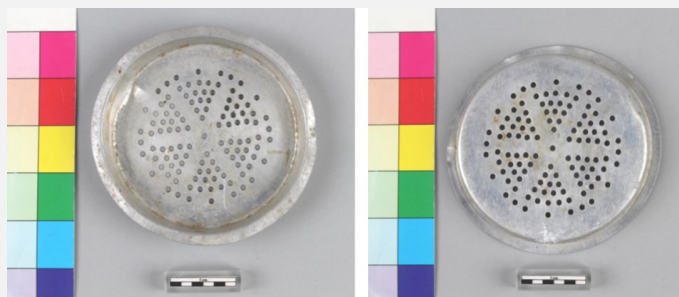
Fig. 1: Front and back sides of a coffee filter,

Description of the artefact	Coffee filter with traces of use (deposits, deformation) and presence of local filiform corrosion (Fig. 1). Dimensions: ø.ext. = 10cm.
Type of artefact	Household implement
Origin	Château de Germolles, Mellecey, Bourgogne, France
Recovering date	Unknown
Chronology category	Modern Times
chronology tpq	1960 A.D. ▼
chronology taq	2000 A.D. ▼
Chronology comment	20th century
Burial conditions / environment	Outdoor atmosphere
Artefact location	Château de Germolles, Mellecey, Bourgogne
Owner	Château de Germolles, Mellecey, Bourgogne

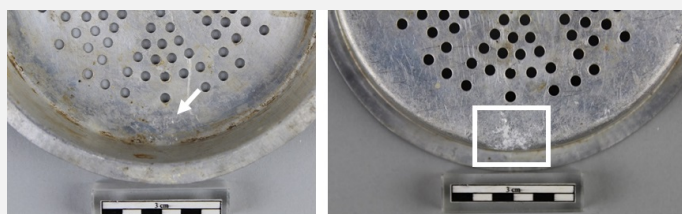
Fig. 2: Detail of the front (left) and back (right) sides of the coffee filter showing the location of Fig. 3,

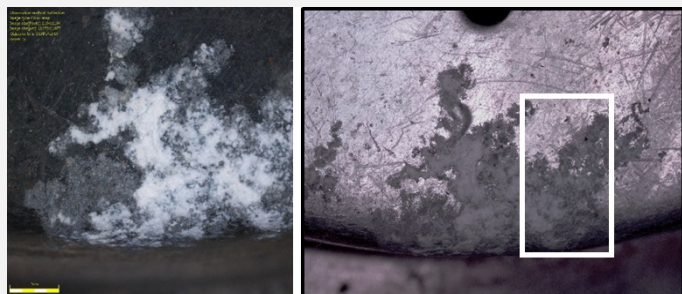
Fig. 3: Detail of the back side of the coffee filter showing the location of the sampling area (white rectangle),

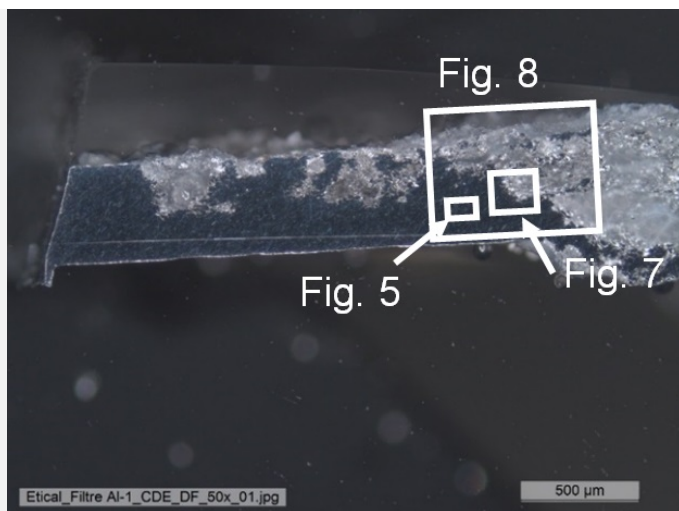
Fig. 4: Micrograph of the cross-section of the fragment sampled from the coffee filter showing the location of Figs. 5, 7 and 8, dark field,

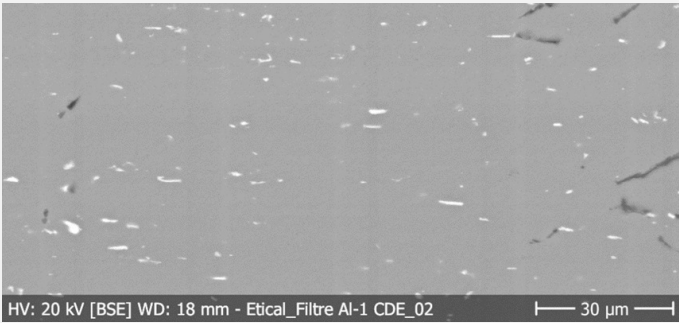
The metal is a relatively pure aluminium alloy with numerous elongated inclusions (Fig. 5). From their chemical composition they can be interpreted as Al₃Fe intermetallic compounds (Fig. 6). Inter- and transgranular corrosion has developed so extensively that some grains (not elongated) are outlined (Fig. 7).

Fig. 5: SEM image of the metal sample from Fig. 4 (detail), BSE-mode. We observe the presence of numerous elongated inclusions,

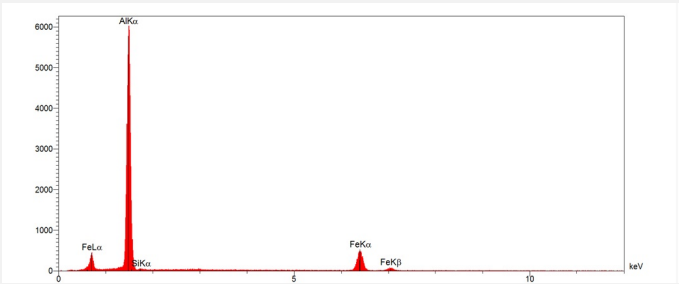
Fig. 6: EDS spectrum of the elongated white inclusions of Fig. 5,

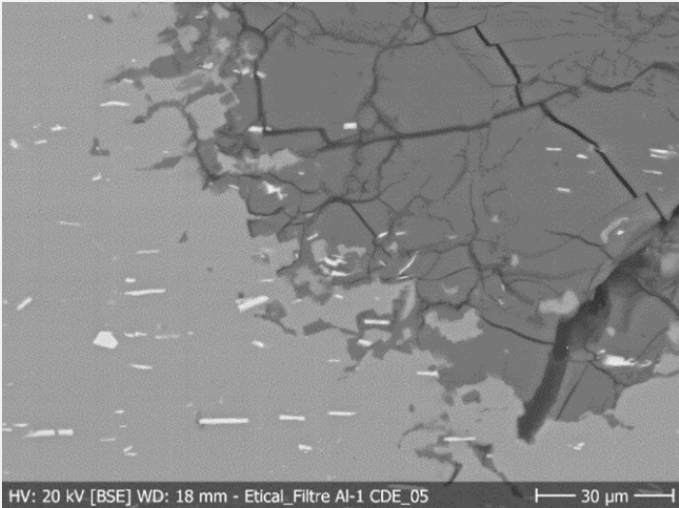
Fig. 7: SEM image of the metal sample from Fig. 4 (detail), BSE-mode. Extensive inter- and transgranular corrosion has developed within the metal,

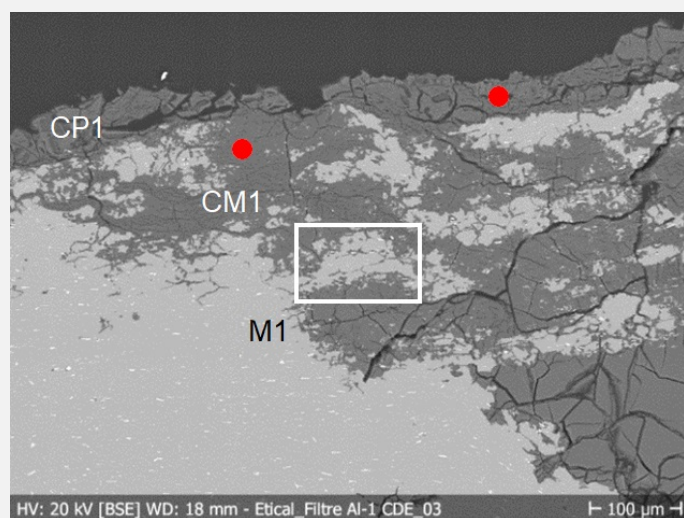
The average thickness of the corrosion layer (CP1) is about 50 micrometers, but may be thinner or thicker depending on the area. Intergranular corrosion developed locally to extend through the entire thickness of the metal. EDS-SEM analysis indicates that the metal is, as expected, covered by a layer rich in Al and O containing chlorides (red spots on Fig. 8) and surprisingly Na (white rectangle on Fig. 8, Figs. 9 and 10). Chlorides do not seem to form active corrosion. A new examination carried out after 4 months (Fig. 11) shows new forms of alteration with a local enrichment of Na, C and O (Na₂CO₃?).

Fig. 8: SEM picture (detail of Fig. 4 with location (red spots) of EDS analyses of Fig. 9), BSE-mode. From bottom to top left: the metal (M1) in light grey, the corroded metal (CM1) and CP1. The area selected for elemental chemical distributions (Figs. 10 and 11) is marked by a rectangle,

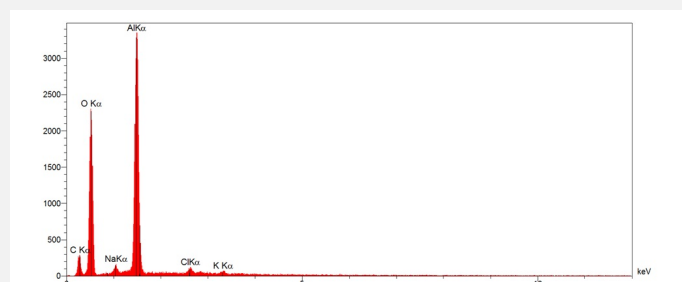
Fig. 9: EDS spectrum of red spots in Fig. 8,

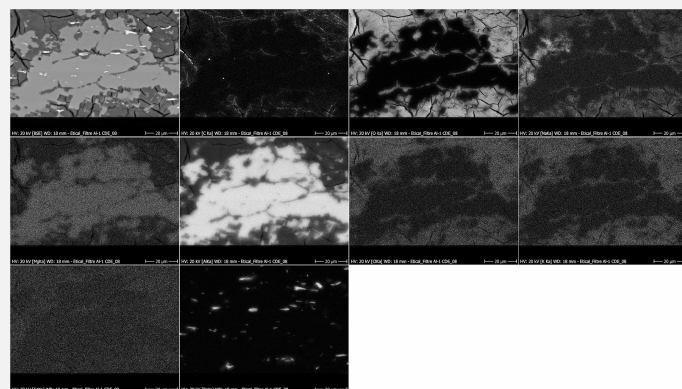
Fig. 10: SEM image, BSE-mode, and elemental chemical distribution of the selected area of Fig. 8. Method of examination: SEM-EDS, Lab of Electronic Microscopy and Microanalysis, IMA (Néode), HEI Arc,
