# COFFEE FILTER – AL ALLOY – MODERN TIMES – FRANCE

**Artefact name** Coffee filter

**Authors** Christian. Degriigny (HE-Arc CR, Neuchâtel, Neuchâtel, Switzerland)

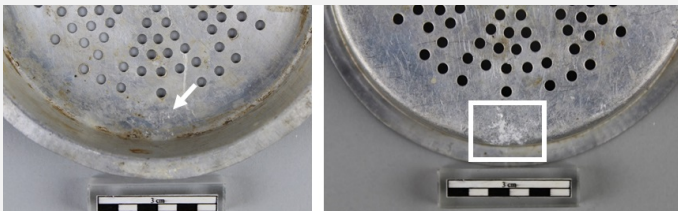
Fig. 2: Detail of the front (left) and back (right) sides of the coffee filter showing the location of Fig. 3,

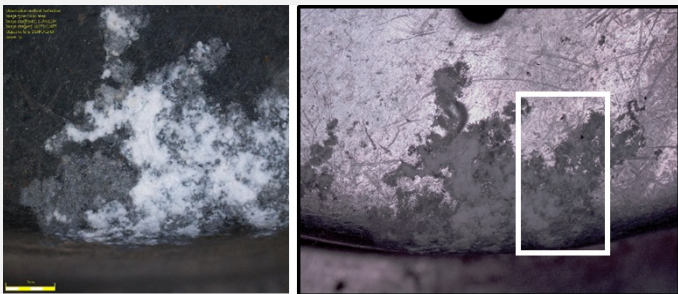
Fig. 3: Detail of the back side of the coffee filter showing the location of the sampling area (white rectangle),

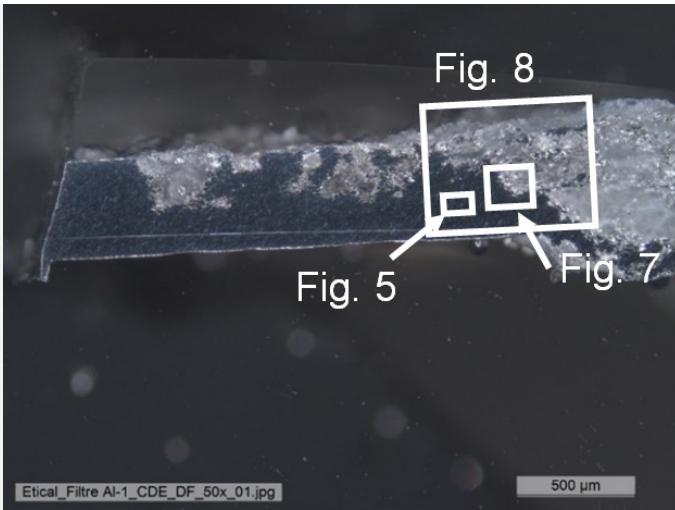
Fig. 4: Micrograph of the cross-section of the fragment sampled from the coffee filter showing the location of Figs. 5, 7 and 8, dark field,

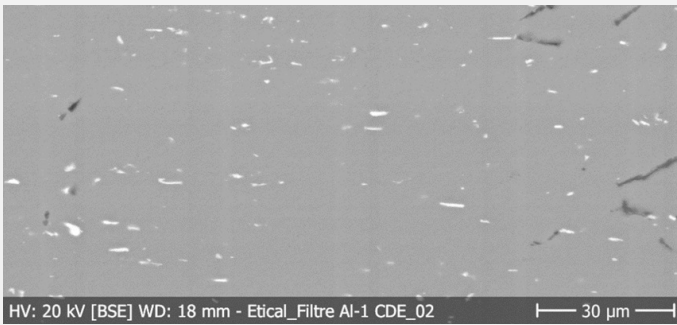
The metal is a relatively pure aluminium alloy with numerous elongated inclusions (Fig. 5). From their chemical composition they can be interpreted as Al<sub>3</sub>Fe intermetallic compounds (Fig. 6). Inter- and transgranular corrosion has developed so extensively that some grains (not elongated) are outlined (Fig. 7).

Fig. 5: SEM image of the metal sample from Fig. 4 (detail), BSE-mode. We observe the presence of numerous elongated inclusions,

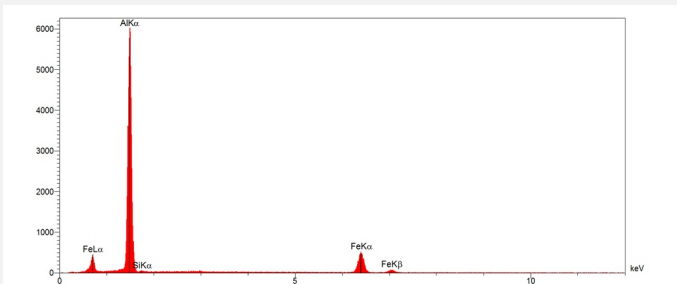
Fig. 6: EDS spectrum of the elongated white inclusions of Fig. 5,

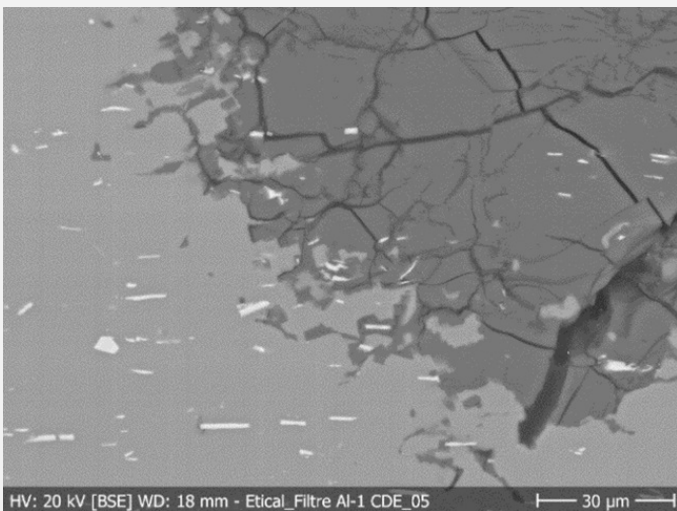
Fig. 7: SEM image of the metal sample from Fig. 4 (detail), BSE-mode. Extensive inter- and transgranular corrosion has developed within the metal,

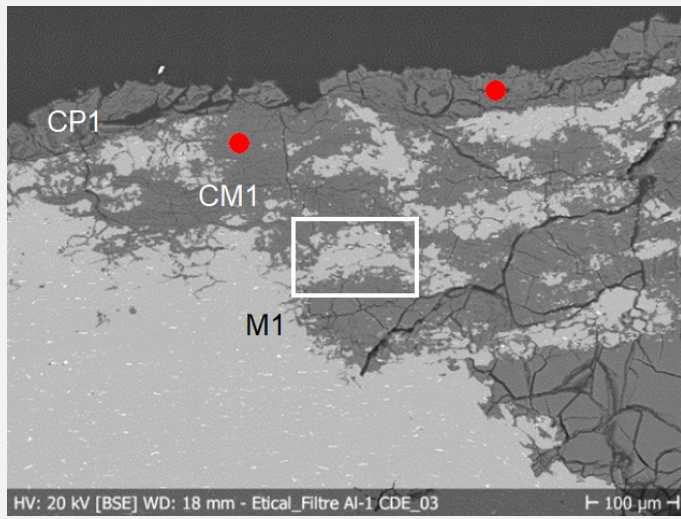
The average thickness of the corrosion layer (CP1) is about 50 micrometers, but may be thinner or thicker depending on the area. Intergranular corrosion developed locally to extend through the entire thickness of the metal. EDS-SEM analysis indicates that the metal is, as expected, covered by a layer rich in Al and O containing chlorides (red spots on Fig. 8) and surprisingly Na (white rectangle on Fig. 8, Figs. 9 and 10). Chlorides do not seem to form active corrosion. A new examination carried out after 4 months (Fig. 11) shows new forms of alteration with a local enrichment of Na, C and O (Na<sub>2</sub>CO<sub>3</sub>?).

Fig. 8: SEM picture (detail of Fig. 4 with location (red spots) of EDS analyses of Fig. 9), BSE-mode. From bottom to top left: the metal (M1) in light grey, the corroded metal (CM1) and CP1. The area selected for elemental chemical distributions (Figs. 10 and 11) is marked by a rectangle,

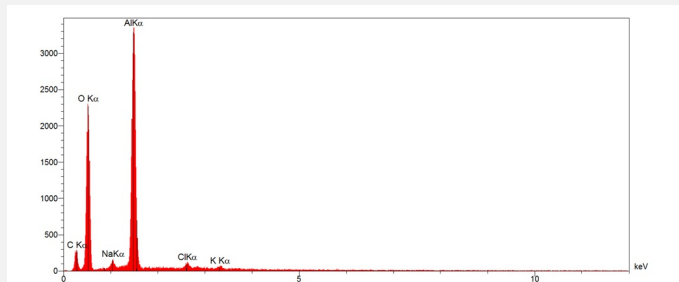
Fig. 9: EDS spectrum of red spots in Fig. 8,

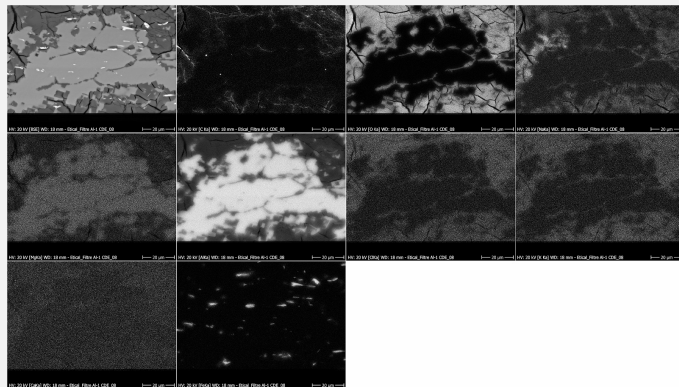
Fig. 10: SEM image, BSE-mode, and elemental chemical distribution of the selected area of Fig. 8. Method of examination: SEM-EDS, Lab of Electronic Microscopy and Microanalysis, IMA (Néode), HEI Arc,
