COFFEE FILTER – AL ALLOY – MODERN TIMES – FRANCE

Artefact name	Coffee filter
Authors	Christian. Degriigny (HE-Arc CR, Neuchâtel, Neuchâtel, Switzerland)
Url	/artefacts/911/

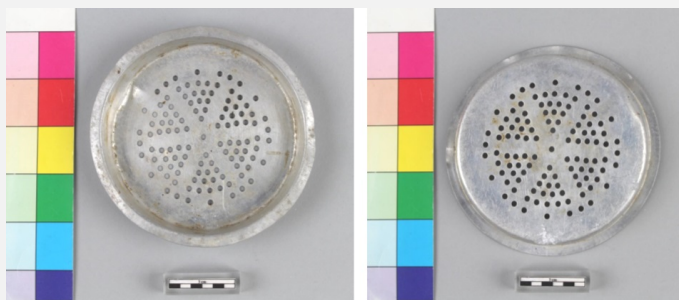
Fig. 1: Front and back sides of a coffee filter,

Description of the artefact	Coffee filter with traces of use (deposits, deformation) and presence of local filiform corrosion (Fig. 1). Dimensions: ø.ext. = 10cm.
Type of artefact	Household implement
Origin	Château de Germolles, Mellecey, Bourgogne, France
Recovering date	Unknown
Chronology category	Modern Times
chronology tpq	<input type="text" value="1960"/> A.D. ∨
chronology taq	<input type="text" value="2000"/> A.D. ∨
Chronology comment	20th century
Burial conditions / environment	Outdoor atmosphere
Artefact location	Château de Germolles, Mellecey, Bourgogne
Owner	Château de Germolles, Mellecey, Bourgogne

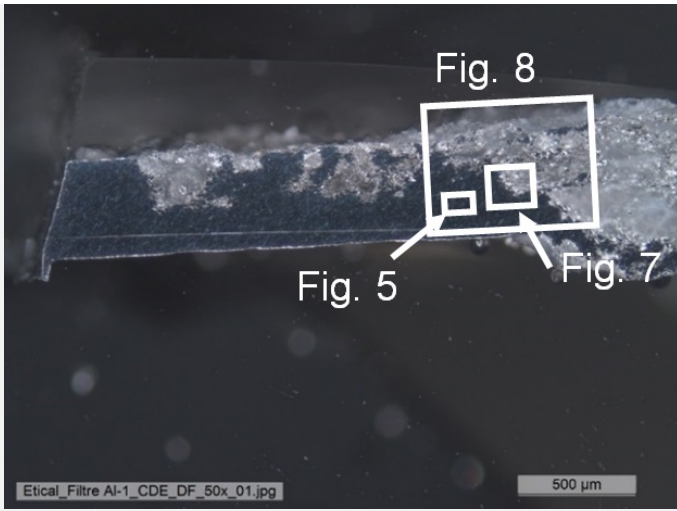
Fig. 4: Micrograph of the cross-section of the fragment sampled from the coffee filter showing the location of Figs. 5, 7 and 8, dark field,

Description of sample	Sample cut from the back side of the coffee filter (Fig. 3).
Alloy	Al Alloy
Technology	Annealed after (hot) rolling
Lab number of sample	None
Sample location	HE-Arc CR, Neuchâtel, Neuchâtel
Responsible institution	HE-Arc CR, Neuchâtel, Neuchâtel
Date and aim of sampling	2017, EtICAL project (Study of corrosion forms of aluminium alloys in Swiss collections)

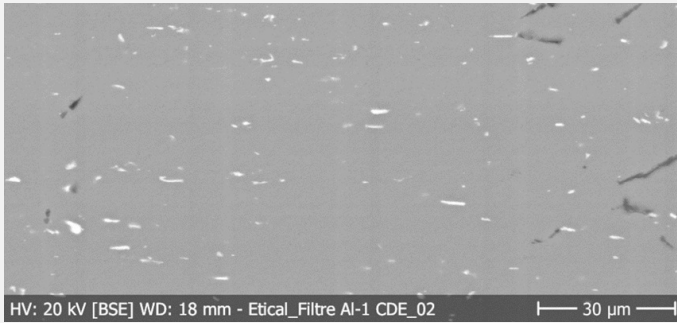
The metal is a relatively pure aluminium alloy with numerous elongated inclusions (Fig. 5). From their chemical composition they can be interpreted as Al₃Fe intermetallic compounds (Fig. 6). Inter- and transgranular corrosion has developed so extensively that some grains (not elongated) are outlined (Fig. 7).

Fig. 5: SEM image of the metal sample from Fig. 4 (detail), BSE-mode. We observe the presence of numerous elongated inclusions,

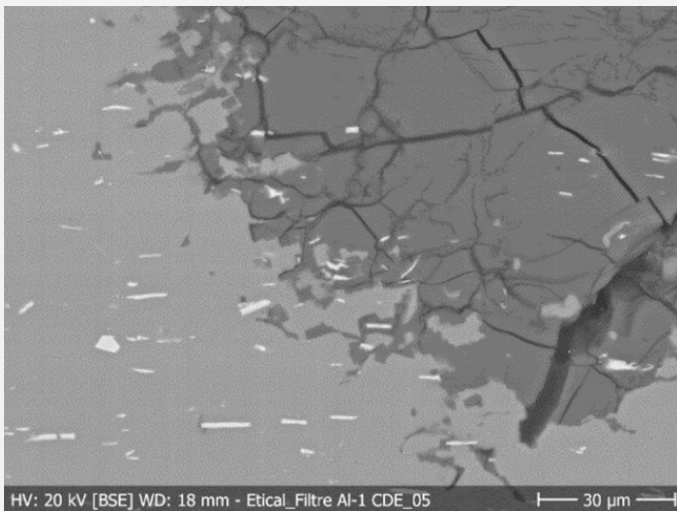
Fig. 7: SEM image of the metal sample from Fig. 4 (detail), BSE-mode. Extensive inter- and transgranular corrosion has developed within the metal,

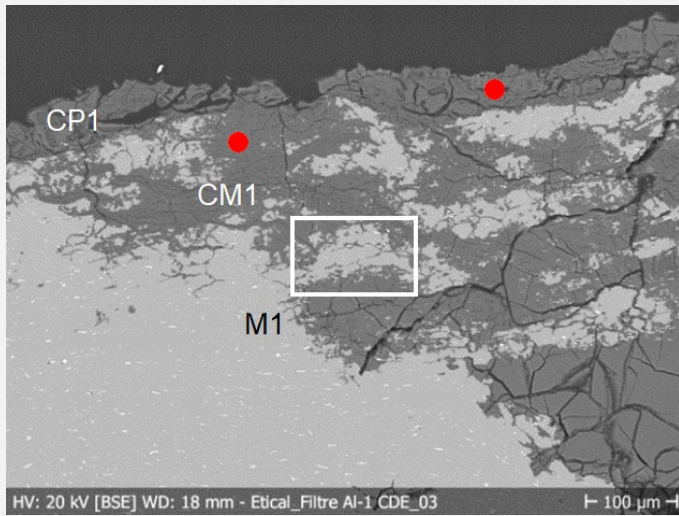
The average thickness of the corrosion layer (CP1) is about 50 micrometers, but may be thinner or thicker depending on the area. Intergranular corrosion developed locally to extend through the entire thickness of the metal. EDS-SEM analysis indicates that the metal is, as expected, covered by a layer rich in Al and O containing chlorides (red spots on Fig. 8) and surprisingly Na (white rectangle on Fig. 8, Figs. 9 and 10). Chlorides do not seem to form active corrosion. A new examination carried out after 4 months (Fig. 11) shows new forms of alteration with a local enrichment of Na, C and O (Na₂CO₃?).

Fig. 8: SEM picture (detail of Fig. 4 with location (red spots) of EDS analyses of Fig. 9), BSE-mode. From bottom to top left: the metal (M1) in light grey, the corroded metal (CM1) and CP1. The area selected for elemental chemical distributions (Figs. 10 and 11) is marked by a rectangle,

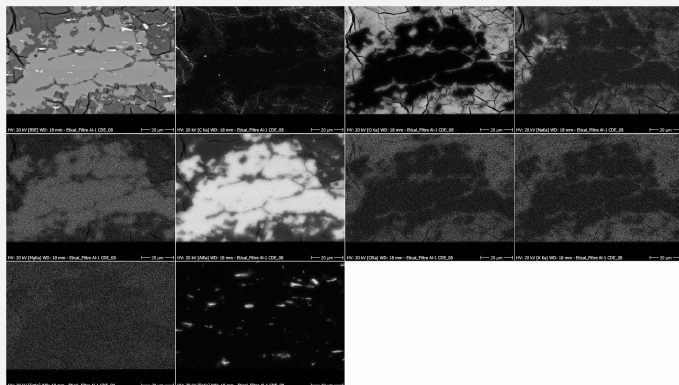
Fig. 10: SEM image, BSE-mode, and elemental chemical distribution of the selected area of Fig. 8. Method of examination: SEM-EDS, Lab of Electronic Microscopy and Microanalysis, IMA (Néode), HEI Arc,
