# COFFEE FILTER – AL ALLOY – MODERN TIMES – FRANCE

**Artefact name** Coffee filter

**Authors** Christian. Degrigny (HE-Arc CR, Neuchâtel, Neuchâtel, Switzerland)

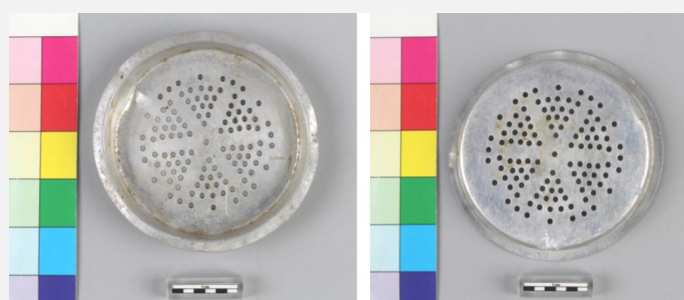
Fig. 1: Front and back sides of a coffee filter,

| <b>Description of the artefact</b> | Coffee filter with traces of use (deposits, deformation) and presence of local filiform corrosion (Fig. 1). Dimensions: ø.ext. = 10cm. |

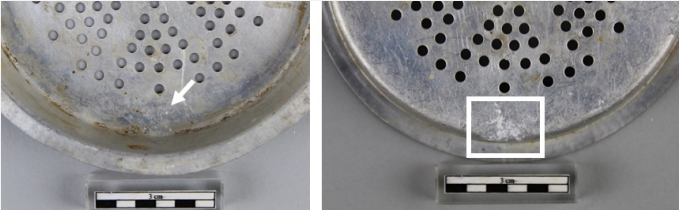
Fig. 2: Detail of the front (left) and back (right) sides of the coffee filter showing the location of Fig. 3,

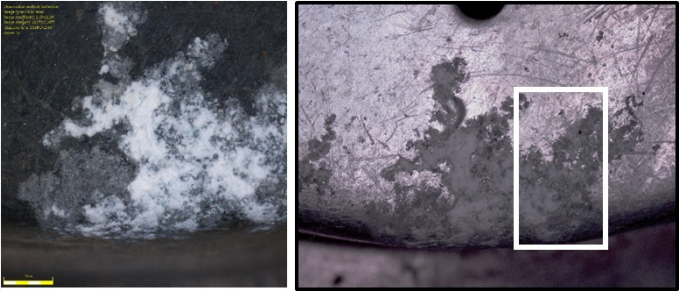
Fig. 3: Detail of the back side of the coffee filter showing the location of the sampling area (white rectangle),

| <b>Description of sample</b> | Sample cut from the back side of the coffee filter (Fig. 3). |

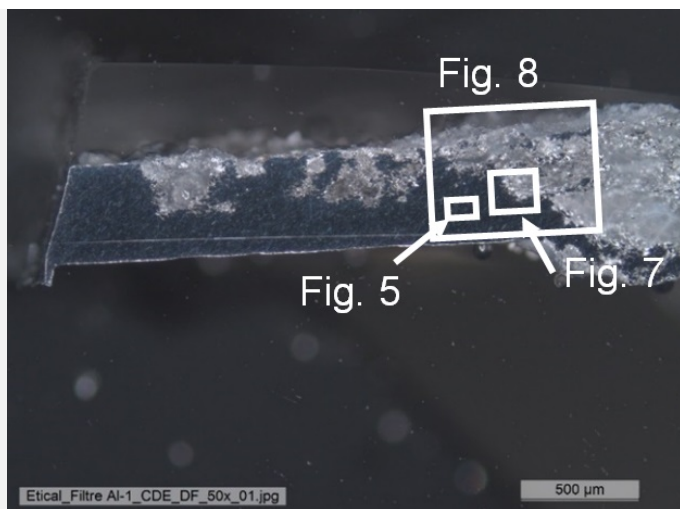
Fig. 4: Micrograph of the cross-section of the fragment sampled from the coffee filter showing the location of Figs. 5, 7 and 8, dark field,

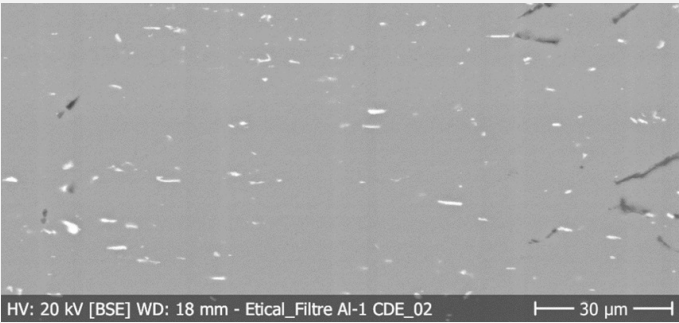
The metal is a relatively pure aluminium alloy with numerous elongated inclusions (Fig. 5). From their chemical composition they can be interpreted as  $\text{Al}_3\text{Fe}$  intermetallic compounds (Fig. 6). Inter- and transgranular corrosion has developed so extensively that some grains (not elongated) are outlined (Fig. 7).

Fig. 5: SEM image of the metal sample from Fig. 4 (detail), BSE-mode. We observe the presence of numerous elongated inclusions,

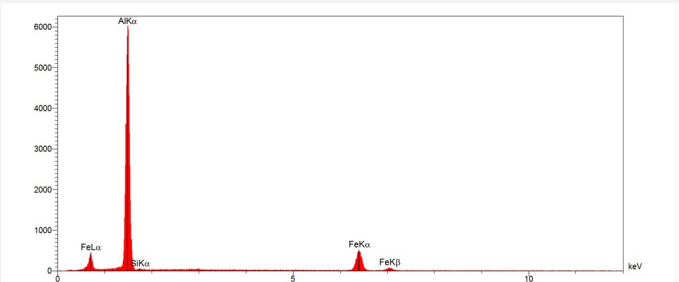
Fig. 6: EDS spectrum of the elongated white inclusions of Fig. 5,

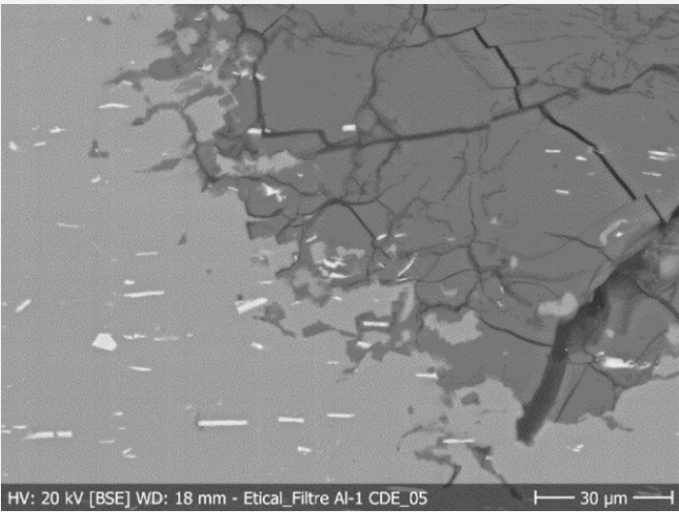
Fig. 7: SEM image of the metal sample from Fig. 4 (detail), BSE-mode. Extensive inter- and transgranular corrosion has developed within the metal,

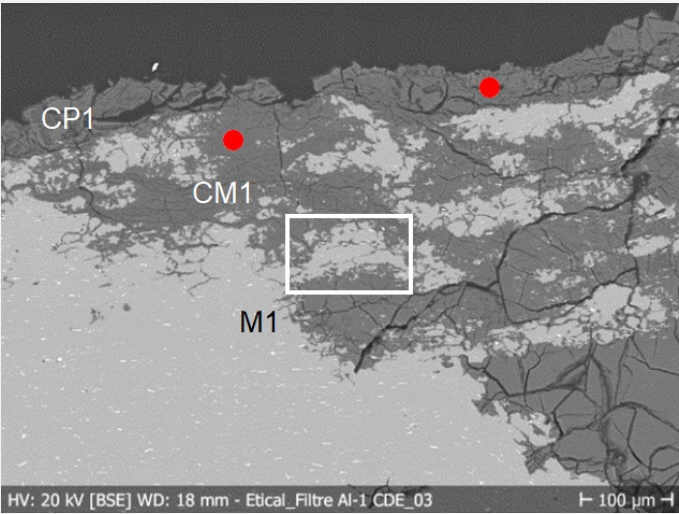
The average thickness of the corrosion layer (CP1) is about 50 micrometers, but may be thinner or thicker depending on the area. Intergranular corrosion developed locally to extend through the entire thickness of the metal. EDS-SEM analysis indicates that the metal is, as expected, covered by a layer rich in Al and O containing chlorides (red spots on Fig. 8) and surprisingly Na (white rectangle on Fig. 8, Figs. 9 and 10). Chlorides do not seem to form active corrosion. A new examination carried out after 4 months (Fig. 11) shows new forms of alteration with a local enrichment of Na, C and O (Na2CO3?).

Fig. 8: SEM picture (detail of Fig. 4 with location (red spots) of EDS analyses of Fig. 9), BSE-mode. From bottom to top left: the metal (M1) in light grey, the corroded metal (CM1) and CP1. The area selected for elemental chemical distributions (Figs. 10 and 11) is marked by a rectangle,

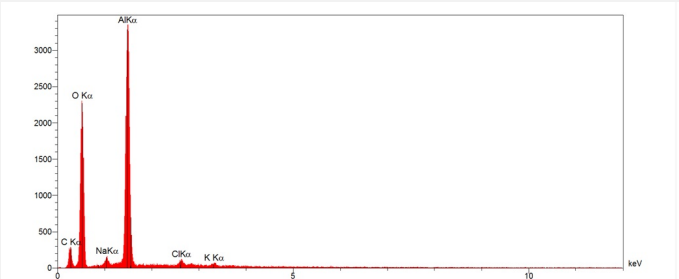
Fig. 9: EDS spectrum of red spots in Fig. 8,

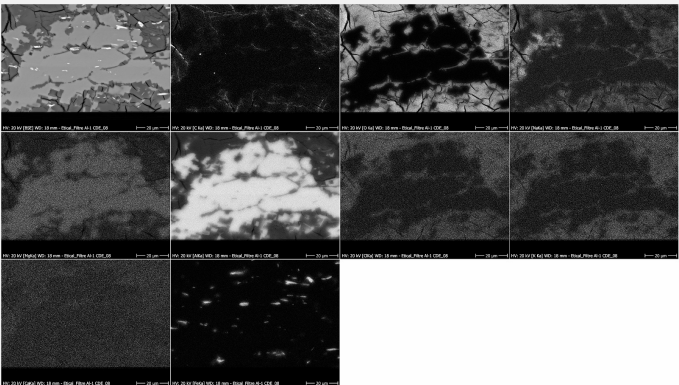
Fig. 10: SEM image, BSE-mode, and elemental chemical distribution of the selected area of Fig. 8. Method of examination: SEM-EDS, Lab of Electronic Microscopy and Microanalysis, IMA (Néode), HEI Arc,
