TOWEL BAR – AL ALLOY – MODERN TIMES – FRANCE

Artefact name	Towel bar
Authors	Christian. Degriigny (HE-Arc CR, Neuchâtel, Neuchâtel, Switzerland)
Url	/artefacts/913/

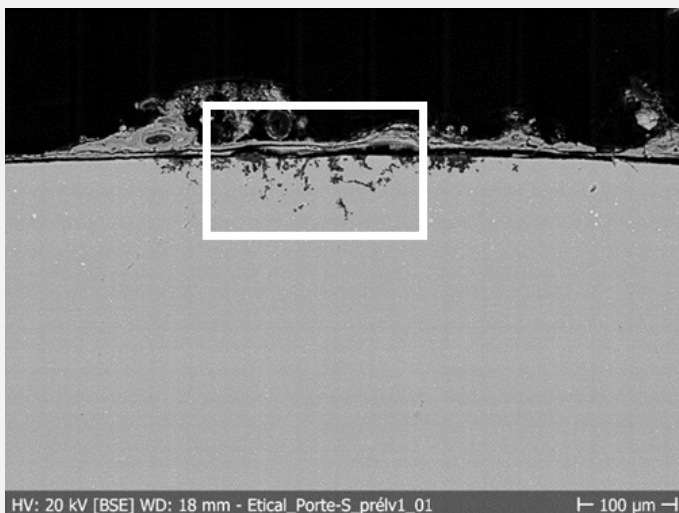
Fig. 3: SEM image of the cross-section of the fragment sampled from the towel bar showing the location of Fig. 4,

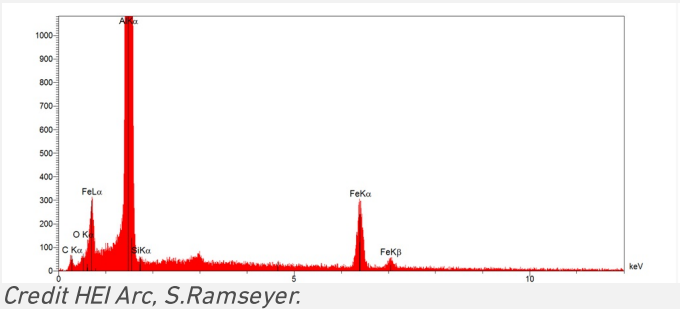
Fig. 5: EDS spectrum of the inclusions of Fig. 4,

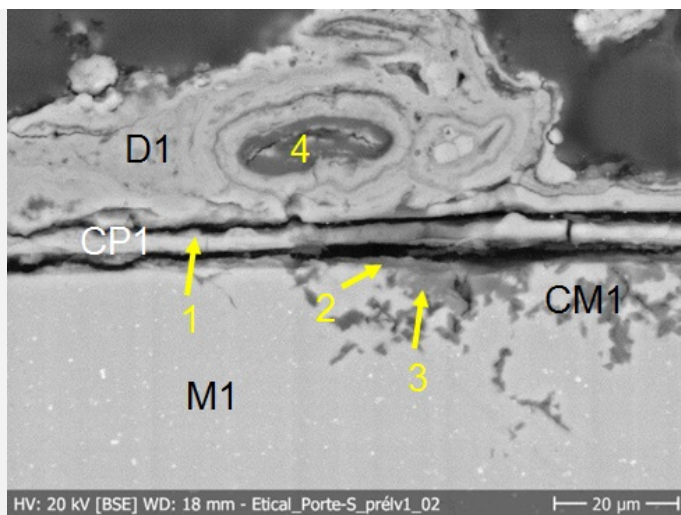
A very thin and loose oxide film has formed on the metal surface (CP1) and is locally covered by white deposits (D1). Intergranular corrosion has developed under the deposits (Fig. 6). EDS-SEM analysis indicates that the oxide layer rich in Al and O is contaminated with P and Si (area 1 on Fig. 6 and Fig. 7). These elements are even more present at the interface between CM1 and CP1 with Cl and S (area 2 on Fig. 6 and Fig. 8). The concentration of P and Si decreases in CM1 (area 3 on Fig. 6 and Fig. 9) while the concentration of S and Cl increases (Fig. 10). The deposit is mainly constituted of Ca, O, C and Si (probably CaCO_3 and SiO_2 , area 4 on Fig. 6 and Fig. 11).

Fig. 6: SEM picture with location of EDS analyses of areas 1 to 4, BSE-mode. From bottom to top: the metal (M1) in light grey, the corroded metal (CM1), CP1 and D1. It can be compared to the stratigraphy representation of Fig. 12,

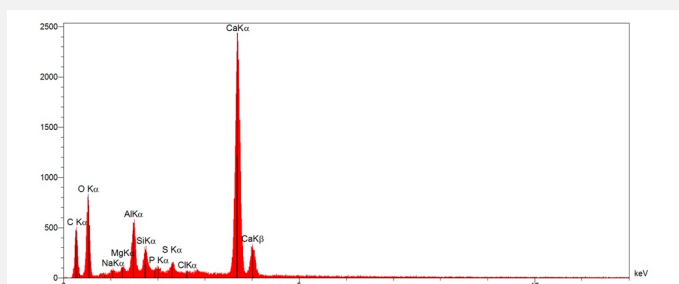
Fig. 7: EDS spectrum of area 1 of Fig. 6,

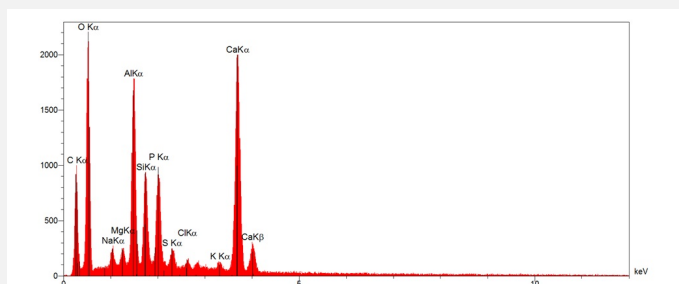
Fig. 8: EDS spectrum of area 2 of Fig. 6,

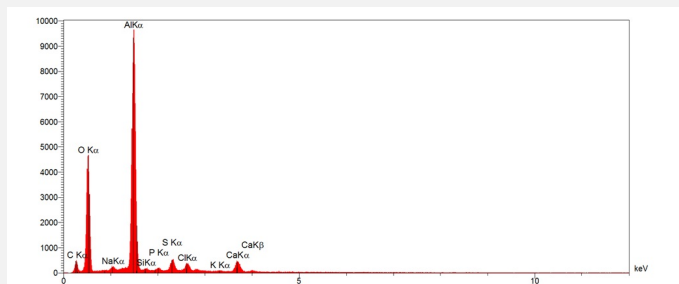
Fig. 9: EDS spectrum of area 3 of Fig. 6,

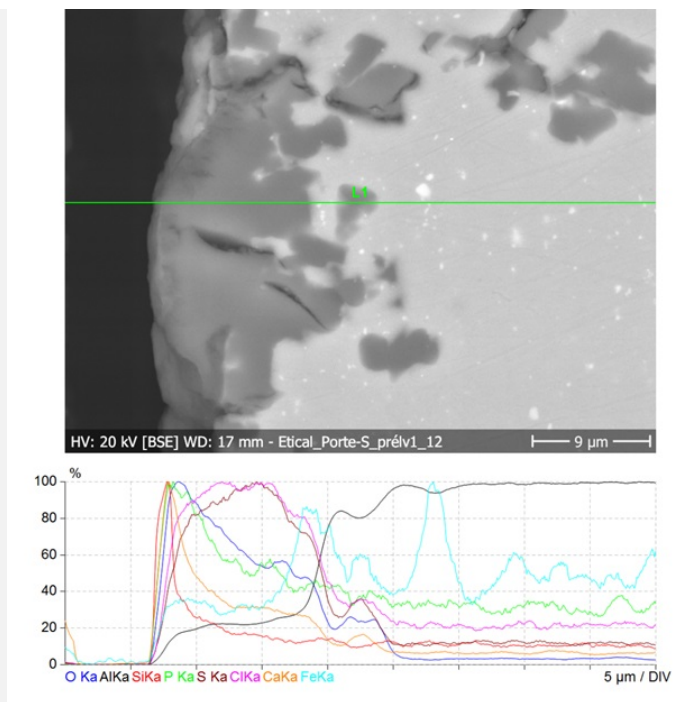
Fig. 10: EDS Linescan from CM1 to M1,

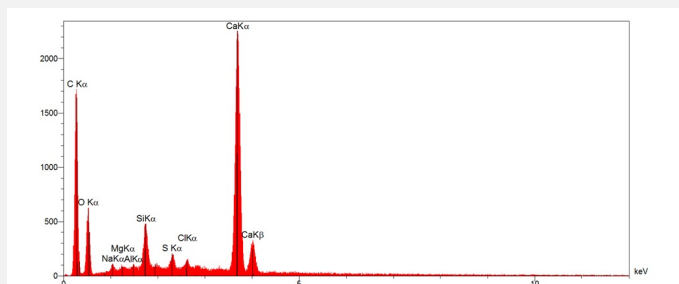
Fig. 11: EDS spectrum of area 4 of Fig. 6,

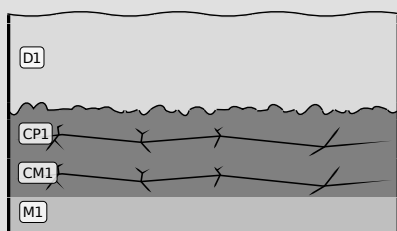
Fig. 12: Stratigraphic representation of the fragment sampled from the towel bar in cross-section (SEM-BSE) using the MiCorr application. The characteristics of the strata are only accessible by clicking on the drawing that redirects you to the search tool by stratigraphy representation. This representation can be compared to Fig. 6, Credit HE-Arc CR, C.Degrigny.
