TOWEL BAR – AL ALLOY – MODERN TIMES – FRANCE

Artefact name Towel bar

Authors Christian. Degriigny (HE-Arc CR, Neuchâtel, Neuchâtel, Switzerland)

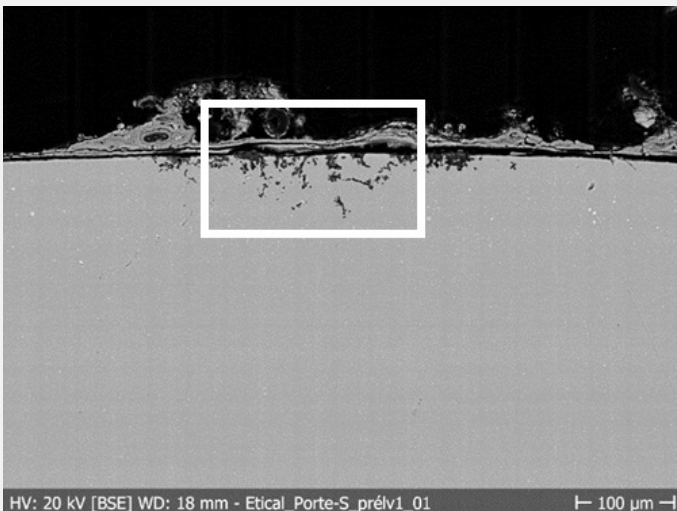
Fig. 3: SEM image of the cross-section of the fragment sampled from the towel bar showing the location of Fig. 4,

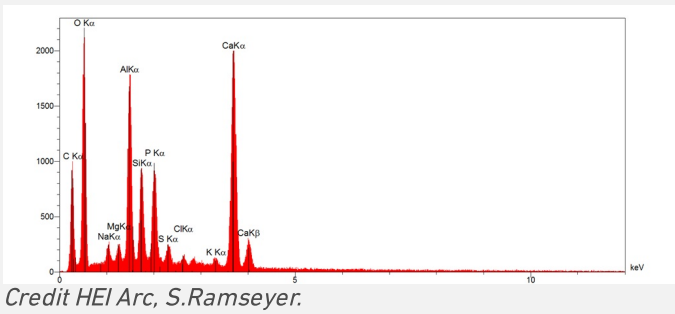
Fig. 8: EDS spectrum of area 2 of Fig. 6,

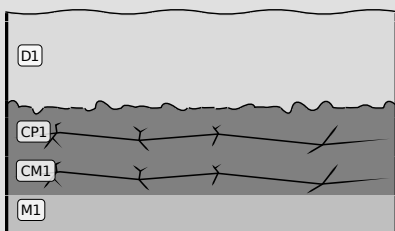
Fig. 12: Stratigraphic representation of the fragment sampled from the towel bar in cross-section (SEM-BSE) using the MiCorr application. The characteristics of the strata are only accessible by clicking on the drawing that redirects you to the search tool by stratigraphy representation. This representation can be compared to Fig. 6, Credit HE-Arc CR, C.Degrigny.
