## TOWEL BAR – AL ALLOY – MODERN TIMES – FRANCE

| Artefact name | Towel bar |
| Authors | Christian. Degriigny (HE-Arc CR, Neuchâtel, Neuchâtel, Switzerland) |

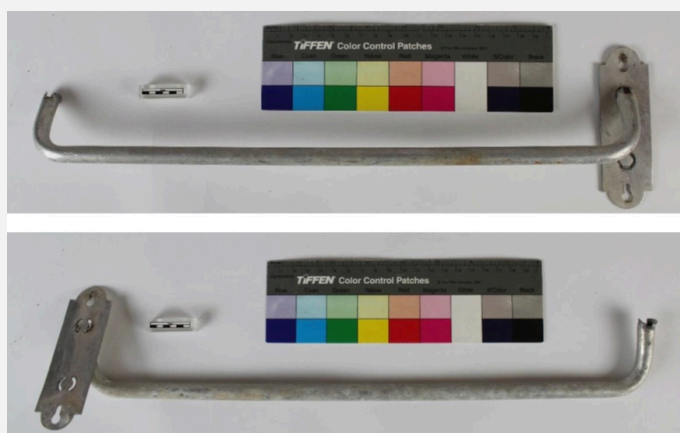
Fig. 1: Front and back sides of a towel bar,

| Description of the artefact | Towel bar with traces of use and a broken section (Fig. 1). White deposits have developed on the metal surface. Dimensions: L = 45cm. | | |

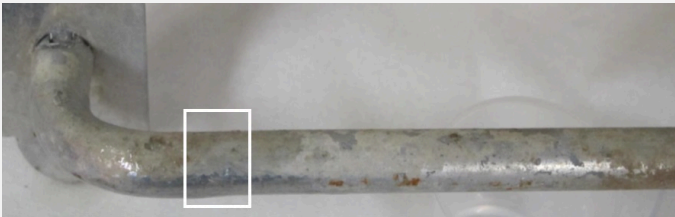
Fig. 2: Detail of the back side of the towel bar showing the location of the sampling area,

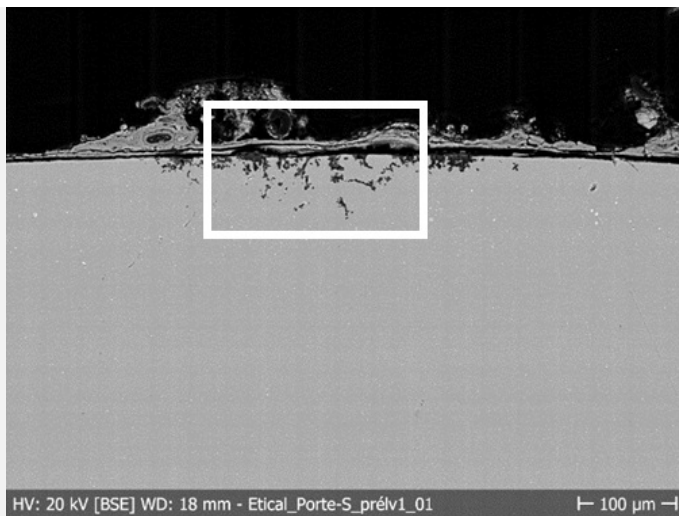
Fig. 3: SEM image of the cross-section of the fragment sampled from the towel bar showing the location of Fig. 4,

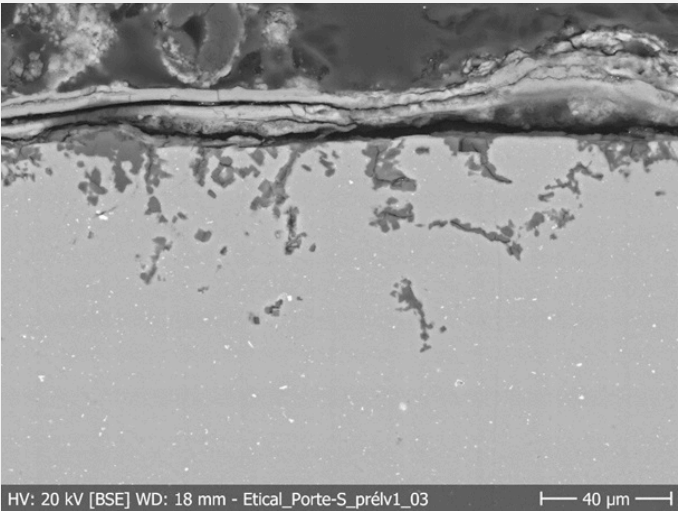
The metal is a relatively pure aluminium alloy with numerous inclusions (Fig. 4). From their chemical composition they can be interpreted as Al<sub>3</sub>Fe intermetallic compounds (Fig. 5). Pitting corrosion as well as a start of intergranular corrosion developing locally under the deposits, outlining some of the grains (Fig. 4).

Fig. 4: SEM image of the metal sample from Fig. 3 (detail), BSE-mode. We observe the presence of numerous inclusions,

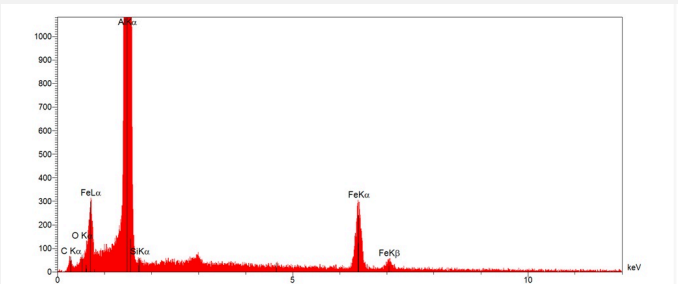
Fig. 5: EDS spectrum of the inclusions of Fig. 4,

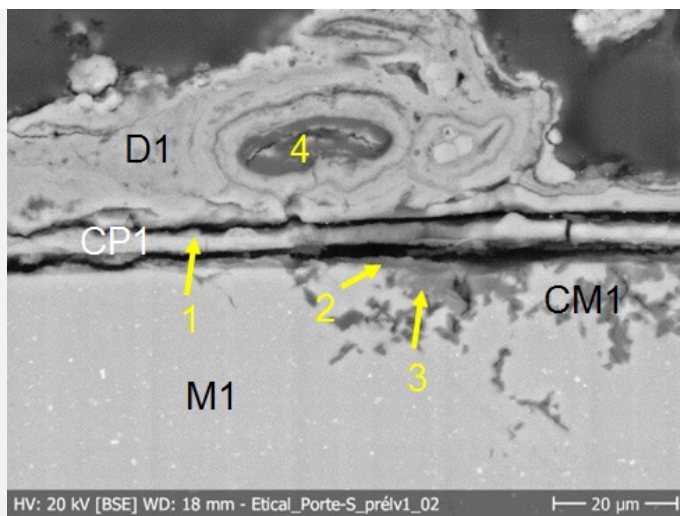
A very thin and loose oxide film has formed on the metal surface (CP1) and is locally covered by white deposits (D1). Intergranular corrosion has developed under the deposits (Fig. 6). EDS-SEM analysis indicates that the oxide layer rich in Al and O is contaminated with P and Si (area 1 on Fig. 6 and Fig. 7). These elements are even more present at the interface between CM1 and CP1 with Cl and S (area 2 on Fig. 6 and Fig. 8). The concentration of P and Si decreases in CM1 (area 3 on Fig. 6 and Fig. 9) while the concentration of S and Cl increases (Fig. 10). The deposit is mainly constituted of Ca, O, C and Si (probably CaCO<sub>3</sub> and SiO<sub>2</sub>, area 4 on Fig. 6 and Fig. 11).

Fig. 6: SEM picture with location of EDS analyses of areas 1 to 4, BSE-mode. From bottom to top: the metal (M1) in light grey, the corroded metal (CM1), CP1 and D1. It can be compared to the stratigraphy representation of Fig. 12,

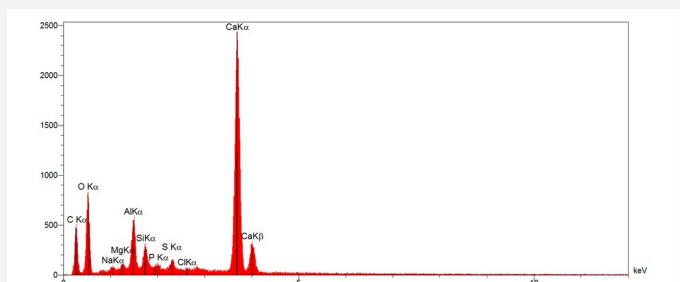
Fig. 7: EDS spectrum of area 1 of Fig. 6,

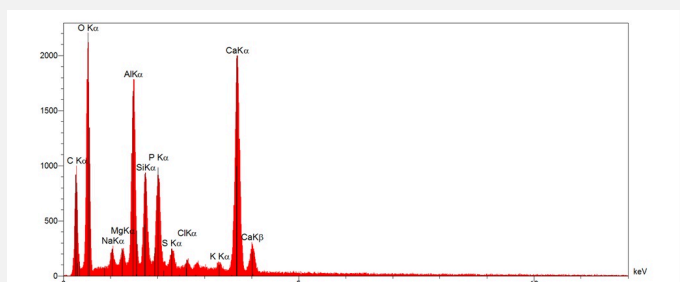
Fig. 8: EDS spectrum of area 2 of Fig. 6,

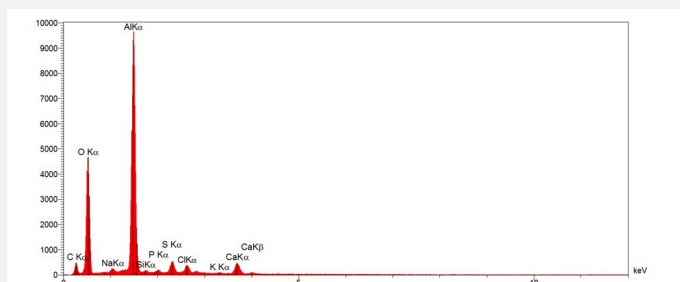
Fig. 9: EDS spectrum of area 3 of Fig. 6,

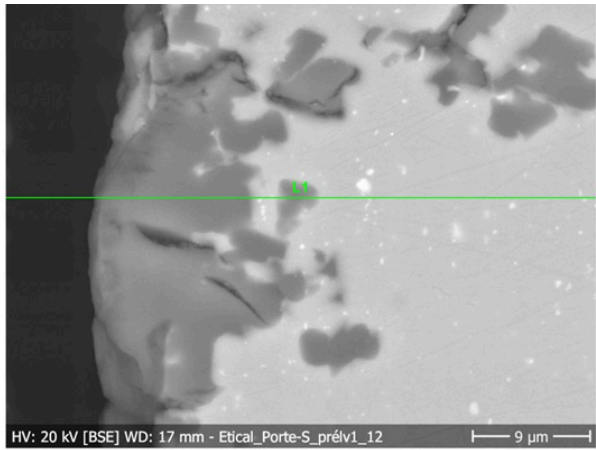
Fig. 10: EDS Linescan from CM1 to M1,

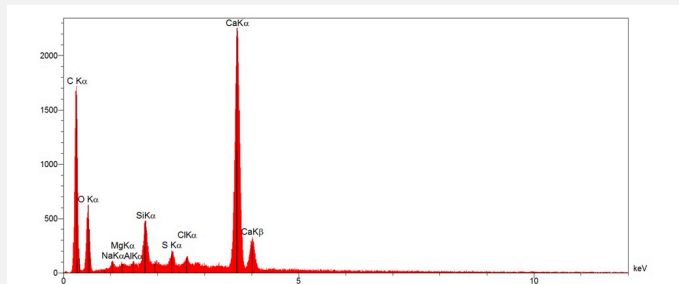
Fig. 11: EDS spectrum of area 4 of Fig. 6,

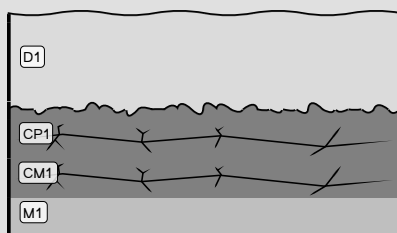
Fig. 12: Stratigraphic representation of the fragment sampled from the towel bar in cross-section (SEM-BSE) using the MiCorr application. The characteristics of the strata are only accessible by clicking on the drawing that redirects you to the search tool by stratigraphy representation. This representation can be compared to Fig. 6, Credit HE-Arc CR, C.Degrigny.
