# TANG FRAGMENT OF A KNIFE HR-6246 – TIN BRONZE – LATE BRONZE AGE – SWITZERLAND

**Artefact name** Tang fragment of a knife HR-6246

**Authors** Marianne. Senn (Empa, Dübendorf, Zurich, Switzerland) & Christian. Degriigny (HE-Arc CR, Neuchâtel, Neuchâtel, Switzerland)

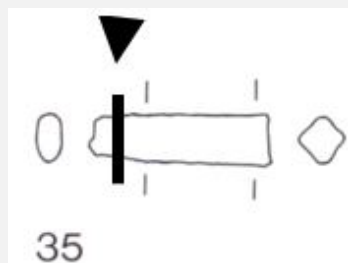
Fig. 4: Location of sampling area,

Fig. 5: Cross-section of the tang and remaining material,

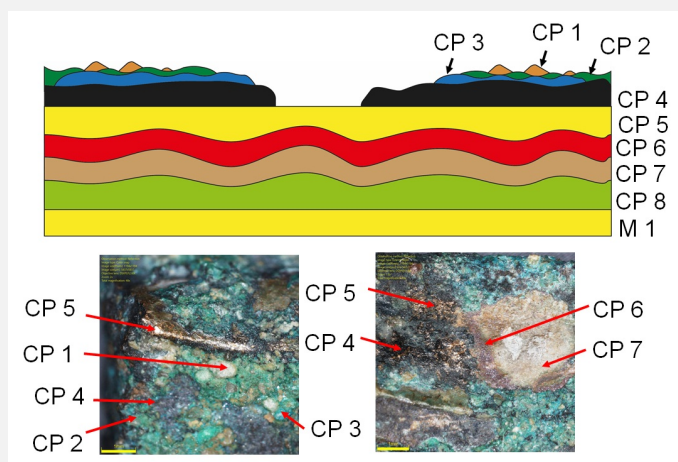
Fig. 6: Stratigraphic representation of the tang fragment and location of the strata,

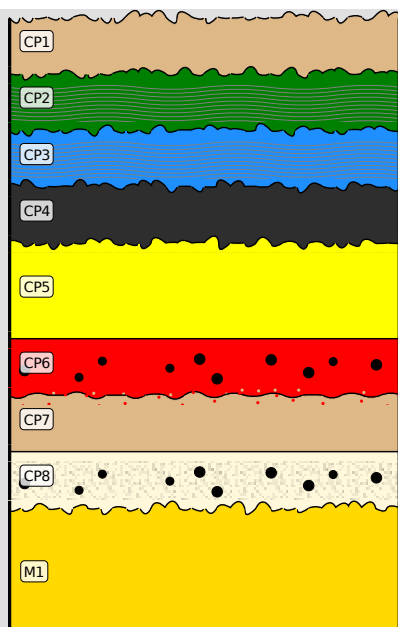
Fig. 7: Stratigraphic representation of the tang fragment under binocular using the MiCorr application. The characteristics of the strata are only accessible by clicking on the drawing that redirects you to the search tool by stratigraphy representation, Credit HE-Arc CR.

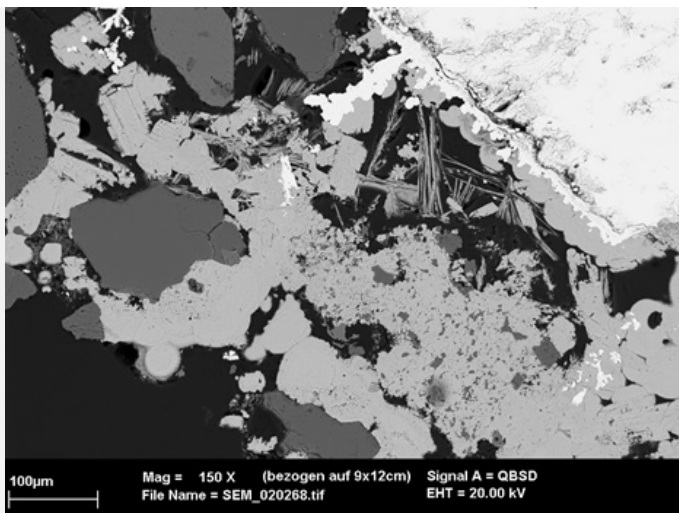
Fig. 14: SEM image, similar to Fig. 13, BSE-mode,

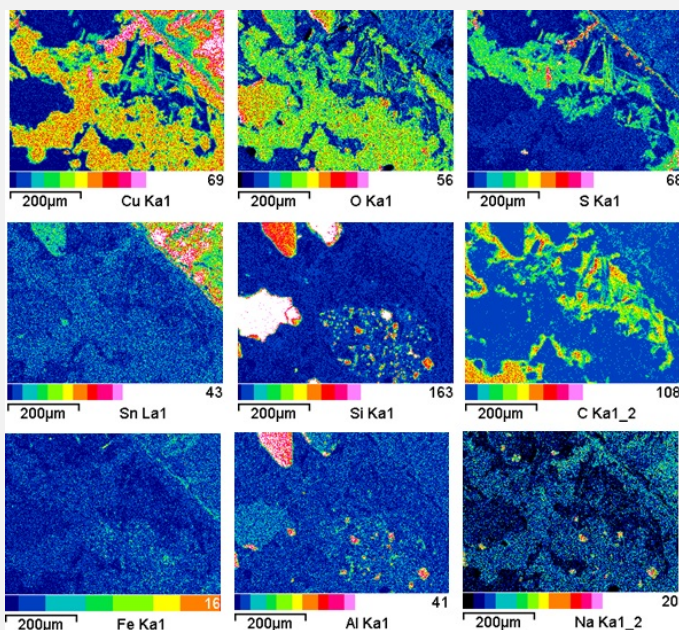
Fig. 15: EDS elemental chemical distribution of the SEM image of Fig. 13. Method of examination: SEM/EDS, Laboratory of Analytical Chemistry, Empa,
