AIRCRAFT REAR FASTENING PLATE VHS-497 – AL ALLOY – MODERN TIMES

Artefact name	Aircraft rear fastening plate VHS-497
Authors	Marianne. Senn (Empa, Dübendorf, Zurich, Switzerland) & Christian. Degriigny (HE-Arc CR, Neuchâtel, Neuchâtel, Switzerland)
Url	/artefacts/916/

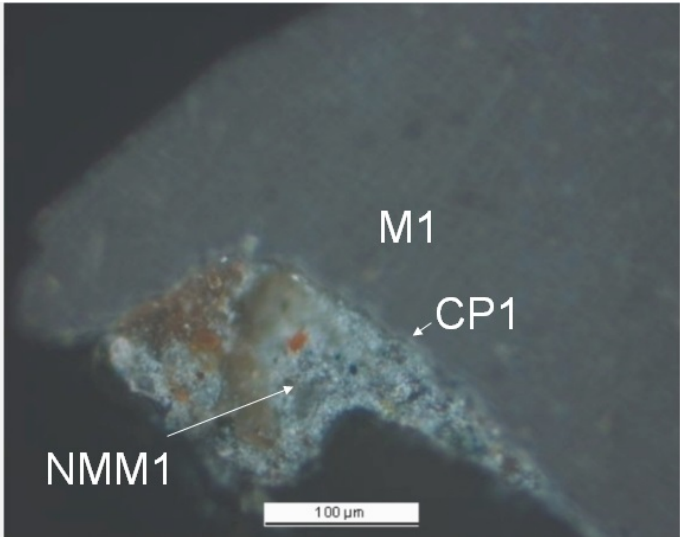
Fig. 8: Micrograph (same as Fig. 7) and corresponding to the stratigraphy of Fig. 11, unetched, polarised light. We observe

in grey the metal matrix and blue-brown the adhering material,

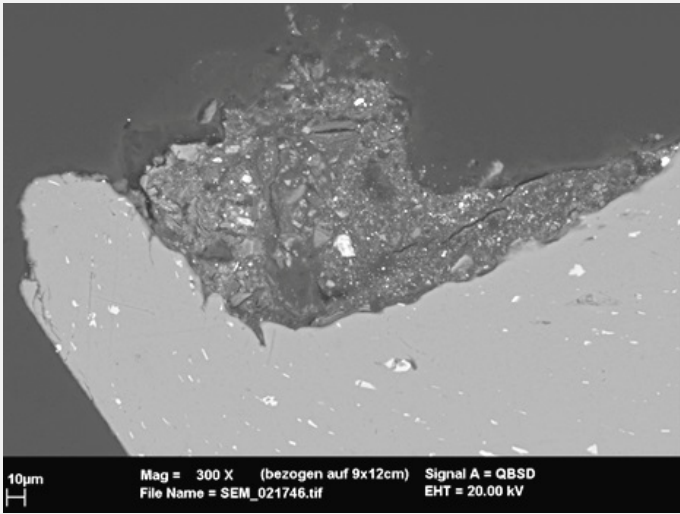
Fig. 9: SEM image (same as Fig. 7, inverted picture, detail), BSE-mode, unetched,

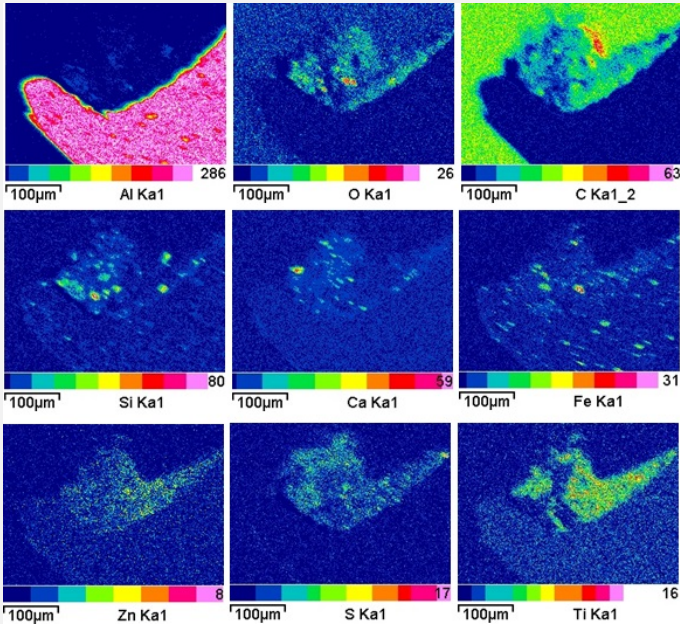
Fig. 10: Elemental chemical distribution of the selected area from Fig. 9. Method of examination: SEM/EDS, Laboratory of Analytical Chemistry, Empa,

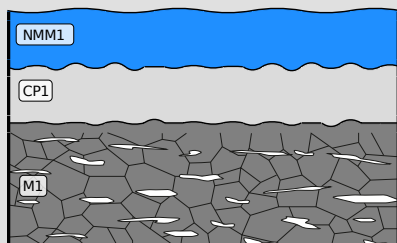
Fig. 11: Stratigraphic representation of the sample taken from the back fastening plate in cross-section (dark field) using the MiCorr application. The characteristics of the strata are only accessible by clicking on the drawing that redirects you to the search tool by stratigraphy representation. This representation can be compared to Fig. 8, Credit HE-Arc CR.
