AIRCRAFT REAR FASTENING PLATE VHS-497 – AL ALLOY – MODERN TIMES

Artefact name	Aircraft rear fastening plate VHS-497
Authors	Marianne. Senn (Empa, Dübendorf, Zurich, Switzerland) & Christian. Degriigny (HE-Arc CR, Neuchâtel, Neuchâtel, Switzerland)
Url	/artefacts/916/

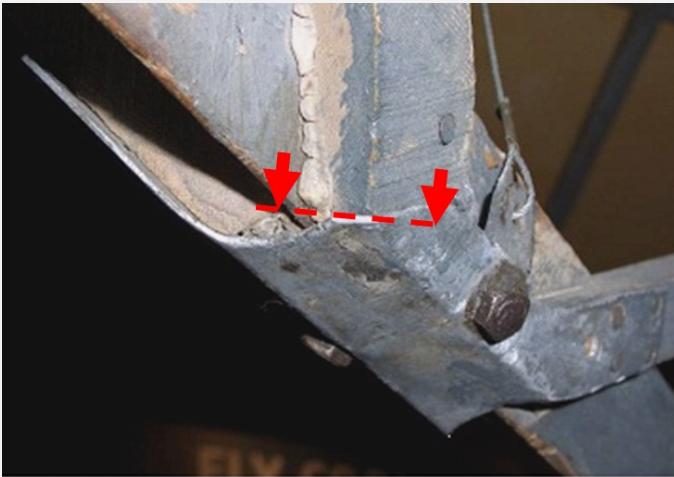
Fig. 2: Location of sampling area,

Description of sample	Sample cut from the corner of the fastening plate (Fig. 2). Dimensions: L = 4mm ; W = 1.2mm.
Alloy	Al Alloy
Technology	Hot rolled and annealed
Lab number of sample	DUF-12
Sample location	HE-Arc CR, Neuchâtel, Neuchâtel
Responsible institution	Swiss Museum of Transport, Luzern, Lucerne
Date and aim of sampling	September 2007, metallography and alloy composition

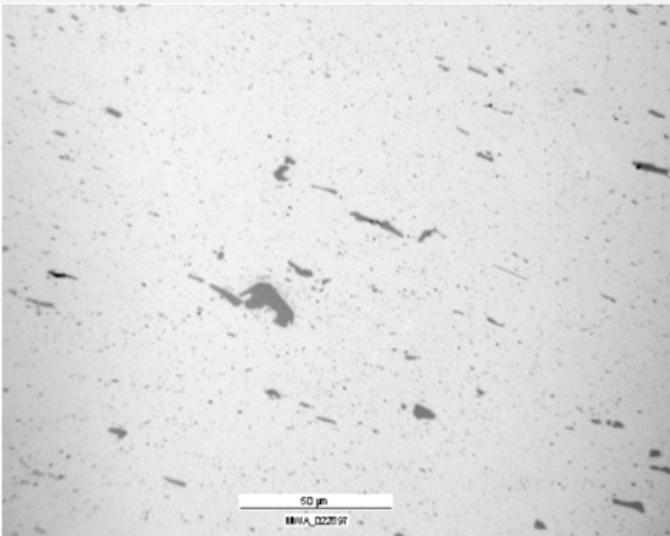
The metal is a relatively pure aluminium alloy with numerous inclusions (Table 1). From the chemical composition of the inclusions they can be interpreted as alpha-AlFeSi intermetallic compounds. In bright field we observe elongated inclusions indicating that the metal was rolled (Fig. 4). The alloy composition is similar to an unalloyed primary aluminium (Al content between 99 and 99.8 mass%). The O content reflects the immediate oxidation of the metal and is not part of the alloy. After etching the organisation of inclusions in rows is more easily seen (Fig. 5). The SEM image shows large grains formed after annealing (Fig. 6). The average hardness of the metal is HV1 40.

Fig. 4: Micrograph of the metal sample from Fig. 3 (detail), unetched, bright field. The metal matrix is in white, the elongated inclusions in grey,

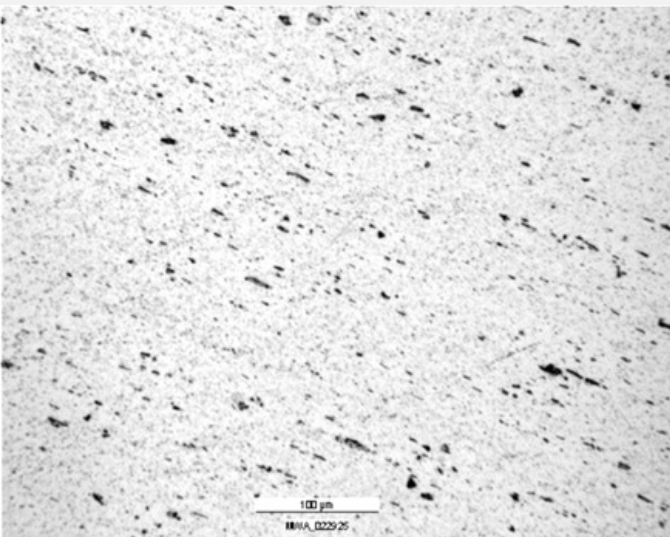
Fig. 5: Micrograph of the metal sample from Fig. 3 (detail), etched, bright field. The metal matrix is in white, the elongated inclusions in dark-grey and black,

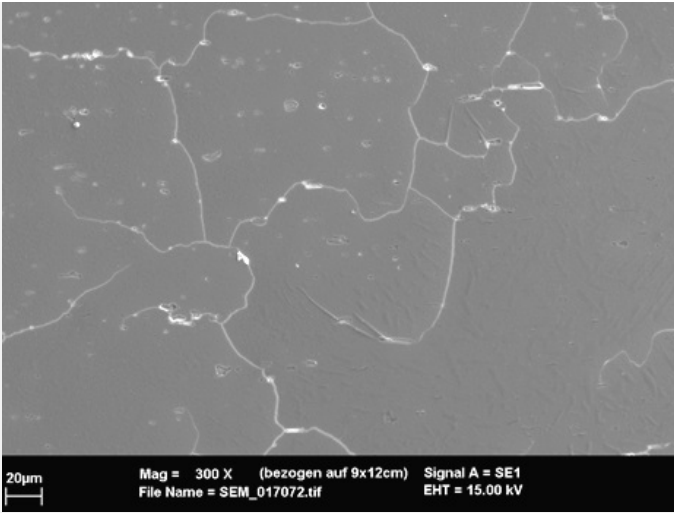
Fig. 6: SEM image of the metal sample from Fig. 3 (detail), SE-mode, etched. We observe the presence of large grains and numerous elongated inclusions,

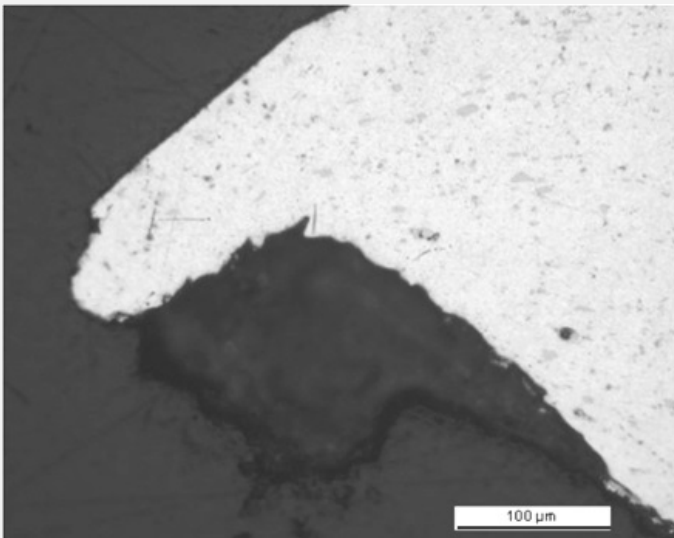
The metal is covered by a very thin corrosion layer (CP1). In addition to this, locally thicker adhering materials can be observed (NMM1, appearing as dark-grey area in Fig. 7). Under polarized light, they appear blue-brown (Fig. 8). Analysis by SEM-EDS indicates that the metal is, as expected, covered by a very thin Al and O-rich layer whereas the particles in the adherent material contain C, O, Si, Ca, Fe, Zn, S and even Ti (Figs. 9 and 10). The location of the adherent material and the presence of both Zn and Ti suggest that it is a residue of a paint coating.

Fig. 7: Micrograph showing the metal - adhering material interface from Fig. 3 (reversed picture, detail), unetched, bright field. We observe in white the metal matrix and dark-grey the adhering material,

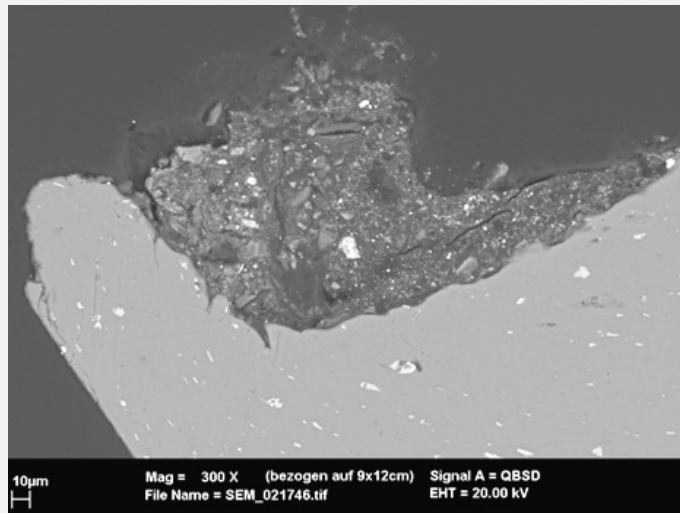
Fig. 9: SEM image (same as Fig. 7, inverted picture, detail), BSE-mode, unetched,

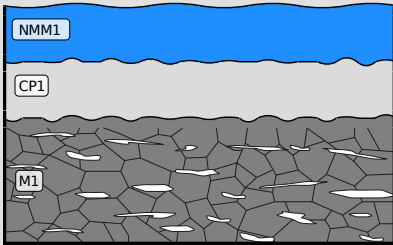
Fig. 11: Stratigraphic representation of the sample taken from the back fastening plate in cross-section (dark field) using the MiCorr application. The characteristics of the strata are only accessible by clicking on the drawing that redirects you to the search tool by stratigraphy representation. This representation can be compared to Fig. 8, Credit HE-Arc CR.
