AIRCRAFT REAR FASTENING PLATE VHS-497 – AL ALLOY – MODERN TIMES

Artefact name Aircraft rear fastening plate VHS-497

Authors Marianne. Senn (Empa, Dübendorf, Zurich, Switzerland) & Christian. Degryny (HE-Arc CR, Neuchâtel, Neuchâtel, Switzerland)

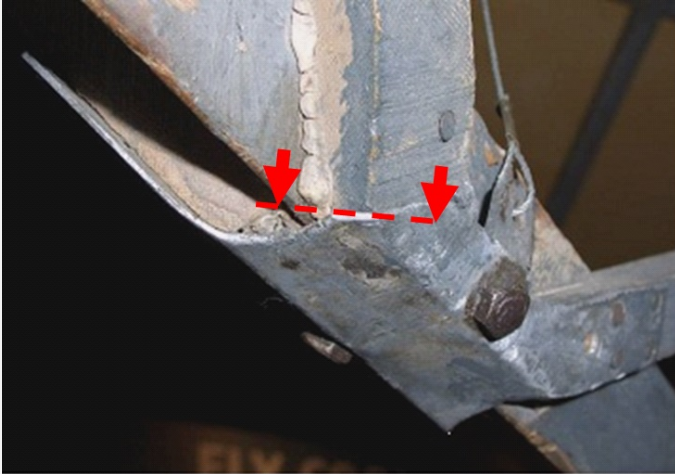
Fig. 2: Location of sampling area,

Description of sample	Sample cut from the corner of the fastening plate (Fig. 2). Dimensions: L = 4mm ; W = 1.2mm.
Alloy	Al Alloy
Technology	Hot rolled and annealed
Lab number of sample	DUF-12
Sample location	HE-Arc CR, Neuchâtel, Neuchâtel
Responsible institution	Swiss Museum of Transport, Luzern, Lucerne
Date and aim of sampling	September 2007, metallography and alloy composition

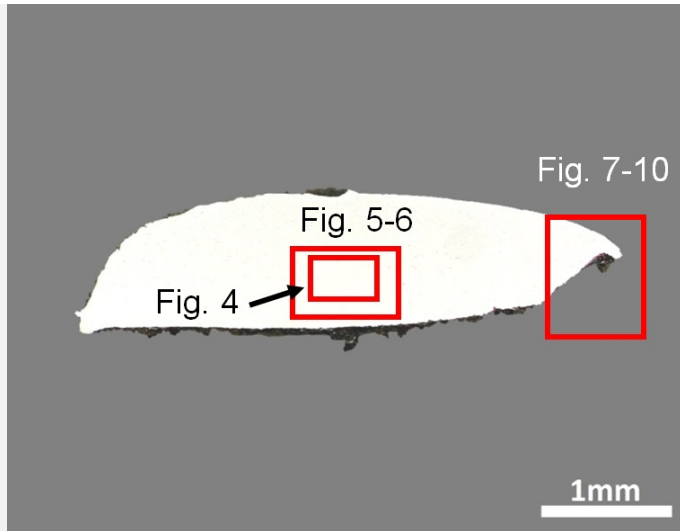
Fig. 3: Micrograph of the cross-section of the sample taken from the back fastening plate showing the location of Figs. 4 to 10,

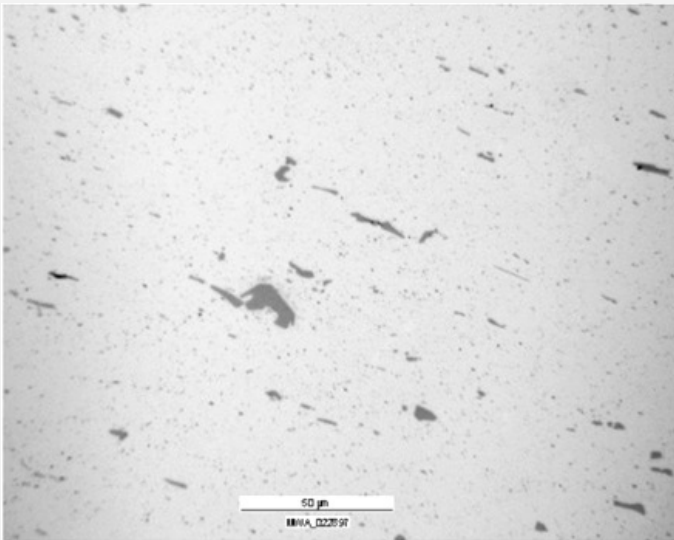
The metal is a relatively pure aluminium alloy with numerous inclusions (Table 1). From the chemical composition of the inclusions they can be interpreted as alpha-AlFeSi intermetallic compounds. In bright field we observe elongated inclusions indicating that the metal was rolled (Fig. 4). The alloy composition is similar to an unalloyed primary aluminium (Al content between 99 and 99.8 mass%). The O content reflects the immediate oxidation of the metal and is not part of the alloy. After etching the organisation of inclusions in rows is more easily seen (Fig. 5). The SEM image shows large grains formed after annealing (Fig. 6). The average hardness of the metal is HV1 40.

Table 1: Chemical composition (mass %) of the metal and inclusions (from Fig. 4). Method of analysis: SEM/EDS, Laboratory of Analytical Chemistry, Empa.

Fig. 4: Micrograph of the metal sample from Fig. 3 (detail), unetched, bright field. The metal matrix is in white, the elongated inclusions in grey,

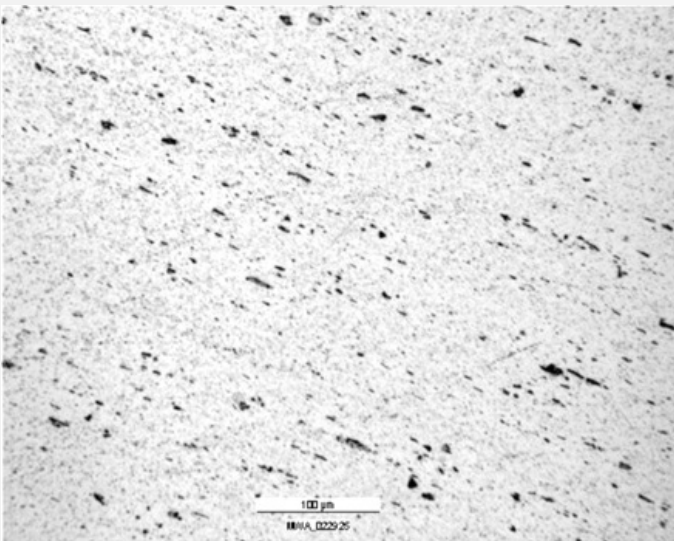
Fig. 5: Micrograph of the metal sample from Fig. 3 (detail), etched, bright field. The metal matrix is in white, the elongated inclusions in dark-grey and black,

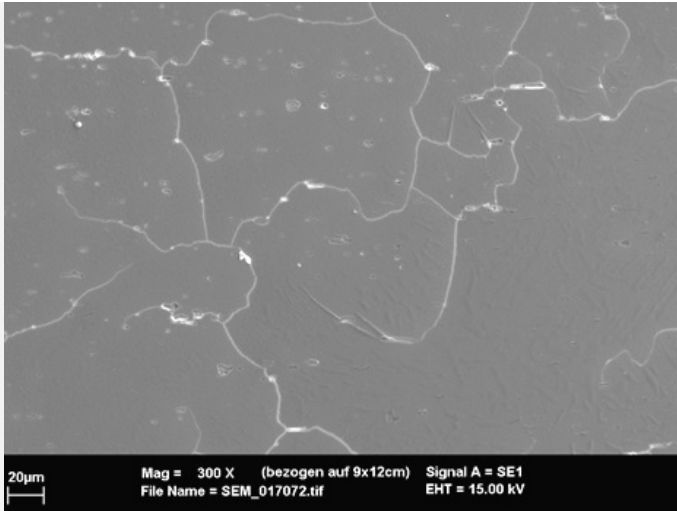
Fig. 6: SEM image of the metal sample from Fig. 3 (detail), SE-mode, etched. We observe the presence of large grains and numerous elongated inclusions,

Microstructure	Recrystallized structure with large grains
First metal element	Al
Other metal elements	Si

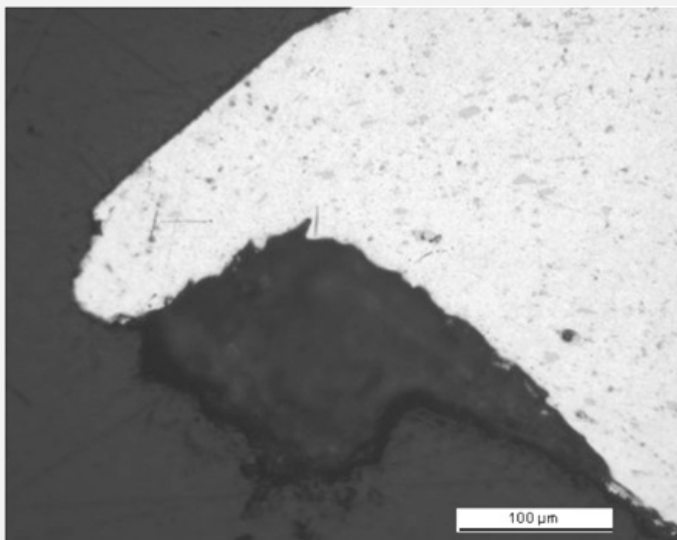
The metal is covered by a very thin corrosion layer (CP1). In addition to this, locally thicker adhering materials can be observed (NMM1, appearing as dark-grey area in Fig. 7). Under polarized light, they appear blue-brown (Fig. 8). Analysis by SEM-EDS indicates that the metal is, as expected, covered by a very thin Al and O-rich layer whereas the particles in the adherent material contain C, O, Si, Ca, Fe, Zn, S and even Ti (Figs. 9 and 10). The location of the adherent material and the presence of both Zn and Ti suggest that it is a residue of a paint coating.

Fig. 7: Micrograph showing the metal - adhering material interface from Fig. 3 (reversed picture, detail), unetched, bright field. We observe in white the metal matrix and dark-grey the adhering material,

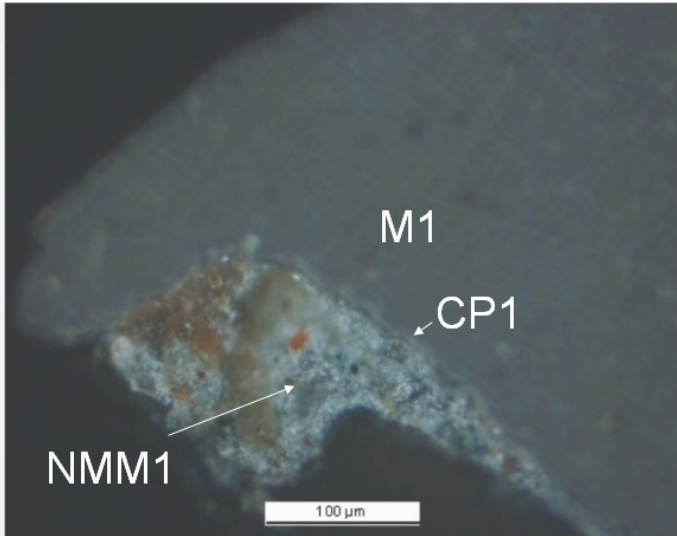
Fig. 8: Micrograph (same as Fig. 7) and corresponding to the stratigraphy of Fig. 11, unetched, polarised light. We observe in grey the metal matrix and blue-brown the adhering material,

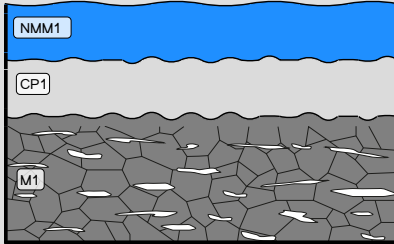
Fig. 11: Stratigraphic representation of the sample taken from the back fastening plate in cross-section (dark field) using the MiCorr application. The characteristics of the strata are only accessible by clicking on the drawing that redirects you to the search tool by stratigraphy representation. This representation can be compared to Fig. 8, Credit HE-Arc CR.
