AIRCRAFT REAR FASTENING PLATE VHS-497 - AL ALLOY - MODERN TIMES

Artefact name Aircraft rear fastening plate VHS-497

Authors Marianne. Senn (Empa, Dübendorf, Zurich, Switzerland) & Christian. Degrigny (HE-Arc CR, Neuchâtel, Neuchâtel, Switzerland)

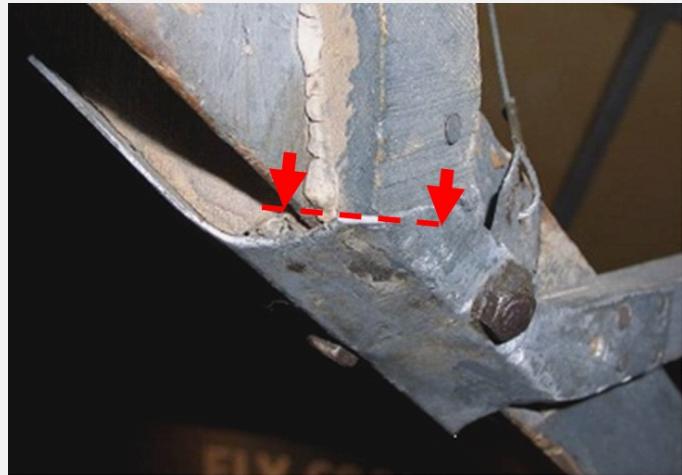
Fig. 2: Location of sampling area,

Description of sample	Sample cut from the corner of the fastening plate (Fig. 2). Dimensions: L = 4mm ; W = 1.2mm.
Alloy	Al Alloy
Technology	Hot rolled and annealed
Lab number of sample	DUF-12
Sample location	HE-Arc CR, Neuchâtel, Neuchâtel
Responsible institution	Swiss Museum of Transport, Luzern, Lucerne
Date and aim of sampling	September 2007, metallography and alloy composition

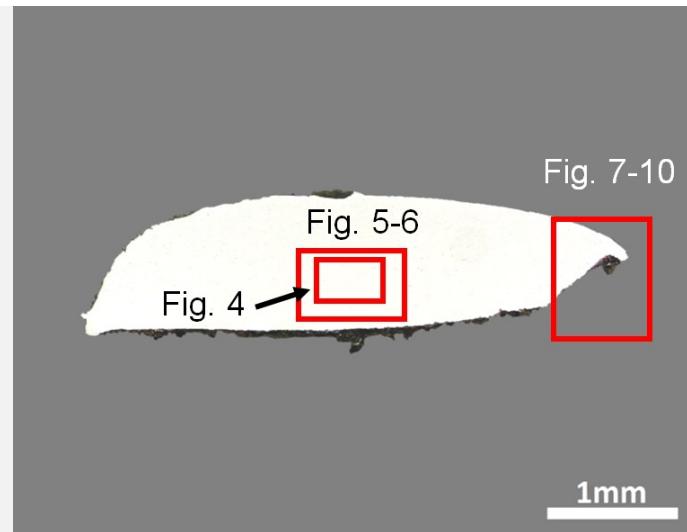
Fig. 3: Micrograph of the cross-section of the sample taken from the back fastening plate showing the location of Figs. 4 to 10,

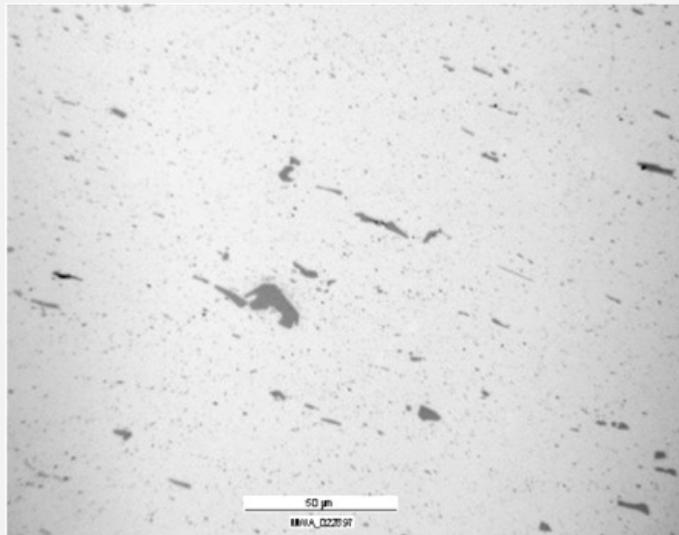
The metal is a relatively pure aluminium alloy with numerous inclusions (Table 1). From the chemical composition of the inclusions they can be interpreted as alpha-AlFeSi intermetallic compounds. In bright field we observe elongated inclusions indicating that the metal was rolled (Fig. 4). The alloy composition is similar to an unalloyed primary aluminium (Al content between 99 and 99.8 mass%). The O content reflects the immediate oxidation of the metal and is not part of the alloy. After etching the organisation of inclusions in rows is more easily seen (Fig. 5). The SEM image shows large grains formed after annealing (Fig. 6). The average hardness of the metal is HV1 40.

Table 1: Chemical composition (mass %) of the metal and inclusions (from Fig. 4). Method of analysis: SEM/EDS, Laboratory of Analytical Chemistry, Empa.

Fig. 4: Micrograph of the metal sample from Fig. 3 (detail), unetched, bright field. The metal matrix is in white, the elongated inclusions in grey,

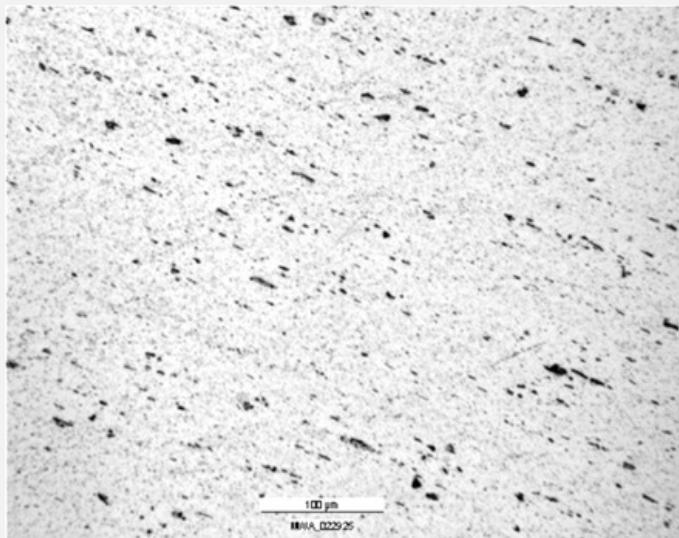
Fig. 5: Micrograph of the metal sample from Fig. 3 (detail), etched, bright field. The metal matrix is in white, the elongated inclusions in dark-grey and black,

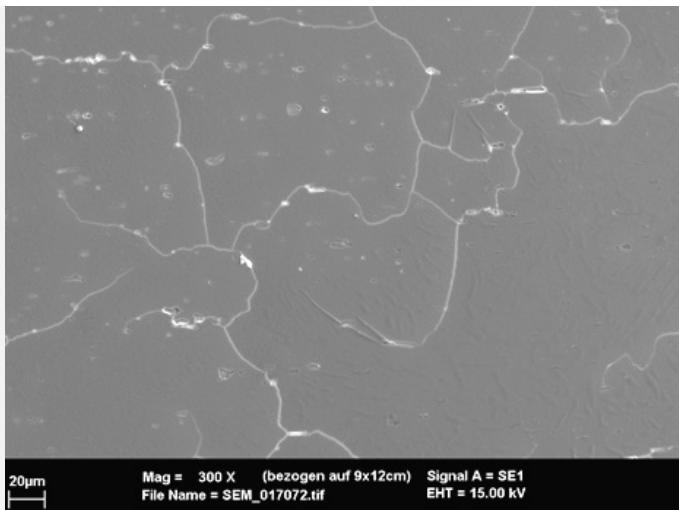
Fig. 6: SEM image of the metal sample from Fig. 3 (detail), SE-mode, etched. We observe the presence of large grains and numerous elongated inclusions,

Microstructure Recrystallized structure with large grains

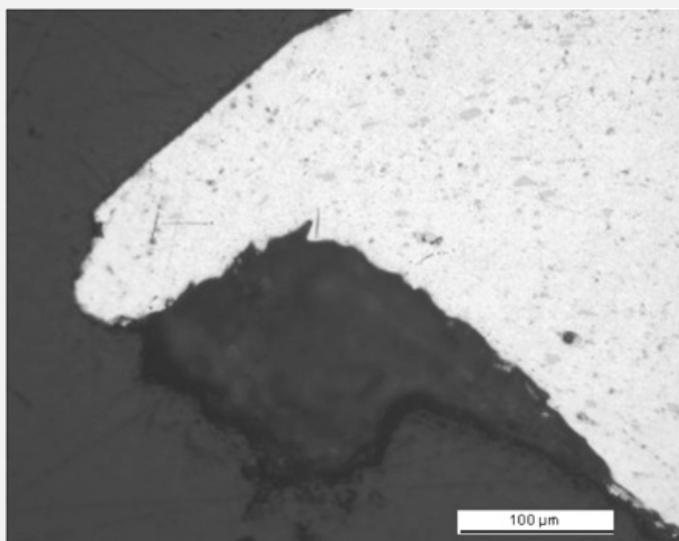
The metal is covered by a very thin corrosion layer (CP1). In addition to this, locally thicker adhering materials can be observed (NMM1, appearing as dark-grey area in Fig. 7). Under polarized light, they appear blue-brown (Fig. 8). Analysis by SEM-EDS indicates that the metal is, as expected, covered by a very thin Al and O-rich layer whereas the particles in the adherent material contain C, O, Si, Ca, Fe, Zn, S and even Ti (Figs. 9 and 10). The location of the adherent material and the presence of both Zn and Ti suggest that it is a residue of a paint coating.

Fig. 7: Micrograph showing the metal - adhering material interface from Fig. 3 (reversed picture, detail), unetched, bright field. We observe in white the metal matrix and dark-grey the adhering material,

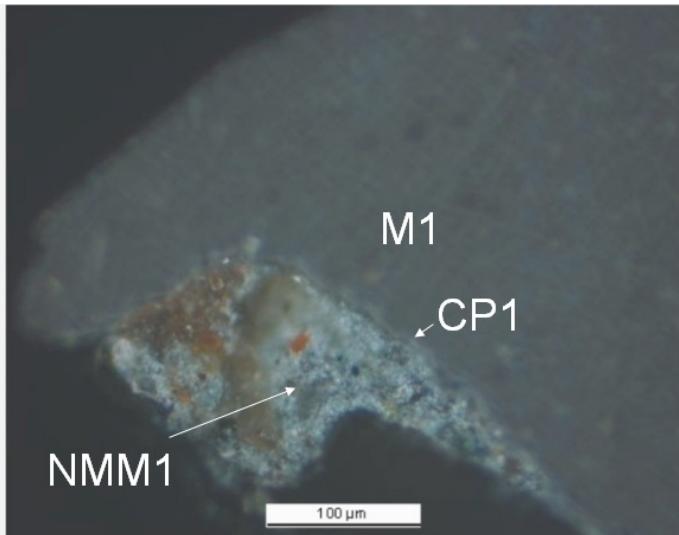
Fig. 8: Micrograph (same as Fig. 7) and corresponding to the stratigraphy of Fig. 11, unetched, polarised light. We observe in grey the metal matrix and blue-brown the adhering material,

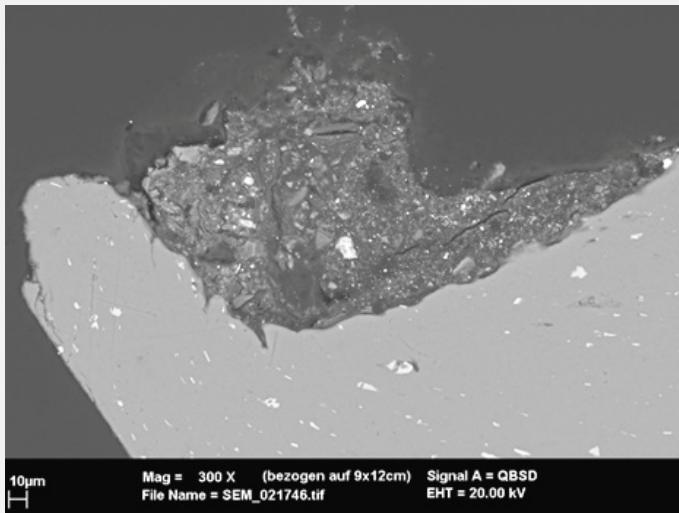
Fig. 9: SEM image (same as Fig. 7, inverted picture, detail), BSE-mode, unetched,

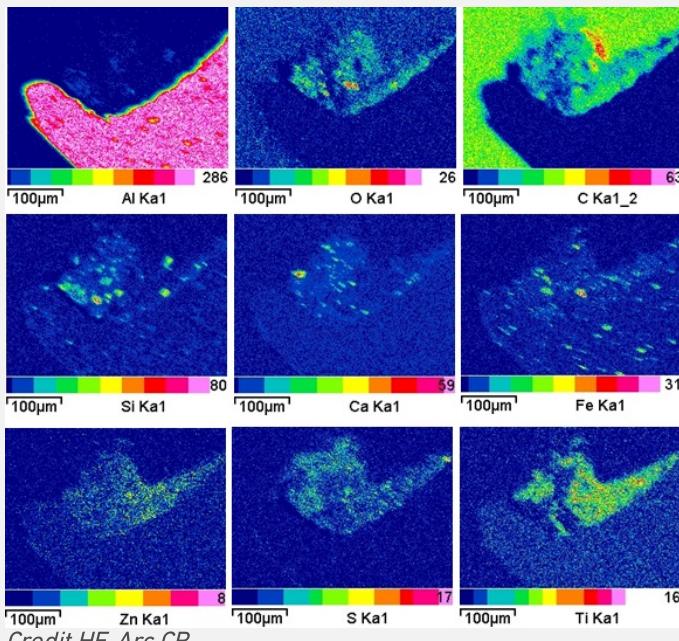
Fig. 10: Elemental chemical distribution of the selected area from Fig. 9. Method of examination: SEM/EDS, Laboratory of Analytical Chemistry, Empa,

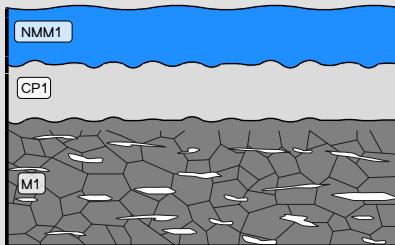
Fig. 11: Stratigraphic representation of the sample taken from the back fastening plate in cross-section (dark field) using the MiCorr application. The characteristics of the strata are only accessible by clicking on the drawing that redirects you to the search tool by stratigraphy representation. This representation can be compared to Fig. 8, Credit HE-Arc CR.
