AIRCRAFT REAR FASTENING PLATE VHS-497 – AL ALLOY – MODERN TIMES

Artefact name Aircraft rear fastening plate VHS-497

Authors Marianne. Senn (Empa, Dübendorf, Zurich, Switzerland) & Christian. Degriigny (HE-Arc CR, Neuchâtel, Neuchâtel, Switzerland)

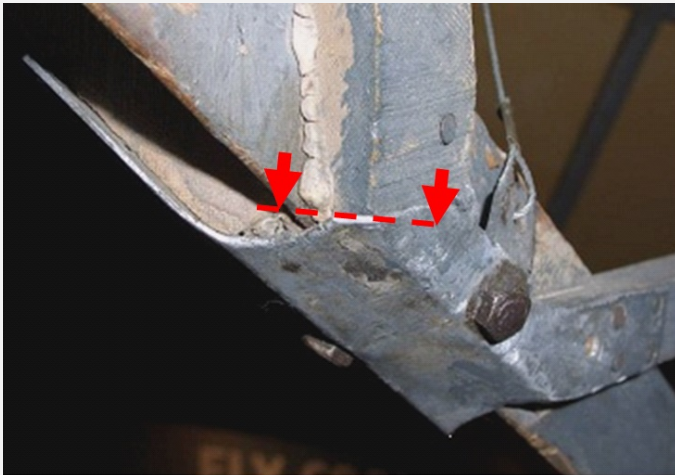
Fig. 2: Location of sampling area,

Description of sample	Sample cut from the corner of the fastening plate (Fig. 2). Dimensions: L = 4mm ; W = 1.2mm.
Alloy	Al Alloy
Technology	Hot rolled and annealed
Lab number of sample	DUF-12
Sample location	HE-Arc CR, Neuchâtel, Neuchâtel
Responsible institution	Swiss Museum of Transport, Luzern, Lucerne
Date and aim of sampling	September 2007, metallography and alloy composition

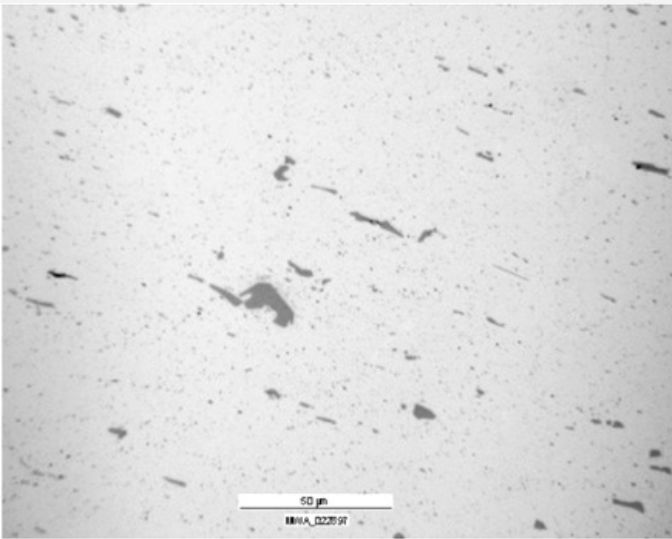
The metal is a relatively pure aluminium alloy with numerous inclusions (Table 1). From the chemical composition of the inclusions they can be interpreted as alpha-AlFeSi intermetallic compounds. In bright field we observe elongated inclusions indicating that the metal was rolled (Fig. 4). The alloy composition is similar to an unalloyed primary aluminium (Al content between 99 and 99.8 mass%). The O content reflects the immediate oxidation of the metal and is not part of the alloy. After etching the organisation of inclusions in rows is more easily seen (Fig. 5). The SEM image shows large grains formed after annealing (Fig. 6). The average hardness of the metal is HV1 40.

Table 1: Chemical composition (mass %) of the metal and inclusions (from Fig. 4). Method of analysis: SEM/EDS, Laboratory of Analytical Chemistry, Empa.

Fig. 4: Micrograph of the metal sample from Fig. 3 (detail), unetched, bright field. The metal matrix is in white, the elongated inclusions in grey,

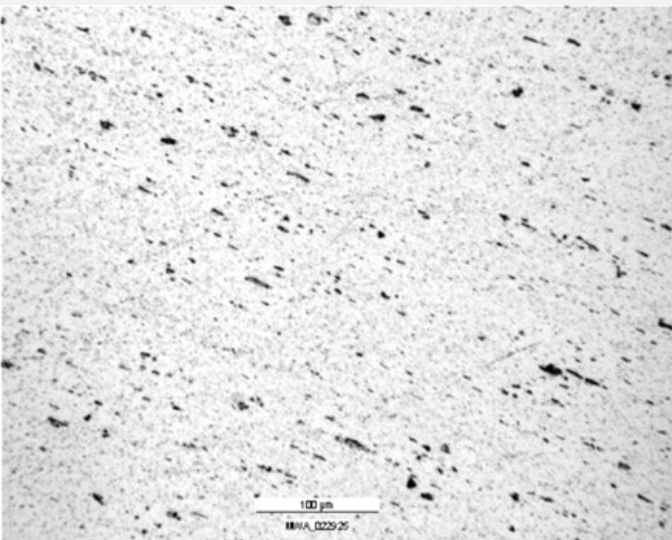
Fig. 5: Micrograph of the metal sample from Fig. 3 (detail), etched, bright field. The metal matrix is in white, the elongated inclusions in dark-grey and black,

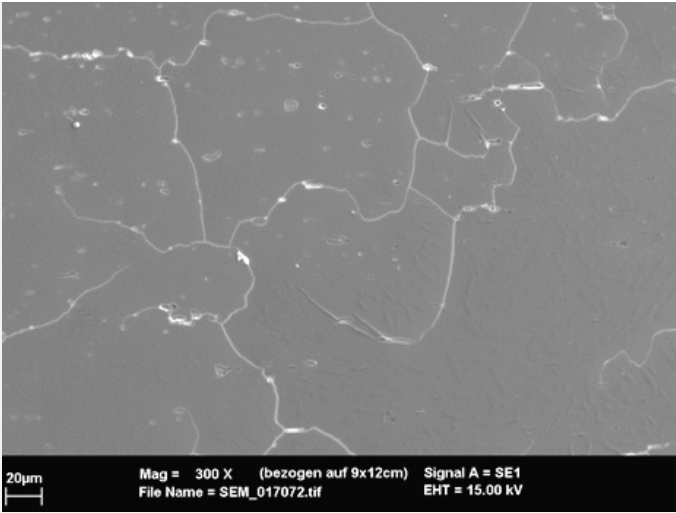
Fig. 6: SEM image of the metal sample from Fig. 3 (detail), SE-mode, etched. We observe the presence of large grains and numerous elongated inclusions,

Microstructure	Recrystallized structure with large grains
First metal element	Al
Other metal elements	Si

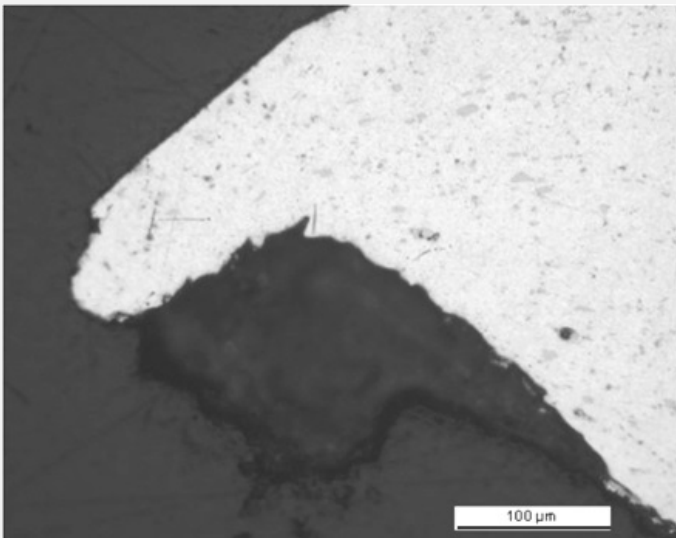
The metal is covered by a very thin corrosion layer (CP1). In addition to this, locally thicker adhering materials can be observed (NMM1, appearing as dark-grey area in Fig. 7). Under polarized light, they appear blue-brown (Fig. 8). Analysis by SEM-EDS indicates that the metal is, as expected, covered by a very thin Al and O-rich layer whereas the particles in the adherent material contain C, O, Si, Ca, Fe, Zn, S and even Ti (Figs. 9 and 10). The location of the adherent material and the presence of both Zn and Ti suggest that it is a residue of a paint coating.

Fig. 7: Micrograph showing the metal - adhering material interface from Fig. 3 (reversed picture, detail), unetched, bright field. We observe in white the metal matrix and dark-grey the adhering material,

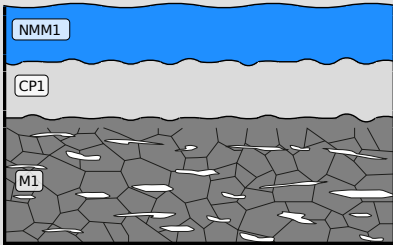
Fig. 11: Stratigraphic representation of the sample taken from the back fastening plate in cross-section (dark field) using the MiCorr application. The characteristics of the strata are only accessible by clicking on the drawing that redirects you to the search tool by stratigraphy representation. This representation can be compared to Fig. 8, Credit HE-Arc CR.
