AIRCRAFT REAR FASTENING PLATE VHS-497 – AL ALLOY – MODERN TIMES

Artefact name	Aircraft rear fastening plate VHS-497
Authors	Marianne. Senn (Empa, Dübendorf, Zurich, Switzerland) & Christian. Degriigny (HE-Arc CR, Neuchâtel, Neuchâtel, Switzerland)
Url	/artefacts/916/

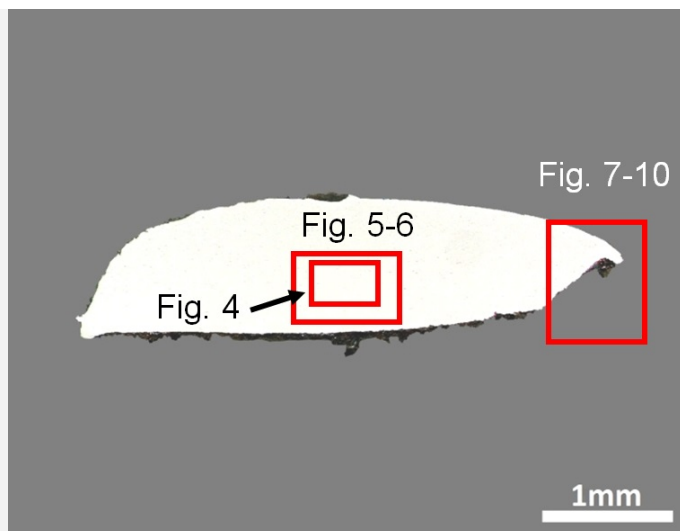
Fig. 3: Micrograph of the cross-section of the sample taken from the back fastening plate showing the location of Figs. 4 to 10,

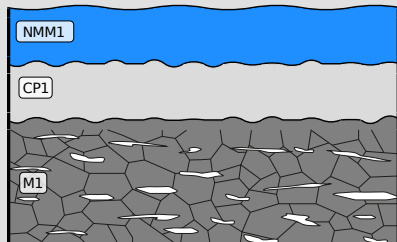
Fig. 11: Stratigraphic representation of the sample taken from the back fastening plate in cross-section (dark field) using the MiCorr application. The characteristics of the strata are only accessible by clicking on the drawing that redirects you to the search tool by stratigraphy representation. This representation can be compared to Fig. 8, Credit HE-Arc CR.
