AIRCRAFT FRONT FASTENING PLATE VHS-497 (2) – AL CU SN ZN SI ALLOY – MODERN TIMES

Artefact name	Aircraft front fastening plate VHS-497 (2)
Authors	Marianne. Senn (Empa, Dübendorf, Zurich, Switzerland) & Christian. Degrigny (HE-Arc CR, Neuchâtel, Neuchâtel, Switzerland)
Url	/artefacts/917/

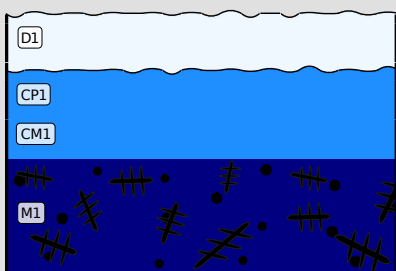
Fig. 9: Stratigraphic representation of the sample taken from the front fastening plate in cross-section (dark field) using the MiCorr application. The characteristics of the strata are only accessible by clicking on the drawing that redirects you to the search tool by stratigraphy representation. This representation can be compared to Fig. 7, Credit HE-Arc CR.
