AIRCRAFT FRONT FASTENING PLATE VHS-497 (2) - AL CU SN ZN SI ALLOY - MODERN TIMES

Artefact name Aircraft front fastening plate VHS-497 (2)

Authors Marianne. Senn (Empa, Dübendorf, Zurich, Switzerland) & Christian. Degriigny (HE-Arc CR, Neuchâtel, Neuchâtel, Switzerland)

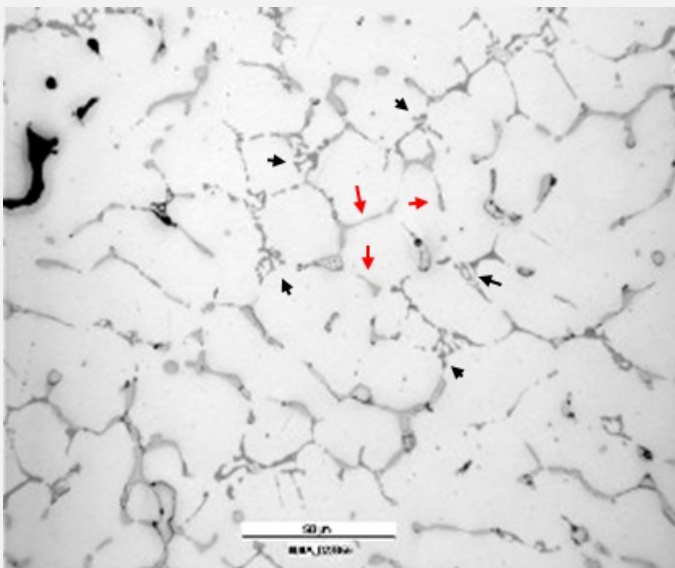
The metal is an aluminium alloy containing Cu, Sn, Zn and Si (Table 1). The unetched metal shows an as-cast structure consisting of the aluminium matrix with Sn (not soluble in Al) inclusions (Figs. 4 and 5), intermetallic compounds such as Al₂Cu (Fig. 4, red arrows) and clusters of Al,Fe,Cu & Si phases (Fig. 4, black arrows). There are porosities in the metal (Figs. 3 and 5). The average hardness of the metal is HV1 80.

Fig. 4: Micrograph of the metal sample from Fig. 3 (detail), unetched, bright field. The cast structure is revealed by light grey intermetallic compounds (Al₂Cu, red arrows), dark-grey Al,Fe,Si & Cu phase clusters (black arrows) and Sn inclusions (nodules). On the top left some pores can be seen,

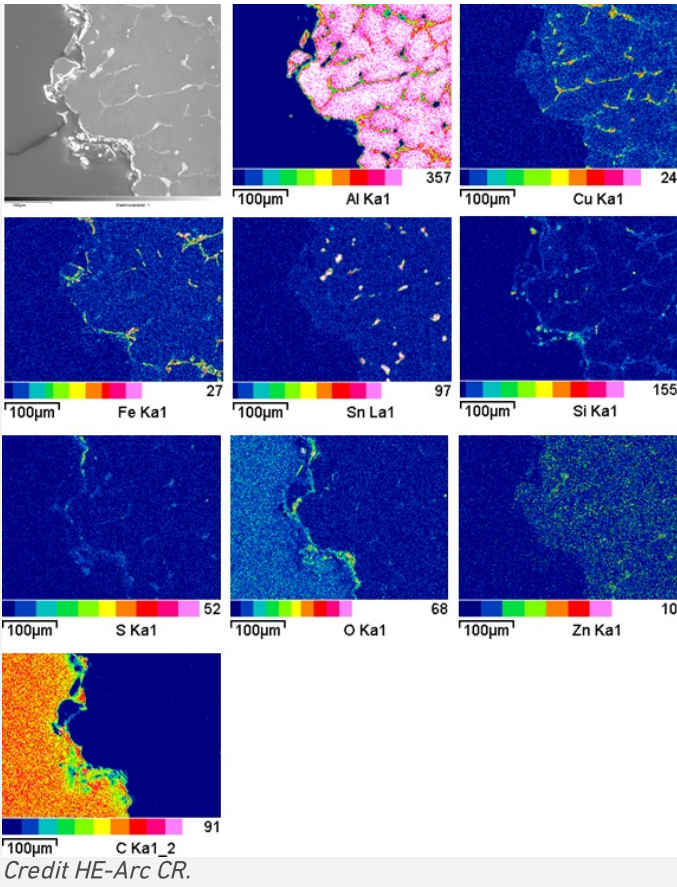
Fig. 8: SEM image, BSE-mode, and elemental chemical distribution of the selected area from Fig. 7 (reversed picture, detail). Method of examination: SEM/EDS, Laboratory of Analytical Chemistry, Empa,

This front fastening plate of Dufaux IV plane is made in cast Al-Cu-Sn-Zn-Si, an alloy rather common at the beginning of the 20th century. No corrosion layer has been found on the metal surface except adherent silica-rich particles and the thin oxidised skin typical of Al alloys. The presence of these materials can be explained by the regular maintenance of the metal, probably using silicon carbide abrasive paper.

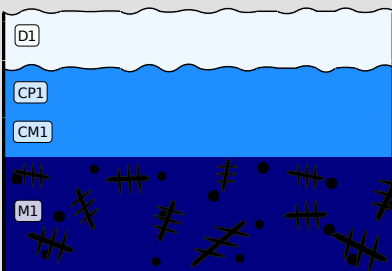
Fig. 9: Stratigraphic representation of the sample taken from the front fastening plate in cross-section (dark field) using the MiCorr application. The characteristics of the strata are only accessible by clicking on the drawing that redirects you to the search tool by stratigraphy representation. This representation can be compared to Fig. 7, Credit HE-Arc CR.
