AIRCRAFT FRONT FASTENING PLATE VHS-497 (2) - AL CU SN ZN SI ALLOY - MODERN TIMES

Artefact name Aircraft front fastening plate VHS-497 (2)

Authors Marianne. Senn (Empa, Dübendorf, Zurich, Switzerland) & Christian. Degrigny (HE-Arc CR, Neuchâtel, Neuchâtel, Switzerland)

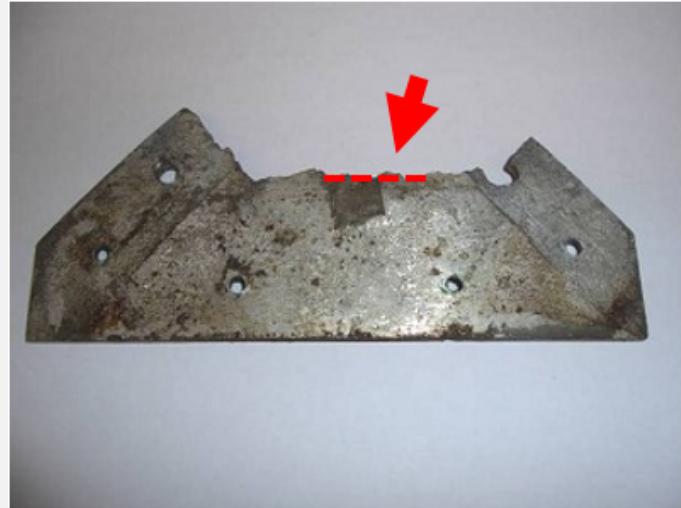
Fig. 2: Location of sampling area,

The top part has been cut during sampling (Fig. 2). The more regular right side is the plate surface and the irregular side is the broken edge (Fig. 3). Dimensions: L = 4mm ; W = 4mm.

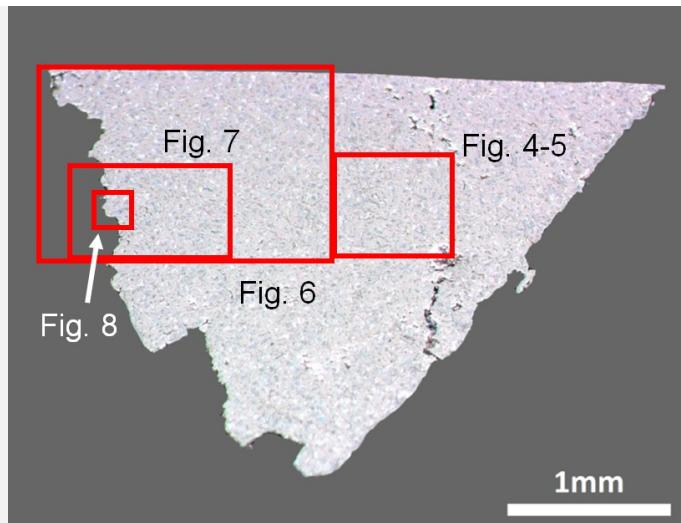
Fig. 3: Micrograph of the cross-section of the sample taken from the front fastening plate showing the location of Figs. 4 to 8,

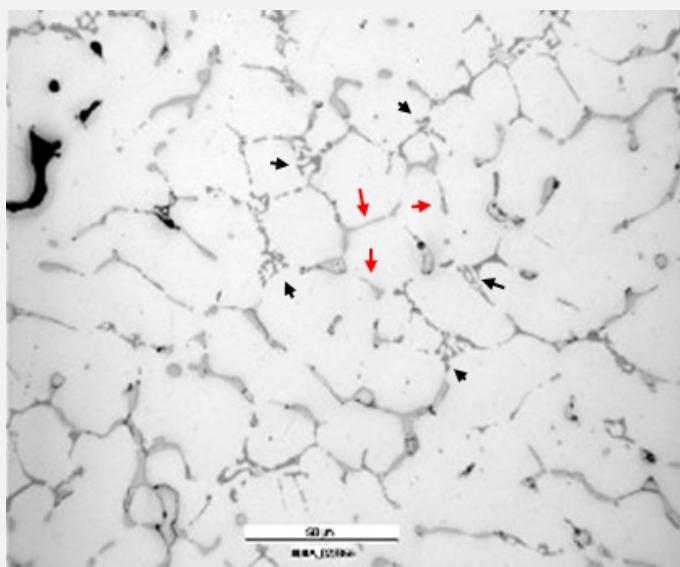
The metal is an aluminium alloy containing Cu, Sn, Zn and Si (Table 1). The unetched metal shows an as-cast structure consisting of the aluminium matrix with Sn (not soluble in Al) inclusions (Figs. 4 and 5), intermetallic compounds such as Al₂Cu (Fig. 4, red arrows) and clusters of Al,Fe,Cu & Si phases (Fig. 4, black arrows). There are porosities in the metal (Figs. 3 and 5). The average hardness of the metal is HV1 80.

Fig. 4: Micrograph of the metal sample from Fig. 3 (detail), unetched, bright field. The cast structure is revealed by light grey intermetallic compounds (Al₂Cu, red arrows), dark-grey Al,Fe,Si & Cu phase clusters (black arrows) and Sn inclusions (nodules). On the top left some pores can be seen,

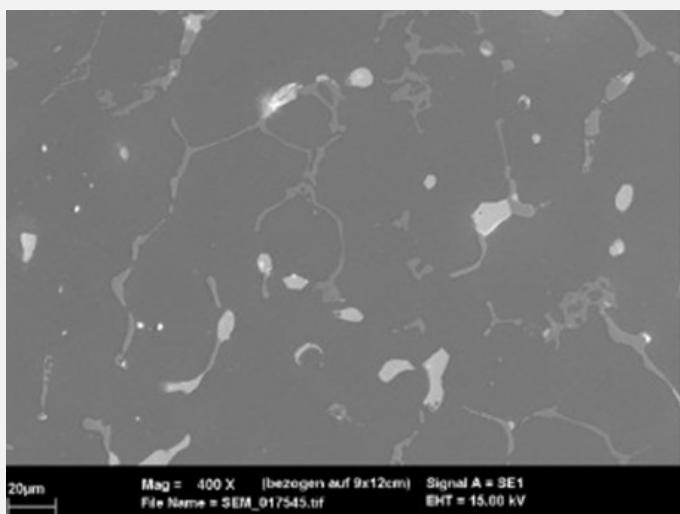
Table 1: Chemical composition (mass %) of the metal and inclusions (from Fig. 5). Method of analysis: SEM/EDS, Laboratory of Analytical Chemistry, Empa.

Fig. 5: SEM image of the metal sample from Fig. 3 (detail), SE-mode, unetched. We observe in dark-grey the metal matrix, in medium-grey the intermetallic compound Al₂Cu as well as Al,Fe,Si & Cu phase clusters and in light-grey the Sn inclusions,

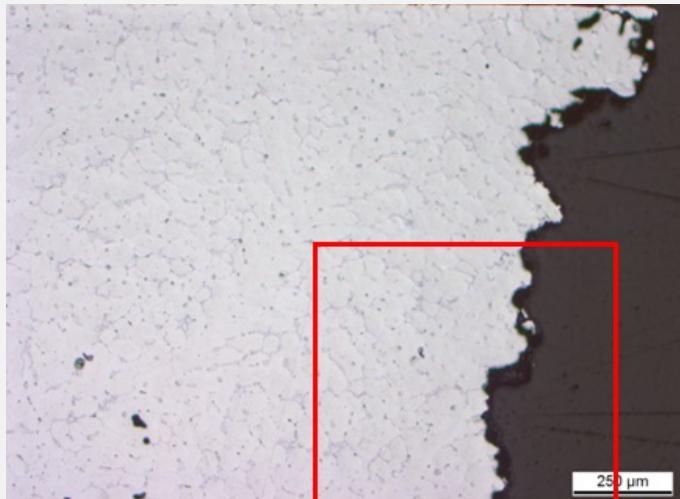
No corrosion layer can be seen on the metal surface (Figs. 3 and 6). Under polarized light small white and brown particles are visible on the broken edge (D1, Fig. 7). Their analysis reveals the presence of silica particles surrounded by dirt (Table 2 and Fig. 8). The metal surface is covered by a thin oxygen bearing skin (CP1, Fig. 8).

Fig. 6: Micrograph showing the metal - "corrosion products" interface from Fig. 3 (reversed picture, detail), unetched, bright field. We observe in white the metal matrix, in dark-grey Al, Fe, Si & Cu phase and light-grey Al₂Cu intermetallic compounds. The micrograph of Fig. 7 is marked by a rectangle,

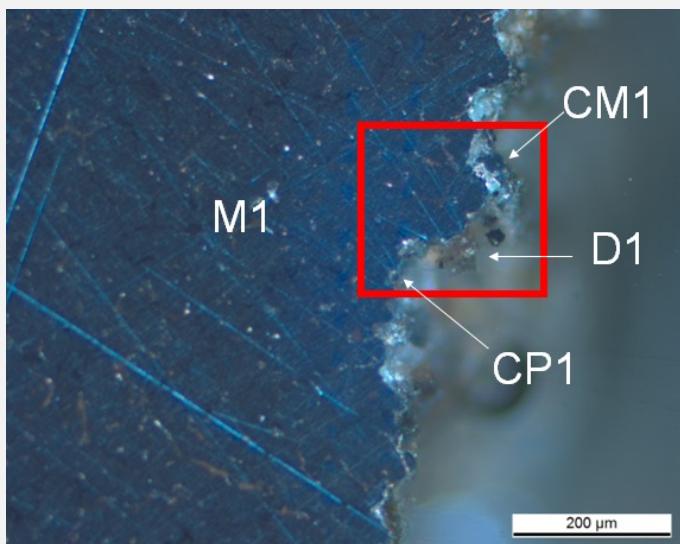
Fig. 7: Micrograph from Fig. 6 (detail) and corresponding to the stratigraphy of Fig. 9, unetched, polarised light. We observe in dark blue the metal matrix and blue-brown the adherent material. The area selected for elemental chemical distribution (Fig. 8) is marked by a rectangle,

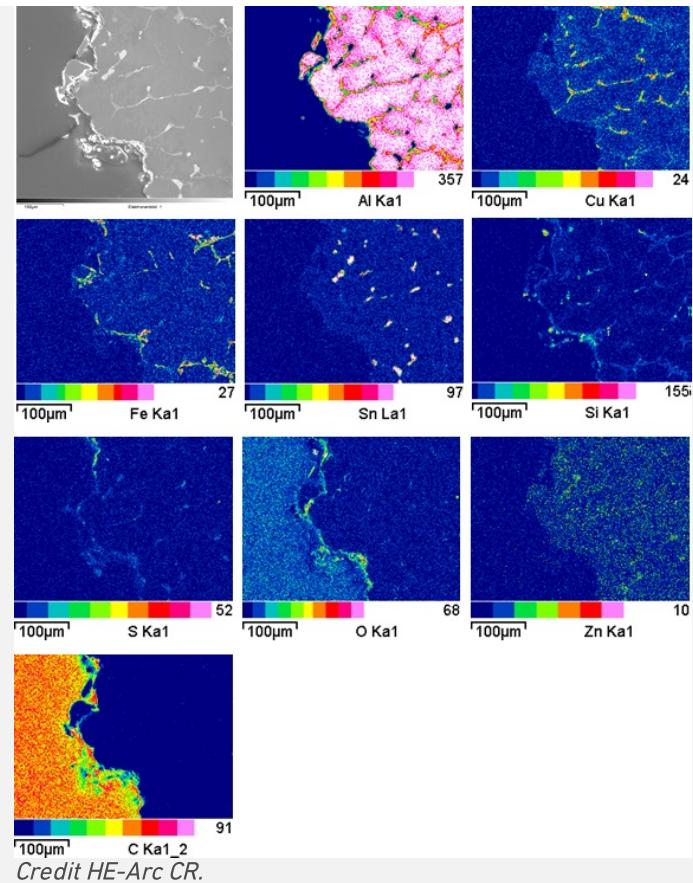
Table 2: Chemical composition (mass %) of the adhering particles to the metal surface (from Fig. 8). Method of analysis: SEM/EDS, Laboratory of Analytical Chemistry, Empa.

Fig. 8: SEM image, BSE-mode, and elemental chemical distribution of the selected area from Fig. 7 (reversed picture, detail). Method of examination: SEM/EDS, Laboratory of Analytical Chemistry, Empa,

This front fastening plate of Dufaux IV plane is made in cast Al-Cu-Sn-Zn-Si, an alloy rather common at the beginning of the 20th century. No corrosion layer has been found on the metal surface except adherent silica-rich particles and the thin oxidised skin typical of Al alloys. The presence of these materials can be explained by the regular maintenance of the metal, probably using silicon carbide abrasive paper.

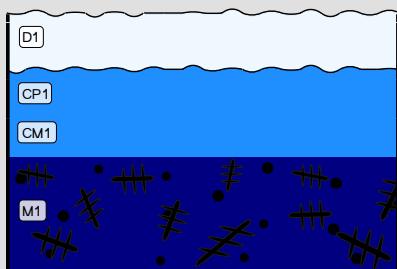
Fig. 9: Stratigraphic representation of the sample taken from the front fastening plate in cross-section (dark field) using the MiCorr application. The characteristics of the strata are only accessible by clicking on the drawing that redirects you to the search tool by stratigraphy representation. This representation can be compared to Fig. 7, Credit HE-Arc CR.
