CIRCULAR DOOR KNOCKER STRIKING PLATE – CU ALLOY – MODERN TIMES – SWITZERLAND

Artefact name	Circular door knocker striking plate
Authors	Marianne. Senn (Empa, Dübendorf, Zurich, Switzerland) & Christian. Degriigny (HE-Arc CR, Neuchâtel, Neuchâtel, Switzerland)
Url	/artefacts/919/

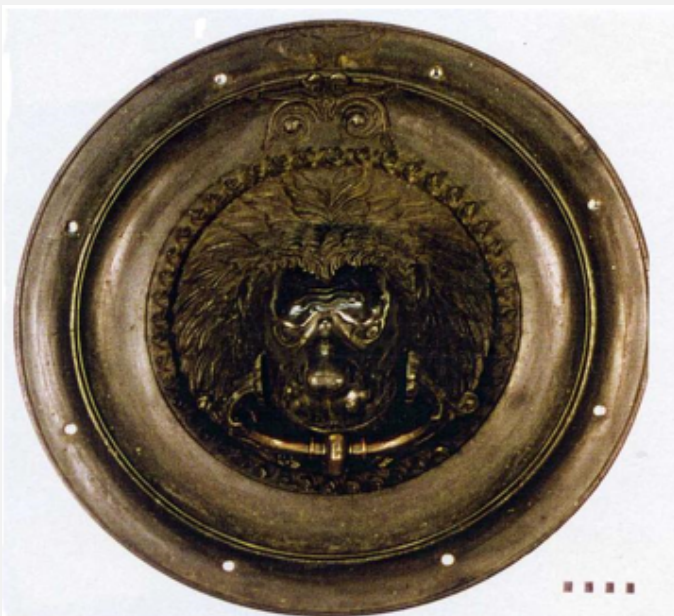
Fig. 1: Circular door knocker striking plate (after Benoît, 1994),

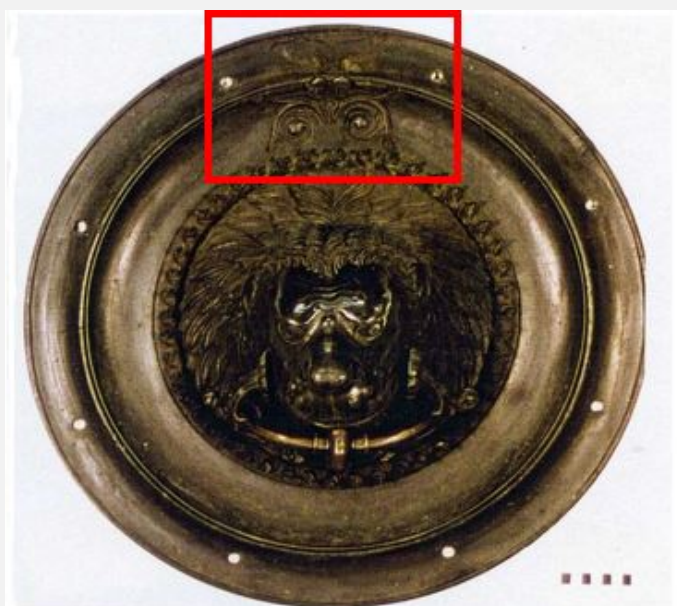
Fig. 2: Possible location of sampling area,

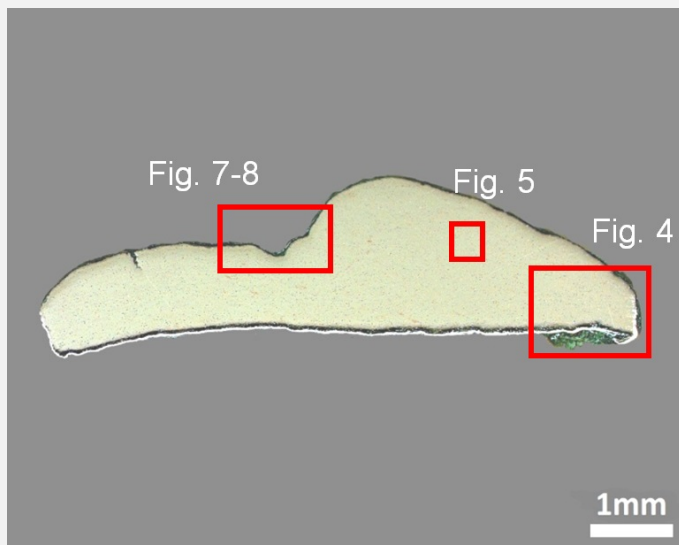
Fig. 3: Micrograph of the cross-section of the sample taken from the circular plate showing the location of Figs. 4 to 5 and 7 to 8,

Description of sample	No information is given on where the sample has been taken. A supposed location is however illustrated in Fig. 2. The polished sample shows a well preserved metal surface with some cracks covered by a thin corrosion crust (Fig. 3).
Alloy	Cu Alloy
Technology	Rolled, annealed after cold working
Lab number of sample	MAH 94-156-001
Sample location	Musées d'art et d'histoire, Genève, Geneva
Responsible institution	Musées d'art et d'histoire, Genève, Geneva
Date and aim of sampling	1994, metallography and presence or not of a gilding treatment

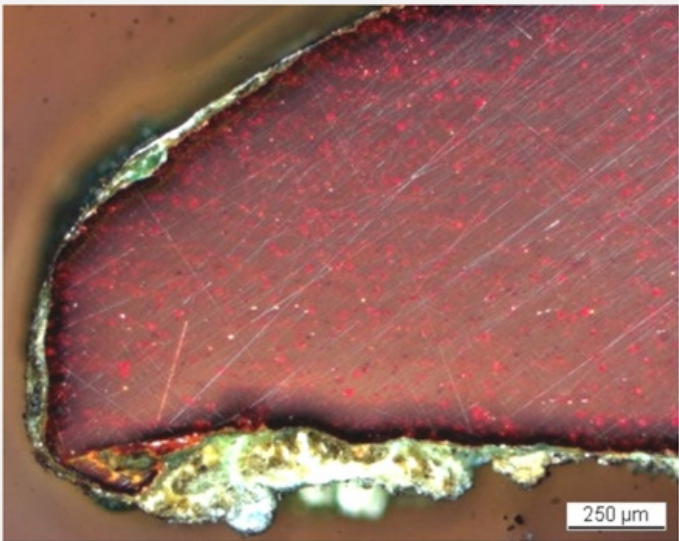
Fig. 4: Micrograph of the metal sample from Fig. 3 (reversed picture), unetched, polarised light. The red copper oxide inclusions form rows in the copper alloy matrix,

The average thickness of the corrosion crust is about 90μm, but may be thinner or thicker depending on the area of origin (Fig. 4). Under polarized light, we observe a multilayer system with a dense and thin inner red corrosion layer (CP2, probably cuprite/Cu₂O) on the metal (Fig. 7) containing chlorides (Fig. 8 and Table 3). This is followed by bands of heterogeneous green corrosion products (CP1, possibly copper chloride / sulphate / carbonate). This outer corrosion layer is contaminated with atmospheric components (Si, Al, Cl, C and O and perhaps gypsum particles (CaSO₄)) (Fig. 8).

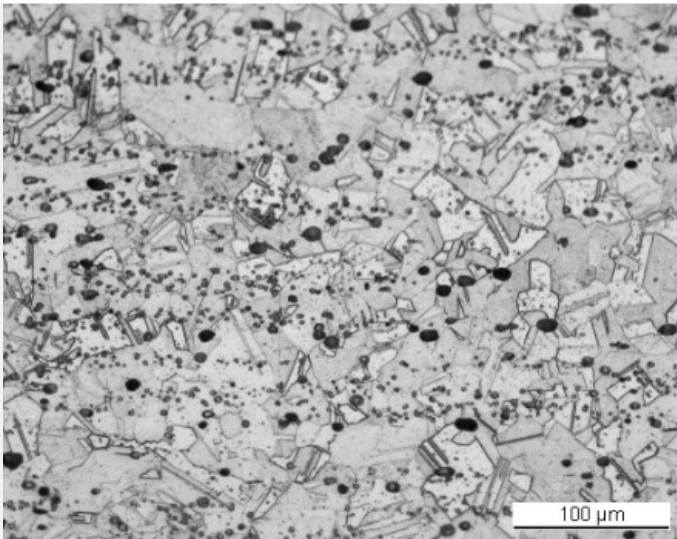
Fig. 5: Micrograph of the metal sample from Fig. 3 (detail), etched, bright field. The metal shows a structure of polygonal and twinned grains. Copper oxide inclusions are visible as dark spots,

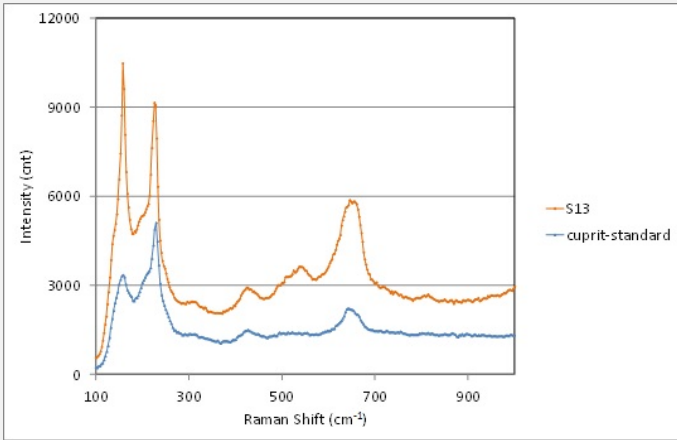
Fig. 6: Raman spectrum of a red inclusion (S13) of Fig. 4 compared to a cuprite standard spectrum. Settings: laser wavelength 532nm, acquisition time 100s, one accumulation, filter D2 (0.75-0.8mW), hole 500, slit 80, grating 600. Method of analysis: Raman spectroscopy. Lab of Swiss National Museum, Affoltern a. Albis ZH,

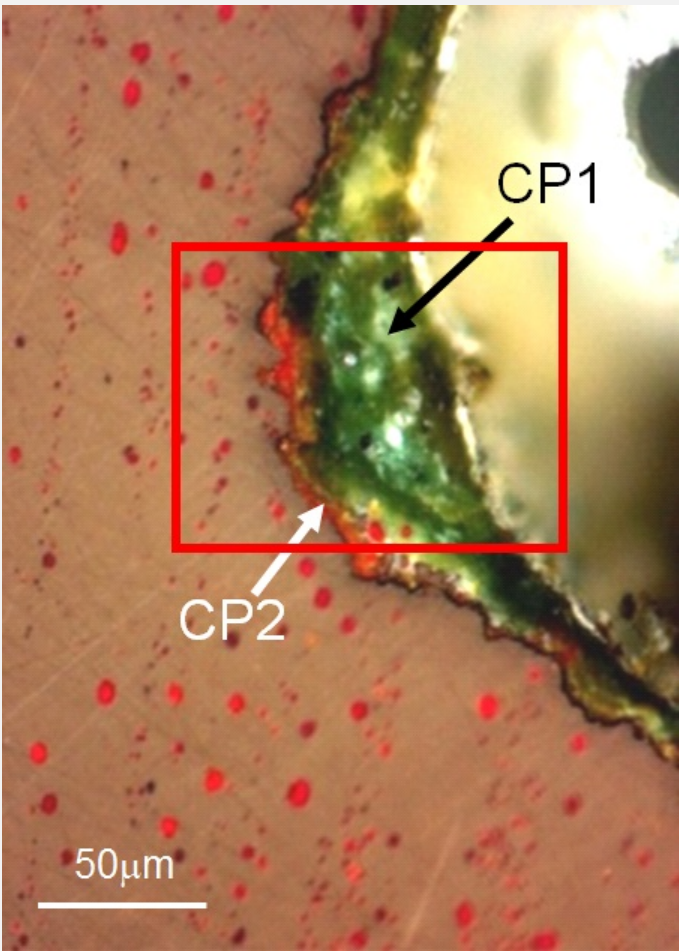
Fig. 7: Micrograph of the metal sample from Fig. 3 (rotated by 90°) and corresponding to the stratigraphy of Fig. 9, polarised light. Metal with red copper oxide inclusions. The black particles in the green corrosion layer are quartz inclusions. The area selected for elemental chemical distribution (Fig. 8) is marked by a red rectangle,

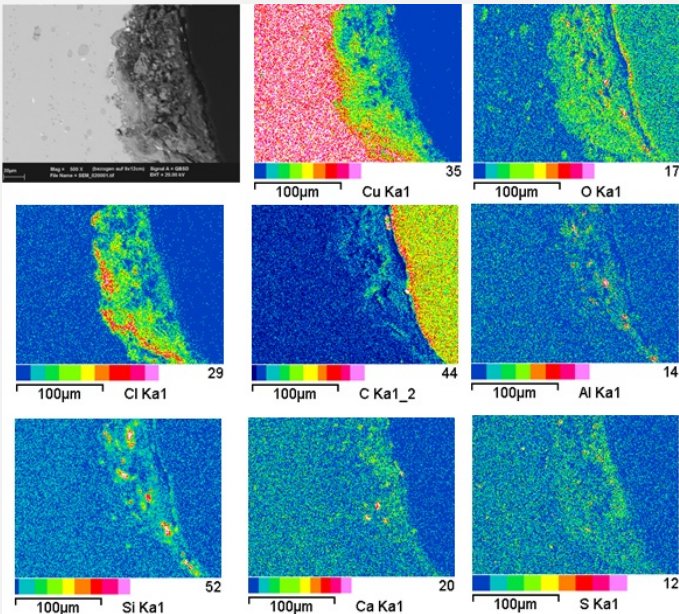
Table 2: Chemical composition (mass %) of the inclusions (light-grey and white in Fig. 8) in the metal. Method of analysis: SEM/EDS, Laboratory of Analytical Chemistry, Empa.

Fig. 8: SEM image, BSE-mode, and elemental chemical distribution of the selected area of Fig. 7. Method of examination: SEM/EDS, Laboratory of Analytical Chemistry, Empa,
