CIRCULAR DOOR KNOCKER STRIKING PLATE - CU ALLOY - MODERN TIMES - SWITZERLAND

Artefact name Circular door knocker striking plate

Authors Marianne. Senn (Empa, Dübendorf, Zurich, Switzerland) & Christian. Degrigny (HE-Arc CR, Neuchâtel, Neuchâtel, Switzerland)

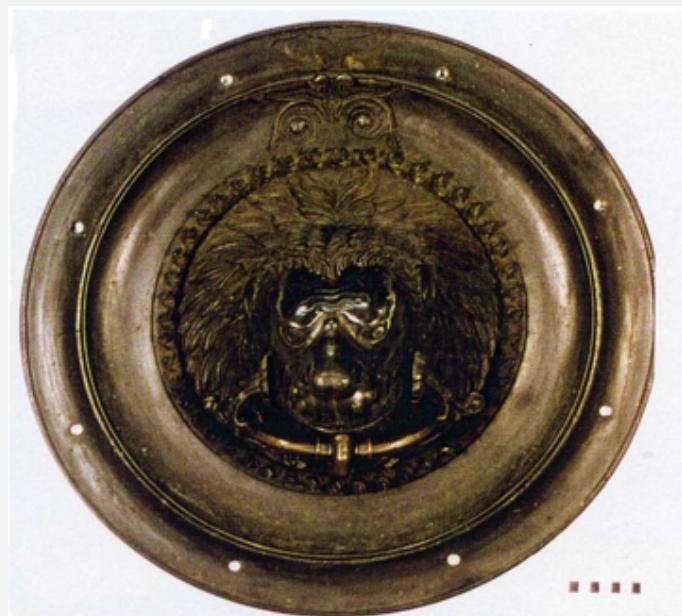
Fig. 1: Circular door knocker striking plate (after Benoît, 1994),

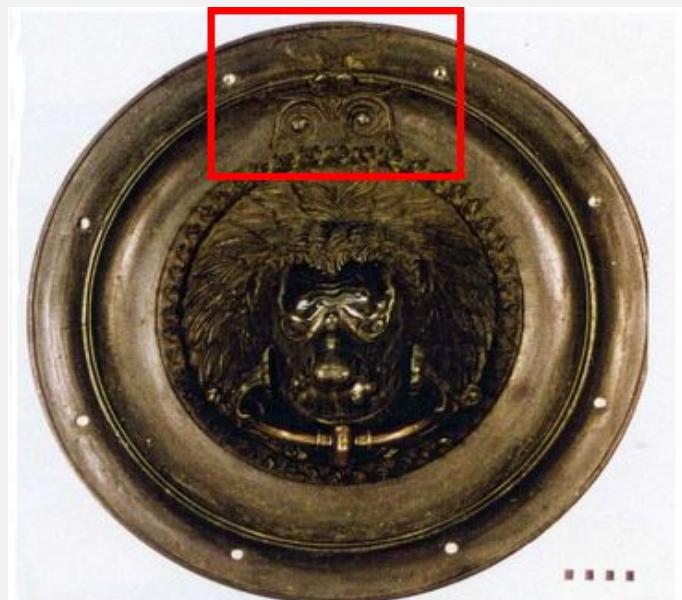
Fig. 2: Possible location of sampling area,

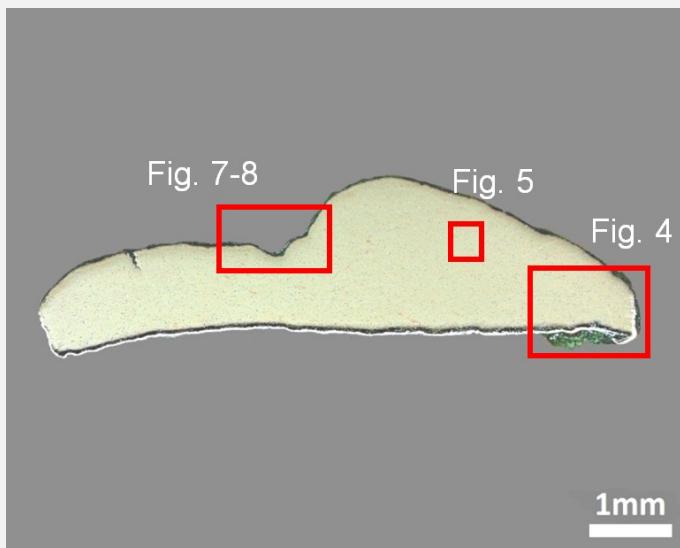
No information is given on where the sample has been taken. A supposed location is however illustrated in Fig. 2. The polished sample shows a well preserved metal surface with some cracks covered by a thin corrosion crust (Fig. 3).

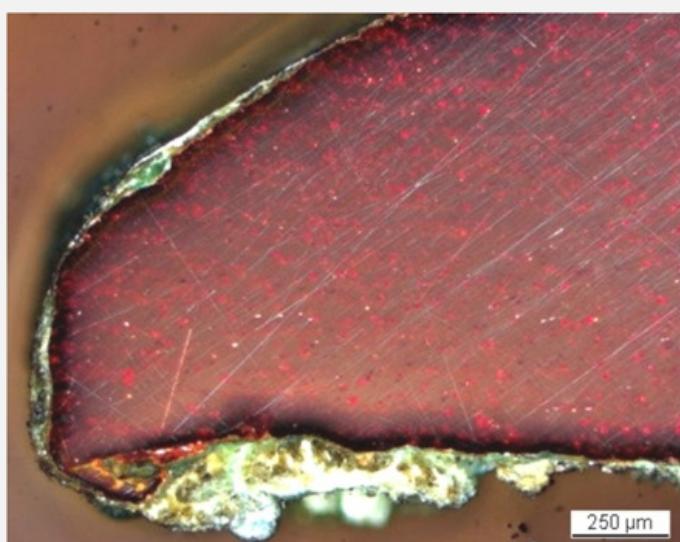
Fig. 4: Micrograph of the metal sample from Fig. 3 (reversed picture), unetched, polarised light. The red copper oxide inclusions form rows in the copper alloy matrix,

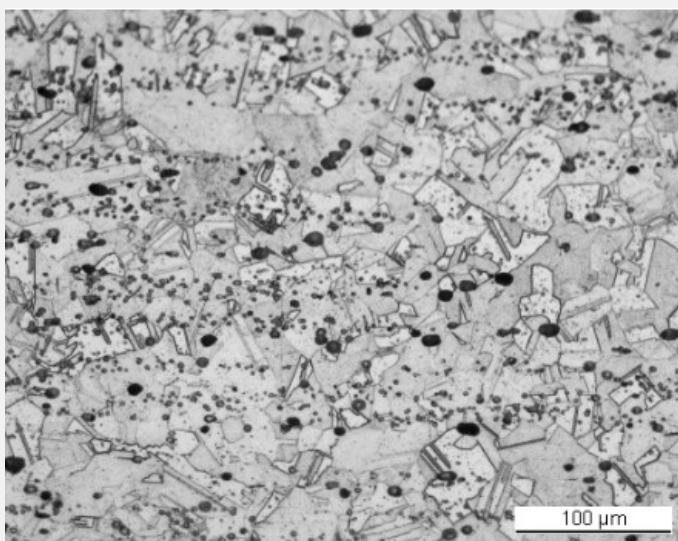
Fig. 5: Micrograph of the metal sample from Fig. 3 (detail), etched, bright field. The metal shows a structure of polygonal and twinned grains. Copper oxide inclusions are visible as dark spots,

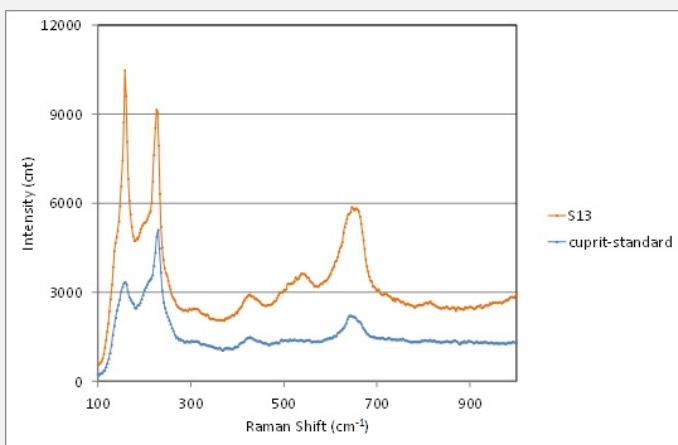
Fig. 6: Raman spectrum of a red inclusion (S13) of Fig. 4 compared to a cuprite standard spectrum. Settings: laser wavelength 532nm, acquisition time 100s, one accumulation, filter D2 (0.75-0.8mW), hole 500, slit 80, grating 600. Method of analysis: Raman spectroscopy. Lab of Swiss National Museum, Affoltern a. Albis ZH,

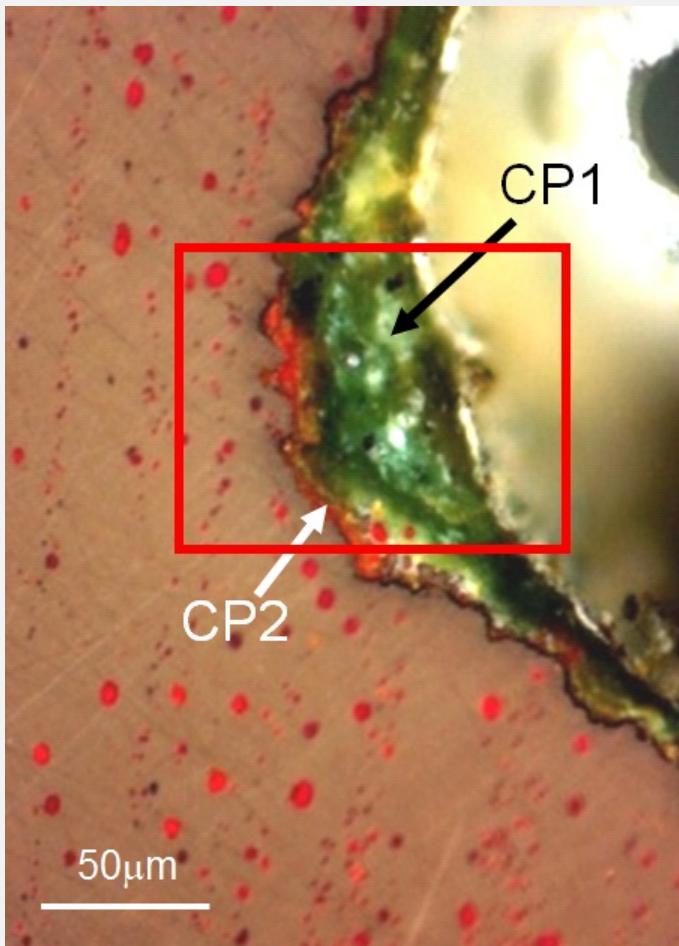
Fig. 7: Micrograph of the metal sample from Fig. 3 (rotated by 90°) and corresponding to the stratigraphy of Fig. 9, polarised light. Metal with red copper oxide inclusions. The black particles in the green corrosion layer are quartz inclusions. The area selected for elemental chemical distribution (Fig. 8) is marked by a red rectangle,

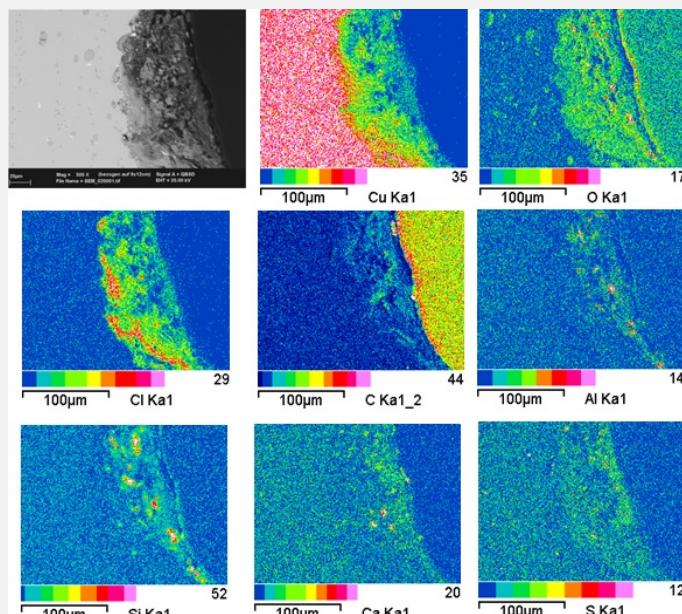
The average thickness of the corrosion crust is about 90μm, but may be thinner or thicker depending on the area of origin (Fig. 4). Under polarized light, we observe a multilayer system with a dense and thin inner red corrosion layer (CP2, probably cuprite/Cu₂O) on the metal (Fig. 7) containing chlorides (Fig. 8 and Table 3). This is followed by bands of heterogeneous green corrosion products (CP1, possibly copper chloride / sulphate / carbonate). This outer corrosion layer is contaminated with atmospheric components (Si, Al, Cl, C and O and perhaps gypsum particles (CaSO₄) (Fig. 8).

Fig. 8: SEM image, BSE-mode, and elemental chemical distribution of the selected area of Fig. 7. Method of examination: SEM/EDS, Laboratory of Analytical Chemistry, Empa,
