CIRCULAR DOOR KNOCKER STRIKING PLATE – CU ALLOY – MODERN TIMES – SWITZERLAND

Artefact name	Circular door knocker striking plate
Authors	Marianne. Senn (Empa, Dübendorf, Zurich, Switzerland) & Christian. Degryny (HE-Arc CR, Neuchâtel, Neuchâtel, Switzerland)
Url	/artefacts/919/

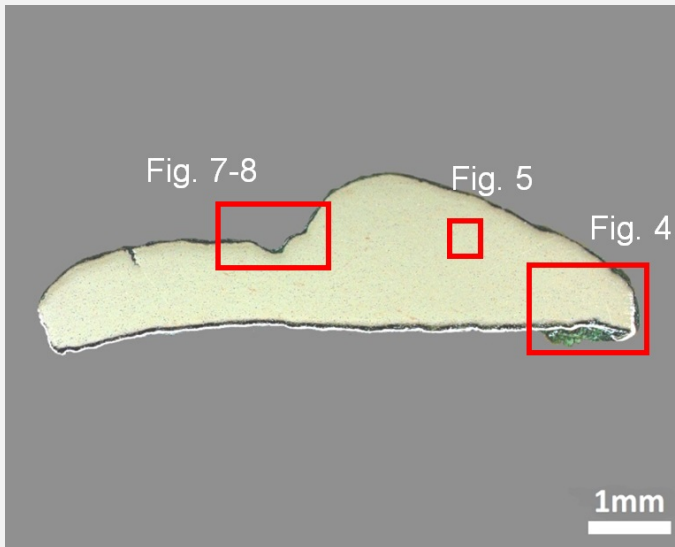
Fig. 3: Micrograph of the cross-section of the sample taken from the circular plate showing the location of Figs. 4 to 5 and 7 to 8,

Description of sample	No information is given on where the sample has been taken. A supposed location is however illustrated in Fig. 2. The polished sample shows a well preserved metal surface with some cracks covered by a thin corrosion crust (Fig. 3).
Alloy	Cu Alloy
Technology	Rolled, annealed after cold working
Lab number of sample	MAH 94-156-001
Sample location	Musées d'art et d'histoire, Genève, Geneva
Responsible institution	Musées d'art et d'histoire, Genève, Geneva
Date and aim of sampling	1994, metallography and presence or not of a gilding treatment

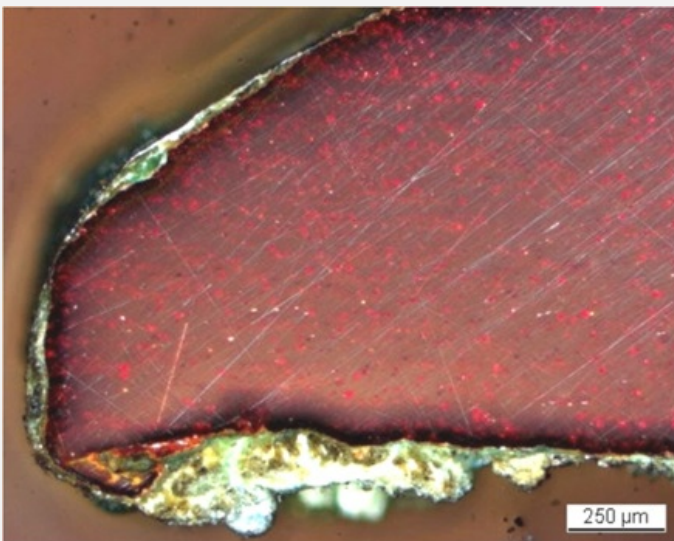
Fig. 4: Micrograph of the metal sample from Fig. 3 (reversed picture), unetched, polarised light. The red copper oxide inclusions form rows in the copper alloy matrix,

The average thickness of the corrosion crust is about 90μm, but may be thinner or thicker depending on the area of origin (Fig. 4). Under polarized light, we observe a multilayer system with a dense and thin inner red corrosion layer (CP2, probably cuprite/Cu₂O) on the metal (Fig. 7) containing chlorides (Fig. 8 and Table 3). This is followed by bands of heterogeneous green corrosion products (CP1, possibly copper chloride / sulphate / carbonate). This outer corrosion layer is contaminated with atmospheric components (Si, Al, Cl, C and O and perhaps gypsum particles (CaSO₄)) (Fig. 8).

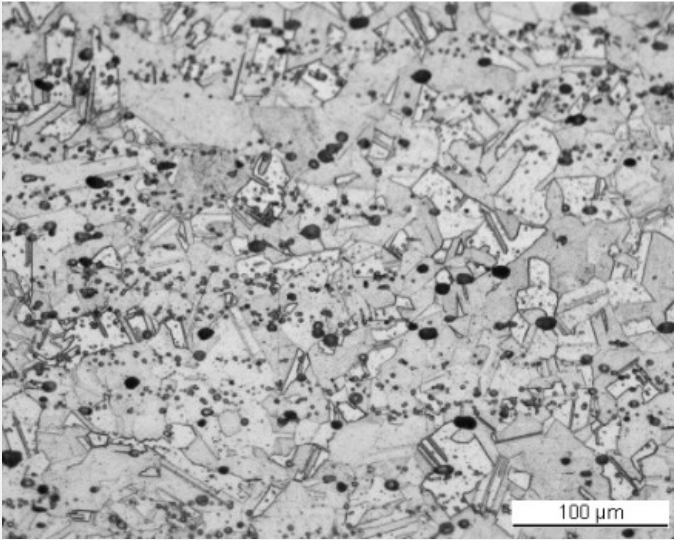
Fig. 5: Micrograph of the metal sample from Fig. 3 (detail), etched, bright field. The metal shows a structure of polygonal and twinned grains. Copper oxide inclusions are visible as dark spots,

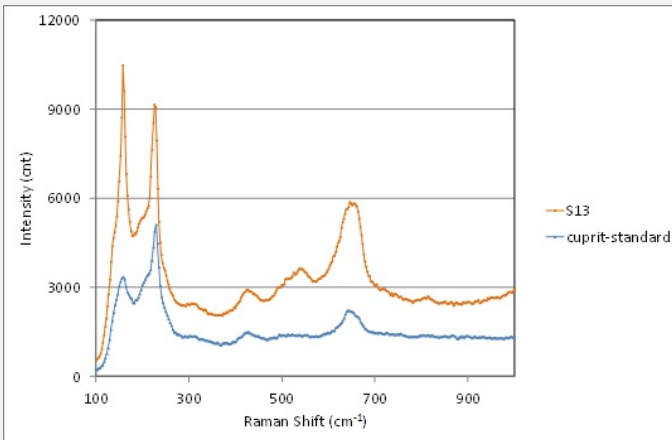
Fig. 6: Raman spectrum of a red inclusion (S13) of Fig. 4 compared to a cuprite standard spectrum. Settings: laser wavelength 532nm, acquisition time 100s, one accumulation, filter D2 (0.75-0.8mW), hole 500, slit 80, grating 600. Method of analysis: Raman spectroscopy. Lab of Swiss National Museum, Affoltern a. Albis ZH,

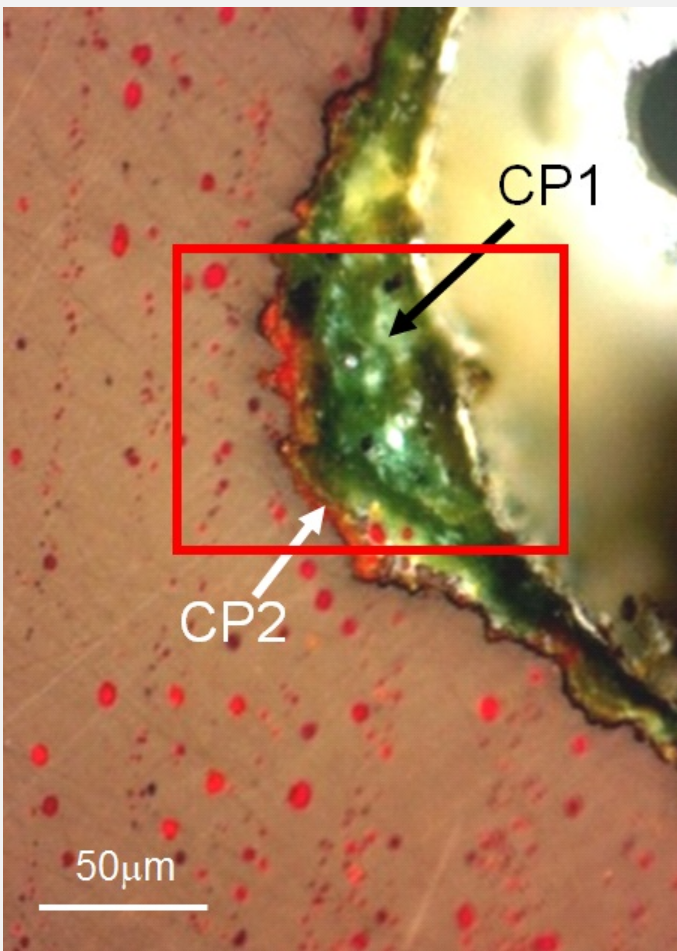
Fig. 7: Micrograph of the metal sample from Fig. 3 (rotated by 90°) and corresponding to the stratigraphy of Fig. 9, polarised light. Metal with red copper oxide inclusions. The black particles in the green corrosion layer are quartz inclusions. The area selected for elemental chemical distribution (Fig. 8) is marked by a red rectangle,

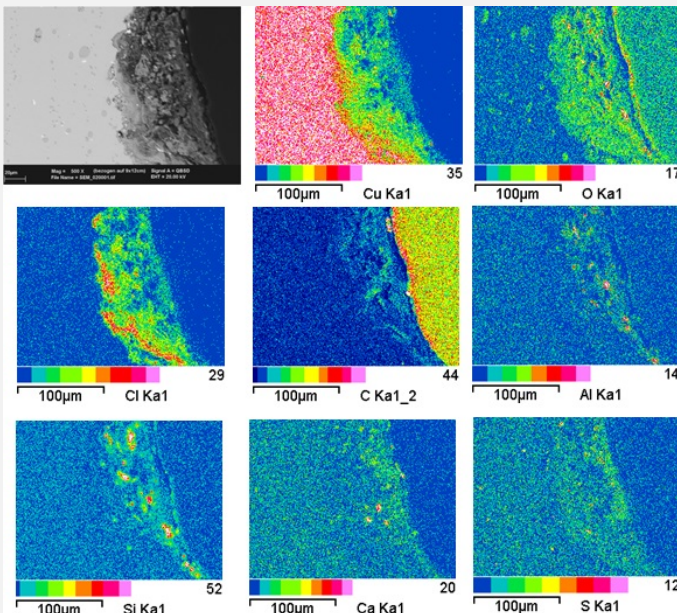
Table 2: Chemical composition (mass %) of the inclusions (light-grey and white in Fig. 8) in the metal. Method of analysis: SEM/EDS, Laboratory of Analytical Chemistry, Empa.

Fig. 8: SEM image, BSE-mode, and elemental chemical distribution of the selected area of Fig. 7. Method of examination: SEM/EDS, Laboratory of Analytical Chemistry, Empa,
