CIRCULAR DOOR KNOCKER STRIKING PLATE – CU ALLOY – MODERN TIMES – SWITZERLAND

Artefact name Circular door knocker striking plate

Authors Marianne. Senn (Empa, Dübendorf, Zurich, Switzerland) & Christian. Degrigny (HE-Arc CR, Neuchâtel,

Origin Door knocker of Lausanne cathedral, Lausanne, Vaud, Switzerland

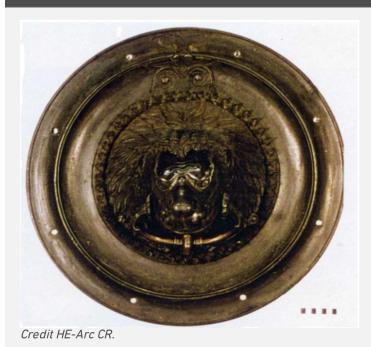
Fig. 1: Circular door knocker striking plate (after Benoît, 1994).

Description of the artefact Circular striking plate no 2 (from a set of two) of a door knocker with a protruding lion head

holding a hinge in his fangs, \emptyset .ext = 64cm. The circular base is said to be covered by a gilded

decorative relief (Fig. 1, Benoit, 1994, 6).

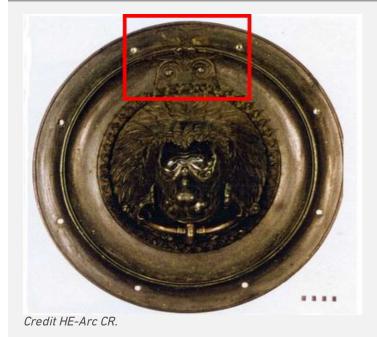
Fig. 2: Possible location of sampling area,

Description of sampleNo information is given on where the sample has been taken. A supposed location is however

illustrated in Fig. 2. The polished sample shows a well preserved metal surface with some

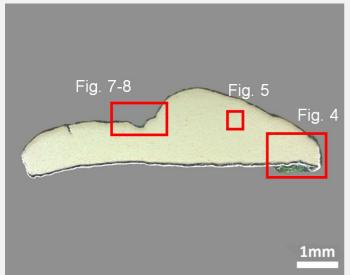
Fig. 3: Micrograph of the cross-section of the sample taken from the circular plate showing the location of Figs. 4 to 5 and 7 to 8,

cracks covered by a thin corrosion crust (Fig. 3).

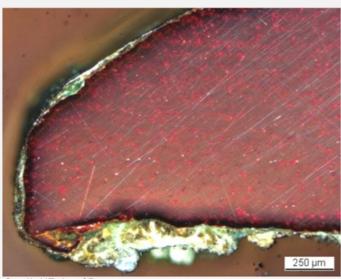
Fig. 4: Micrograph of the metal sample from Fig. 3 (reversed picture), unetched, polarised light. The red copper oxide inclusions form rows in the copper alloy matrix,

Fig. 5: Micrograph of the metal sample from Fig. 3 (detail), etched, bright field. The metal shows a structure of polygonal and twinned grains. Copper oxide inclusions are visible as dark spots,

Polygonal and twinned grains, elongated inclusions

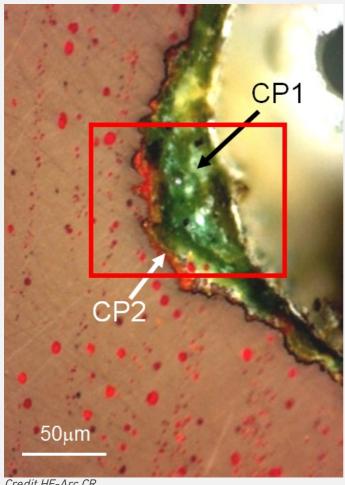
The average thickness of the corrosion crust is about $90\mu m$, but may be thinner or thicker depending on the area of origin (Fig. 4). Under polarized light, we observe a multilayer system with a dense and thin inner red corrosion layer (CP2, probably cuprite/Cu20) on the metal (Fig. 7) containing chlorides (Fig. 8 and Table 3). This is followed by bands of heterogeneous green corrosion products (CP1, possibly copper chloride / sulphate / carbonate). This outer corrosion layer is contaminated with atmospheric components (Si, Al, Cl, C and O and perhaps gypsum particles (CaSO4)) (Fig. 8).

Fig. 7: Micrograph of the metal sample from Fig. 3 (rotated by 90°) and corresponding to the stratigraphy of Fig. 9, polarised light. Metal with red copper oxide inclusions. The black particles in the green corrosion layer are quartz inclusions. The area selected for elemental chemical distribution (Fig. 8) is marked by a red rectangle,

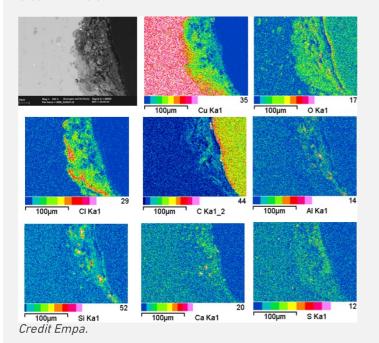
Table 2: Chemical composition (mass %) of the inclusions (light-grey and white in Fig. 8) in the metal. Method of analysis: SEM/EDS, Laboratory of Analytical Chemistry, Empa.

Fig. 8: SEM image, BSE-mode, and elemental chemical distribution of the selected area of Fig. 7. Method of examination: SEM/EDS, Laboratory of Analytical Chemistry, Empa,
