# MILITARY ID TAG 5668-MXX-1008-1 - ZN PB ALLOY - MODERN TIMES - FRANCE

<b>Artefact name</b>	Military ID tag 5668-MXX-1008-1
<b>Authors</b>	Christian Degrigny (HE-Arc CR, Neuchâtel, Neuchâtel, Switzerland) & Marie-Jeanne Scholl (HE-Arc CR, Neuchâtel, Neuchâtel, Switzerland) & Valentin Boissonnas (HE-Arc CR, Neuchâtel, Neuchâtel, Switzerland)
<b>Url</b>	/artefacts/921/

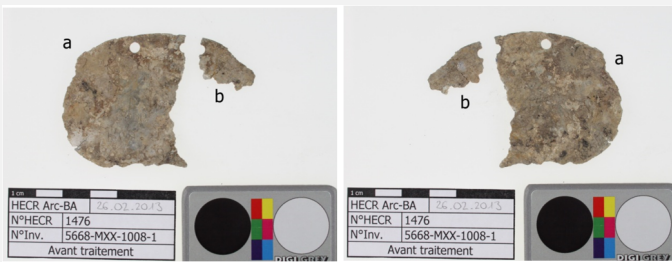
Fig. 1: German military ID tag from First World War, recto and verso, 2013,

<b>Description of the artefact</b>	Fragments from an oval shaped German military plate with two circular holes at the central upper edge (Fig. 1). The plate is covered with sediments. Dimensions (70 x 50 mm initially): L = 65mm; W = 50mm; T = 1 mm; WT = 6.3g.
<b>Type of artefact</b>	Military object
<b>Origin</b>	German army, 94th Infantry Regiment, 1918, Carspach, Alsace, France
<b>Recovering date</b>	Recovered in 2011
<b>Chronology category</b>	Modern Times
<b>chronology tpq</b>	<input type="text" value="1915"/> A.D. ▼
<b>chronology taq</b>	<input type="text" value="1915"/> A.D. ▼
<b>Chronology comment</b>	First World War
<b>Burial conditions / environment</b>	Soil

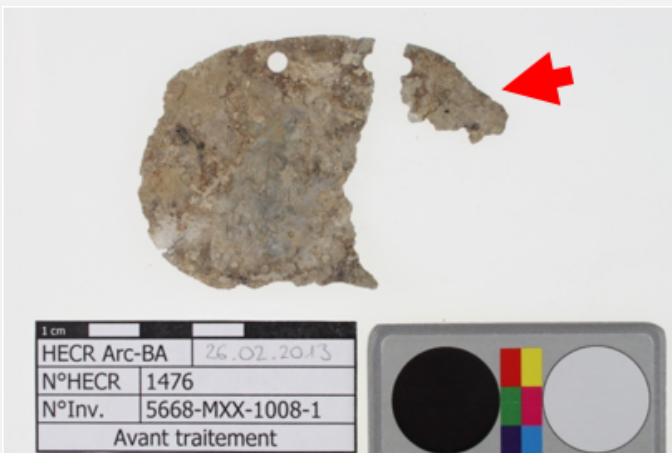
Fig. 2: Location of sample (from fragment b),

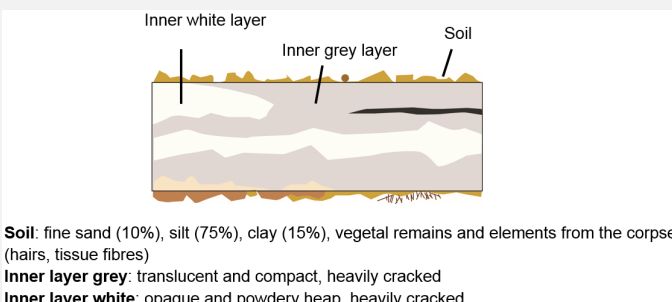
Fig. 3: Stratigraphic representation of fragment b of the military tag by macroscopic observation,

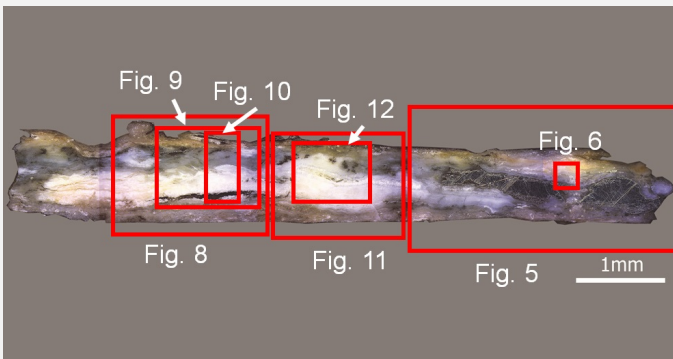
Fig. 4: Micrograph of the cross-section of fragment b of the military tag showing the location of Figs. 5, 6 and 8 to 12. Unetched, dark field, 50x,

This sample was cut out of fragment b in Fig. 1. The cross-section shows the entire thickness of the plate (L = 8 mm, W = 1 mm). The corrosion goes through the whole metal thickness but a metallic core remains (Figs. 4 and 5).

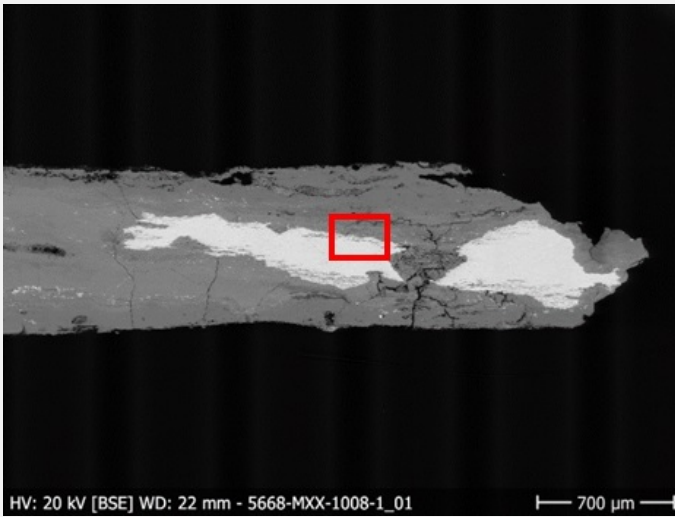
Fig. 5: SEM image of the cross-section, from Fig. 4 (detail), BSE-mode. Note the presence of Pb inclusions all through the thickness of the heavily cracked corrosion layers. The SEM image of Fig. 6 is marked by a rectangle,

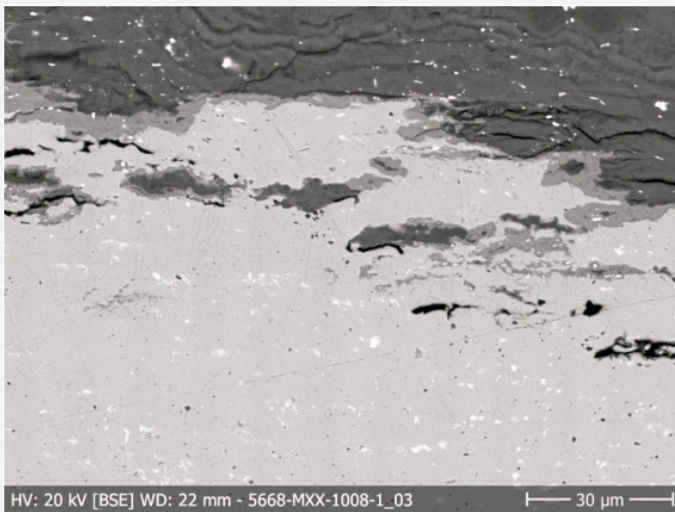
The remaining metal is a zinc alloy (Table 1) containing 1.8% in weight lead. Lead appears in the metal in the form of small flattened white Pb inclusions (Fig. 6), confirming the manufacturing technique, namely lamination. The etched metal does not show any specific microstructure (Fig. 7).

Fig. 6: SEM image of the cross-section, from Fig. 5 (detail), BSE-mode,

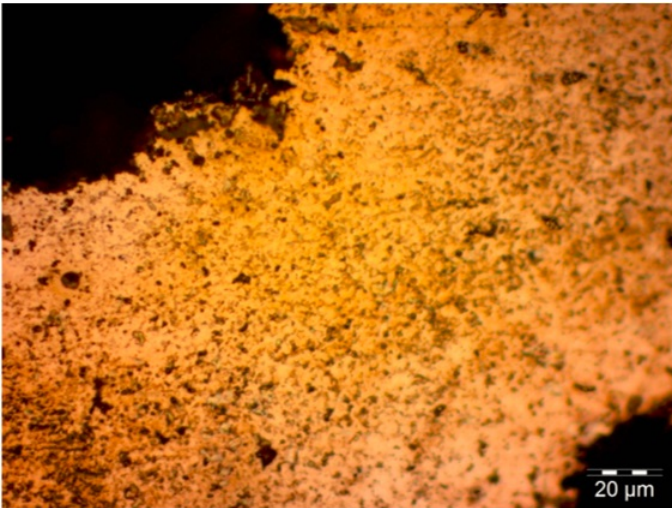
Fig. 7: Micrograph of the cross-section, etched, bright field, 500x,

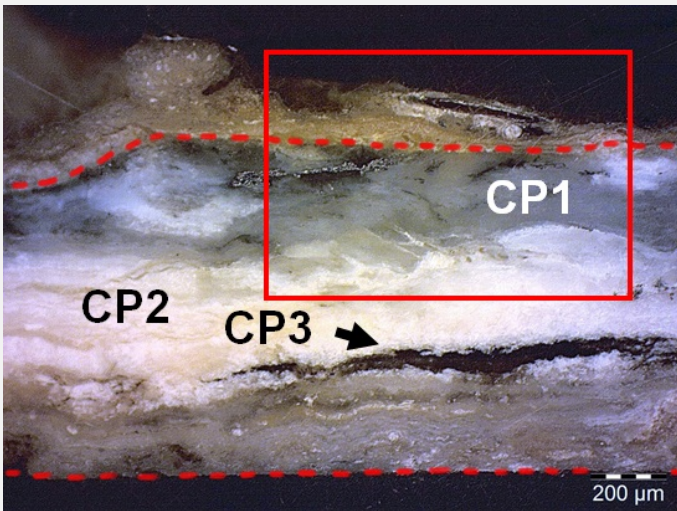
The inner grey layer (CP1, Figs. 8 and 16) has been identified by FTIR as a zinc carbonate (smithsonite), mixed with other unidentified corrosion products. Raman spectra seems to confirm it (Fig. 13). The exact composition of the inner white layer (CP2) is unknown. It shows a bluish fluorescence under UV light and has been identified by FTIR as a mixture of zinc oxides and carbonates, that could be zinc hydroxycarbonates (hydrozincite). Raman spectroscopy shows also a mixture of carbonates and other corrosion products (Fig. 14). The inner black layer (CP3) is a zinc carbonate as well, identified by FTIR and Raman spectroscopy (Fig. 15) appearing as a vein between layers of grey and white (Fig. 8).

Fig. 8: Micrograph of the cross-section, from Fig. 4 (detail) and corresponding to the stratigraphy of Fig. 5, unetched, dark field, 50x. View of the inner layers and the limit of the original surface (red line). We can see that the interfaces between the different layers are not well defined: some of the white corrosion product is found inside the inner grey layer. The micrograph of Fig. 9 is marked by a rectangle,

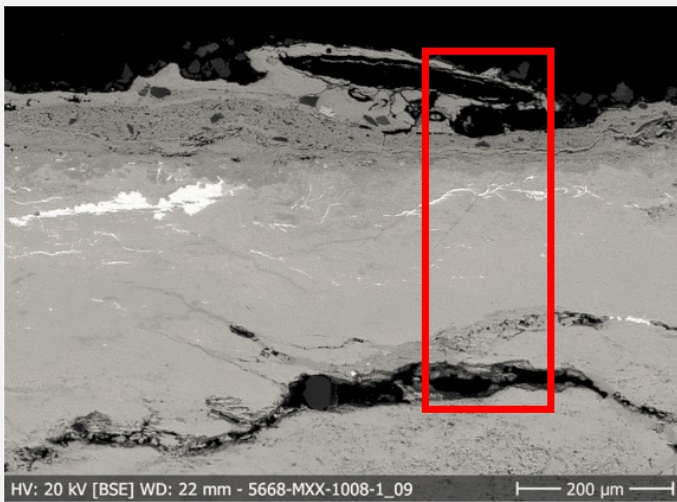
Fig. 9: SEM image of the cross-section from Fig. 8 (detail), BSE-mode. The area selected for elemental chemical distribution (Fig. 10) is marked by a rectangle,

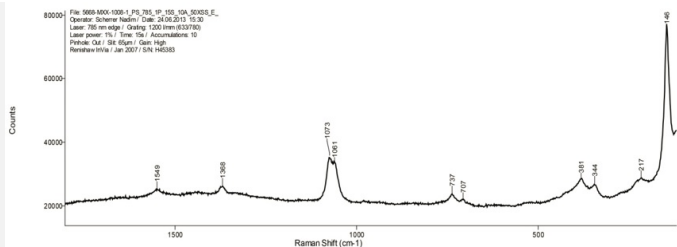
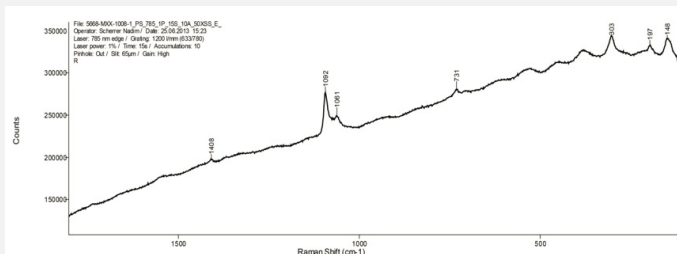
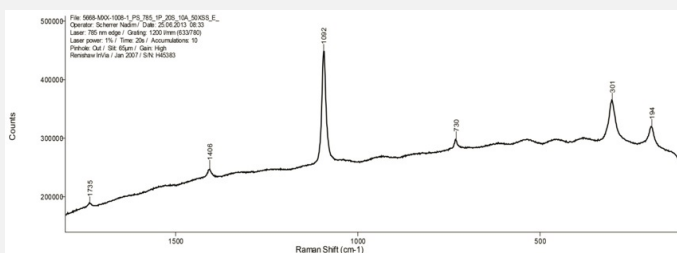
Fig. 14: Raman spectrum of the inner white layer (CP2 on Fig. 8, zinc hydroxycarbonate?). Settings: laser wavelength 532nm, acquisition time 10s, one accumulation, filter D2 (0.75-0.8mW), hole 500, slit 80, grating 600. Method of analysis: Raman spectroscopy, Art Technological Laboratory, Departement Conservation HKB,

Fig. 15: Raman spectrum of the inner black layer (CP3 on Fig. 8, zinc carbonate?). Settings: laser wavelength 532nm, acquisition time 10s, one accumulation, filter D2 (0.75-0.8mW), hole 500, slit 80, grating 600. Method of analysis: Raman spectroscopy, Art Technological Laboratory, Departement Conservation HKB,

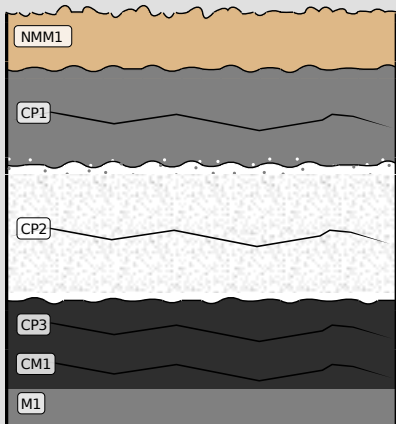
Fig. 16: Stratigraphic representation of fragment b of the military tag in cross-section (dark field) using the MiCorr application. The characteristics of the strata are only accessible by clicking on the drawing that redirects you to the search tool by stratigraphy representation. This representation can be compared to Fig. 10, Credit HE-Arc CR, M-J.Scholl.

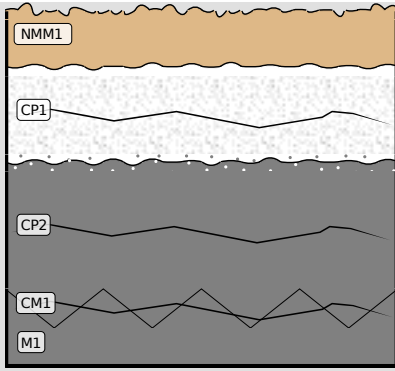
Fig. 17: Stratigraphic representation of fragment b of the military tag in cross-section (dark field) using the MiCorr application. The characteristics of the strata are only accessible by clicking on the drawing that redirects you to the search tool by stratigraphy representation. This

representation is different from Fig. 10 due to the inversion of CP1 and CP2. Furthermore, CP3 is not represented, Credit HE-Arc CR, M-J.Scholl.

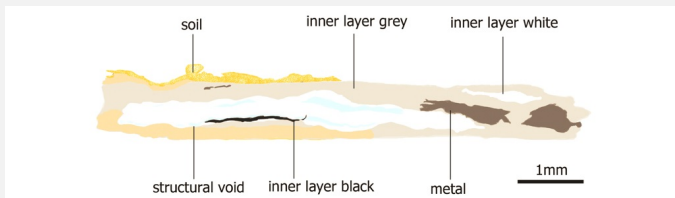
Fig. 18: Improved representation of the stratigraphy of corrosion layers of the military tag from visual observations and analyses,

Strate	Composition
Soil (S)	Elements from soil, organic elements
Grey corrosion product (CP1)	Zinc carbonate (smithsonite) + S
White corrosion product (CP2)	Zinc hydroxycarbonate + mixture of CP
Black corrosion product (CP3)	Zinc carbonate
Corroded metal (CM)	
Metal (M)	Zn-Pb
