# MILITARY ID TAG 5668-MXX-1008-1 - ZN PB ALLOY - MODERN TIMES - FRANCE

**Artefact name** Military ID tag 5668-MXX-1008-1

**Authors** Christian Degrigny (HE-Arc CR, Neuchâtel, Neuchâtel, Switzerland) & Marie-Jeanne Scholl (HE-Arc CR, Neuchâtel, Neuchâtel, Switzerland) & Valentin Boissonnas (HE-Arc CR, Neuchâtel, Neuchâtel, Switzerland)

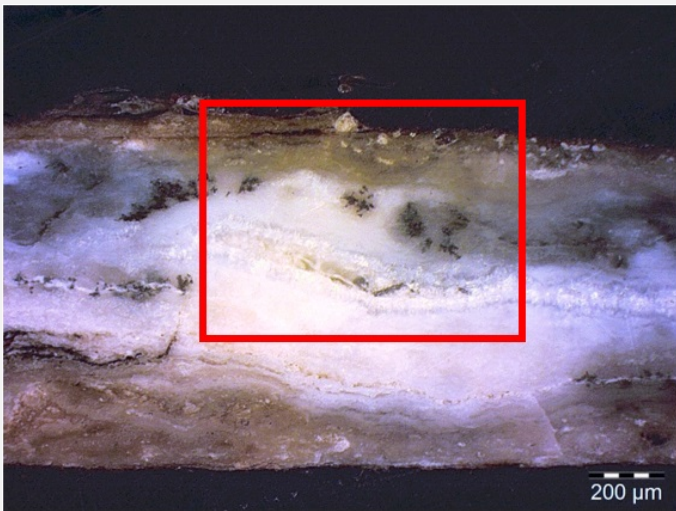
- Inner white layer – CP2 (up to 0.6 mm thick) is an opaque and powdery heap, occurring in different places inside inner grey layer and sometimes near the surface, as pitting corrosion. The interface between inner layers grey and white is gradual. Localized aggregates showing a crystalline microstructure of thickness of 50 µm are located against the walls of a structural void, inside the white corrosion product (Figs. 11 and 12).

Fig. 11: Micrograph of the cross-section, from Fig. 4 (detail), unetched, dark field, 50x. The micrograph of Fig. 12 is marked by a rectangular,

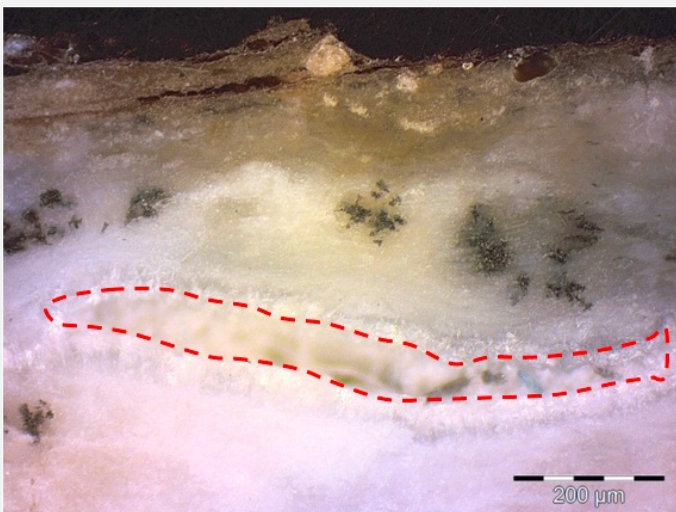
Fig. 12: Micrograph of the cross-section, from Fig. 9 (detail) unetched, dark field, 100x. Structural void (dotted red line) with aggregates,

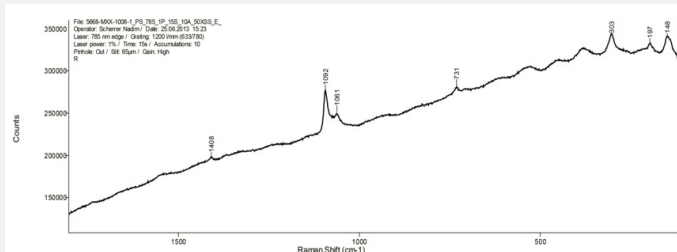
Fig. 14: Raman spectrum of the inner white layer (CP2 on Fig. 8, zinc hydroxycarbonate?). Settings: laser wavelength 532nm, acquisition time 10s, one accumulation, filter D2 (0.75-0.8mW), hole 500, slit 80, grating 600. Method of analysis: Raman spectroscopy, Art Technological Laboratory, Departement Conservation HKB,

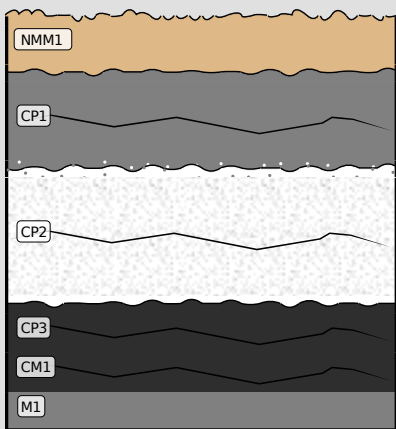
Fig. 16: Stratigraphic representation of fragment b of the military tag in cross-section (dark field) using the MiCorr application. The characteristics of the strata are only accessible by clicking on the drawing that redirects you to the search tool by stratigraphy representation. This representation can be compared to Fig. 10, Credit HE-Arc CR, M-J.Scholl.

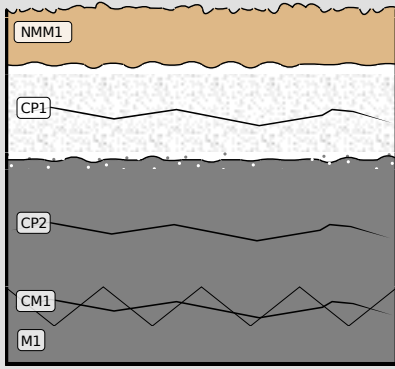
Fig. 17: Stratigraphic representation of fragment b of the military tag in cross-section (dark field) using the MiCorr application. The characteristics of the strata are only accessible by clicking on the drawing that redirects you to the search tool by stratigraphy representation. This

representation is different from Fig. 10 due to the inversion of CP1 and CP2. Furthermore, CP3 is not represented, Credit HE-Arc CR, M-J.Scholl.
