LEAD CAMES OF A STAINED GLASS WINDOW 52583 – PB SB ALLOY – UNKNOWN – SWITZERLAND

Artefact name Lead comes of a stained glass window 52583

Authors Alice Gerber. (Haute École Arc Neuchâtel, Neuchâtel, Neuchâtel, Switzerland)

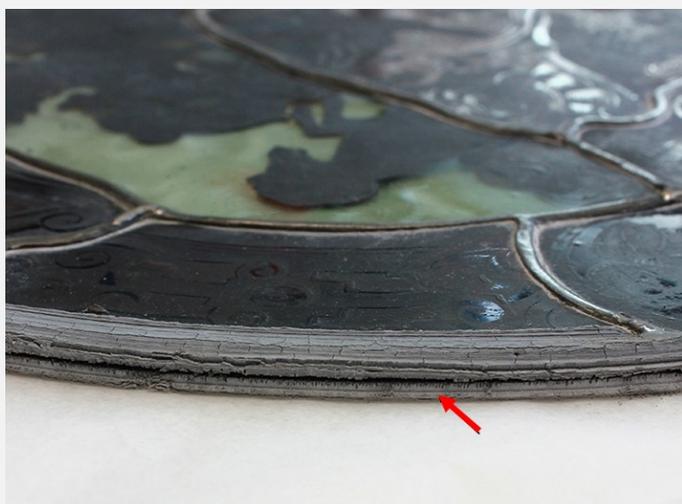
In 2009 two stained glass panels were placed in a showcase for a permanent exhibition, the lead came were then in a good conservation condition. In 2018, the lead showed voluminous efflorescence of white, powdery corrosion products.

The environment of this showcase contained a high level of acetic acid. Lead being sensitive to organic acids, it corroded strongly. This is not new, but what is interesting here is that the two objects corroded in a very heterogeneous way. One lead came may be deformed and completely covered with bulky white efflorescences, and the one next to it shows no corrosion.

The "stokar" window, which is of interest here, was restored in 2008, just before it was put on display. The restoration consisted of replacing some of the lead came. Thus, while the object is dated to the 16th century, the replaced came were new when they entered the display case. In 2018, they were completely corroded. In comparison, the other stained glass panel, with older lead came, was placed in the same display case at the same time. For this second panel, the came are slightly corroded in 2018, but not as badly as those of the 'Stokar' panel. The metal chosen by the restorer reacted more strongly with the corrosive environment (the display case) than the historical metal.

Fig. 2: Corroded "modern" lead came on the "Stokar" stained glass panel with location of the sampling area,

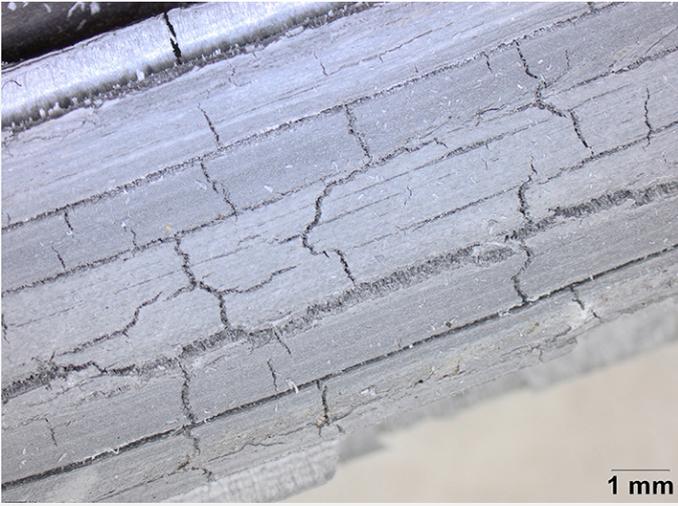
Fig. 3: Detail of the corroded lead came,

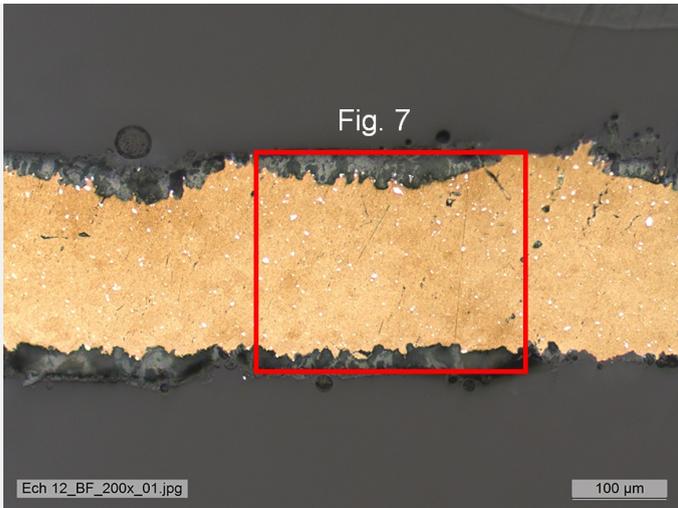
Fig. 5: Micrograph of the cross-section of the corroded lead came with location of Fig. 7, unetched, dark field. The grains of the metal are slightly visible, and the light-coloured dots in the alloy are inclusions,

Description of sample	The sample is a piece of metal taken from the corroded lead came of the stained glass (Fig. 2). This came was replaced during the 2009 restoration. The purpose was to understand why this new metal has been completely corroded in a few years (Fig. 2, 3 and 5), while the historical metal next to it is not affected at all.
Alloy	Pb Sb alloy
Technology	Cast and cold worked
Lab number of sample	None
Sample location	HE-Arc CR, Neuchâtel, Neuchâtel
Responsible institution	HE-Arc CR, Neuchâtel, Neuchâtel
Date and aim of sampling	None

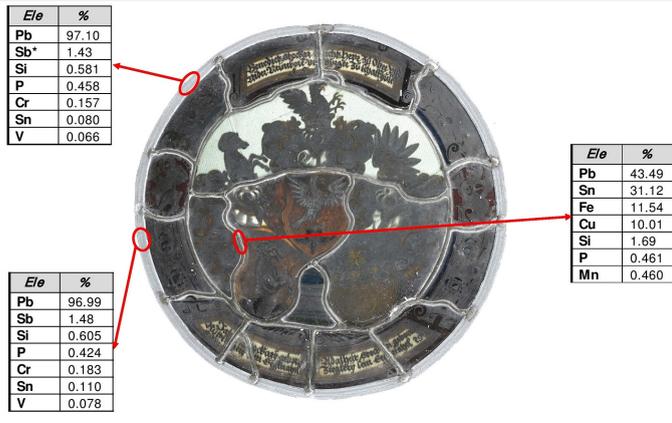
Fig. 6: XRF analyses of a selection of the comes,

XRF analyses of the different lead comes of the "Stokar" stained glass panel showed that the tin (Sn) content is very variable from one came to another (Fig. 6). Those with a very low Sn but a high Sb (1.4%) contents are much more corroded.

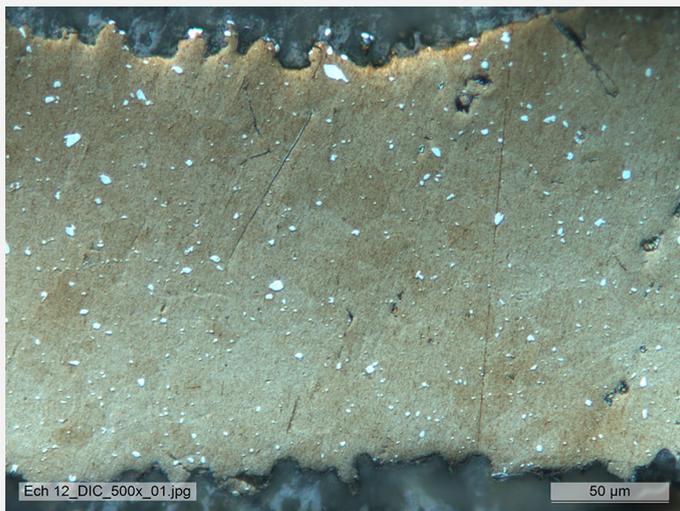
Fig. 7: Micrograph (detail of Fig. 5), unetched, dark field,

The lead alloy contains approximately 1.5% antimony. The grains of the metal are slightly visible, even without etching. The light-coloured dots in the alloy are Sb-rich inclusions (Fig. 7).

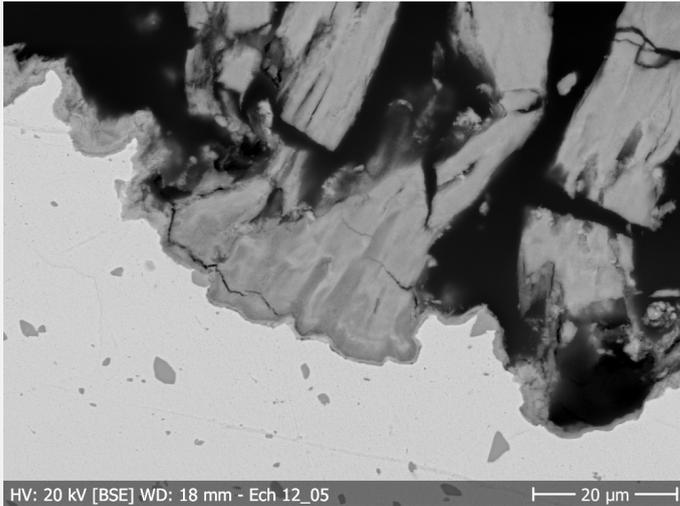
CP1 seems to be a heterogeneous compound as indicated on Figs. 8 and 9. It is heavily cracked (Fig. 9). EDX analyses do not indicate a significant difference in composition. The attack of lead by organic acids causes the formation of salts, such as lead acetate which are then transformed into basic lead carbonates by the action of CO₂ from the environment as indicated by FTIR analysis of CP1.

Fig. 9: SEM image (BSE mode) of the cross-section of the corroded lead came,

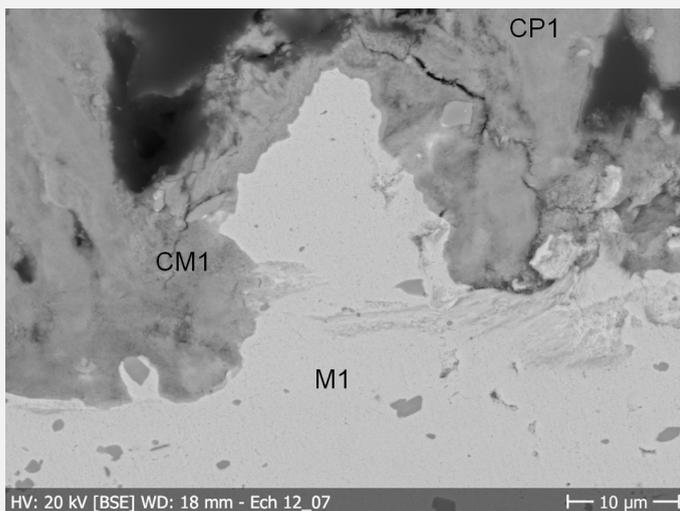
Corrosion develops specifically on comes made of a lead-antimony alloy, where antimony inclusions constitute the cathode (0.150 V/SHE) versus lead (-0.125 V/SHE) which corrodes as an anode in presence of lead acetate (the electrolyte). Fig. 8 shows that corrosion does not attack the antimony nodules in the alloy, it progresses by mineralizing the lead around these nodules.

Fig. 8: SEM image (BSE mode) of a detail of the cross-section of the corroded lead came. The area in light grey is the metal, the corrosion is in darker grey with a blurred appearance. Sb-dots are dark grey. Corrosion progresses around them, without mineralising them,

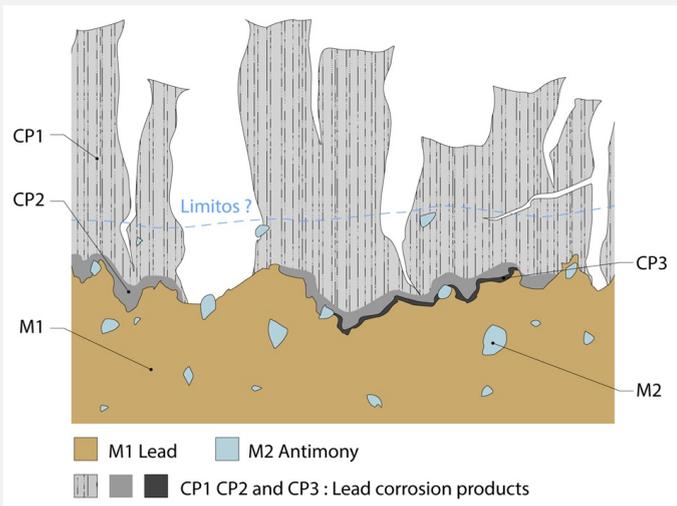
Fig. 11 shows an optimised stratigraphic representation of the corrosion structure. It is to be noted that CP1, CP2 and CP3 although visible on some cross-sections (Fig. 9) could not be differentiated by analysis.

The limit of the original surface lies somewhere in the corrosion layers. Antimony nodules are inferior markers of the limit of the original surface.

Fig. 11: Optimised stratigraphic representation of a corroded lead came integrating additional information based on the analyses carried out,
