LEAD CAMES OF A STAINED GLASS WINDOW 52583 - PB SB ALLOY - UNKNOWN - SWITZERLAND

Artefact name Lead cames of a stained glass window 52583

Authors Alice Gerber, (Haute École Arc Neuchâtel, Neuchâtel, Neuchâtel, Switzerland)

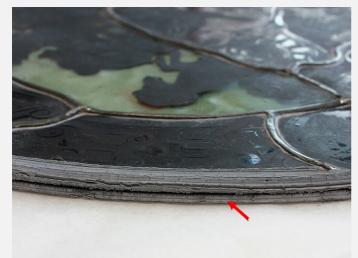
Fig. 2: Corroded "modern" lead came on the "Stokar" stained glass panel with location of the sampling area,

Fig. 3: Detail of the corroded lead came,

This came was replaced during the 2009 restoration. The purpose was to understand why this new metal has been completely corroded in a few years (Fig. 2, 3 and 5), while the historical

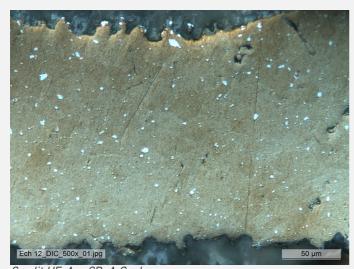
The lead alloy contains approximatly 1.5% antimony. The grains of the metal are slightly visible, even without etching. The light-coloured dots in the alloy are Sb-rich inclusions (Fig. 7).

Fig. 7: Micrograph (detail of Fig. 5), unetched, dark field,

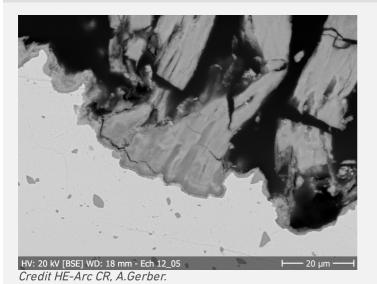
CP1 seems to be an heterogeneous compound as indicated on Figs. 8 and 9. It is heavily cracked (Fig. 9). EDX analyses do not indicate a significant difference in composition. The attack of lead by organic acids causes the formation of salts, such as lead acetate which are then transformed into basic lead carbonates by the action of CO2 from the environment as indicated by FTIR analysis of CP1.

Fig. 9: SEM image (BSE mode) of the cross-section of the corroded lead came,

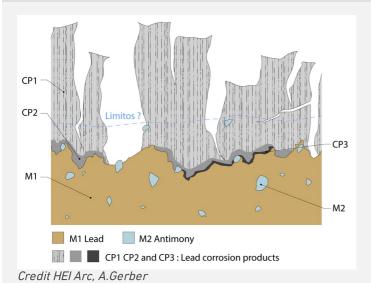
Fig. 11 shows an optimised stratigraphic representation of the corrosion structure. It is to be noted that CP1, CP2 and CP3 although visible on some cross-sections (Fig. 9) could not be differentiated by analysis.

The limit of the original surface lies somewhere in the corrosion layers. Antimony nodules are inferior markers of the limit of the original surface.

lead came integrating additional information based on the analyses carried out,

Fig. 11: Optimised stratigraphic representation of a corroded
