LEAD CAMES OF A STAINED GLASS WINDOW 52583 - PB SB ALLOY - UNKNOWN - SWITZERLAND

Artefact name Lead cames of a stained glass window 52583

Authors Alice Gerber. (Haute École Arc Neuchâtel, Neuchâtel, Neuchâtel, Switzerland)

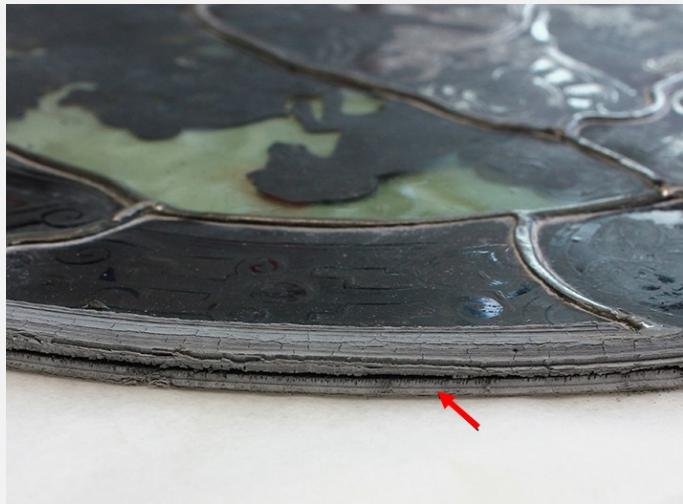
The "stokar" window, which is of interest here, was restored in 2008, just before it was put on display. The restoration consisted of replacing some of the lead cames. Thus, while the object is dated to the 16th century, the replaced cames were new when they entered the display case. In 2018, they were completely corroded. In comparison, the other stained glass panel, with older lead cames, was placed in the same display case at the same time. For this second panel, the cames are slightly corroded in 2018, but not as badly as those of the 'Stokar' panel. The metal chosen by the restorer reacted more strongly with the corrosive environment (the display case) than the historical metal.

Fig. 2: Corroded "modern" lead came on the "Stokar" stained glass panel with location of the sampling area,

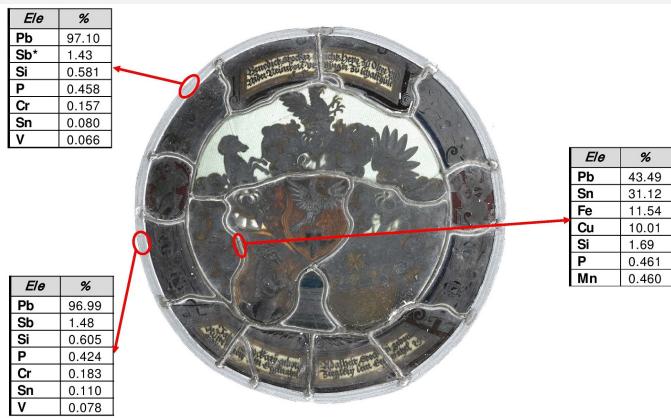
XRF analyses of the different lead cames of the "Stokar" stained glass panel showed that the tin (Sn) content is very variable from one came to another (Fig. 6). Those with a very low Sn but a high Sb (1.4%) contents are much more corroded.

Fig. 6: XRF analyses of a selection of the cames,

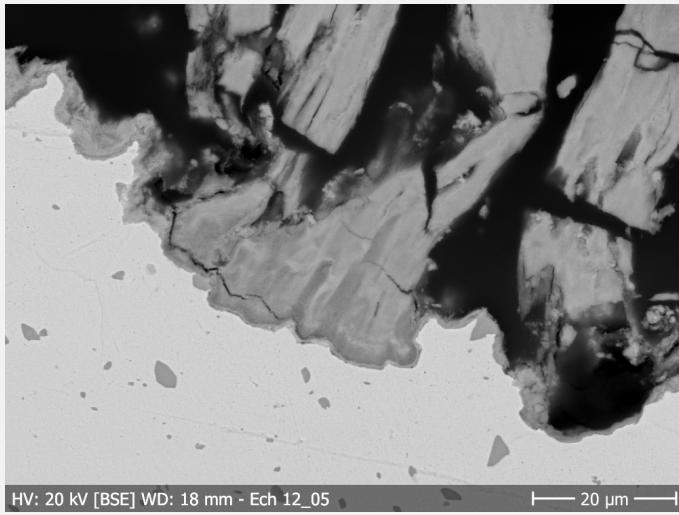
CP1 seems to be an heterogeneous compound as indicated on Figs. 8 and 9. It is heavily cracked (Fig. 9). EDX analyses do not indicate a significant difference in composition. The attack of lead by organic acids causes the formation of salts, such as lead acetate which are then transformed into basic lead carbonates by the action of CO₂ from the environment as indicated by FTIR analysis of CP1.

Fig. 9: SEM image (BSE mode) of the cross-section of the corroded lead came,

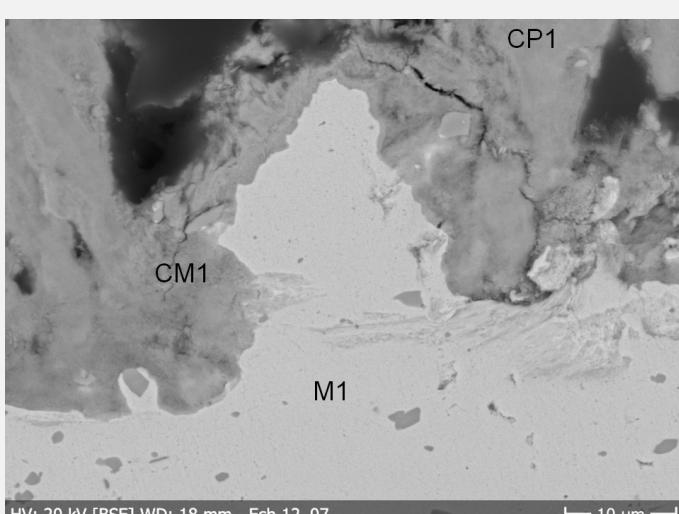
Corrosion develops specifically on cames made of a lead-antimony alloy, where antimony inclusions constitute the cathode (0.150 V/SHE) versus lead (-0.125 V/SHE) which corrodes as an anode in presence of lead acetate (the electrolyte). Fig. 8 shows that corrosion does not attack the antimony nodules in the alloy, it progresses by mineralizing the lead around these nodules.

Fig. 8: SEM image (BSE mode) of a detail of the cross-section of the corroded lead came. The area in light grey is the metal, the corrosion is in darker grey with a blurred appearance. Sb-dots are dark grey. Corrosion progresses around them, without mineralising them,

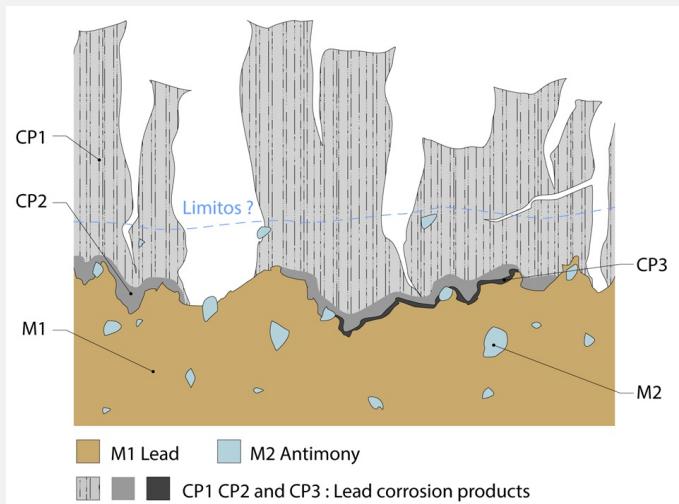
Fig. 11 shows an optimised stratigraphic representation of the corrosion structure. It is to be noted that CP1, CP2 and CP3 although visible on some cross-sections (Fig. 9) could not be differentiated by analysis.

The limit of the original surface lies somewhere in the corrosion layers. Antimony nodules are inferior markers of the limit of the original surface.

Fig. 11: Optimised stratigraphic representation of a corroded lead came integrating additional information based on the analyses carried out,
