# LEAD CAMES OF A STAINED GLASS WINDOW 52583 – PB SB ALLOY – UNKNOWN – SWITZERLAND

**Artefact name** Lead comes of a stained glass window 52583

**Authors** Alice Gerber. (Haute École Arc Neuchâtel, Neuchâtel, Neuchâtel, Switzerland)

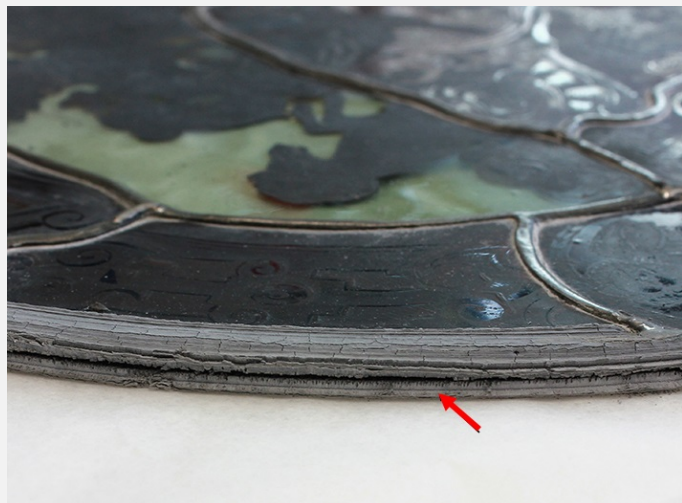
In 2009 two stained glass panels were placed in a showcase for a permanent exhibition, the lead came were then in a good conservation condition. In 2018, the lead showed voluminous efflorescence of white, powdery corrosion products.

The environment of this showcase contained a high level of acetic acid. Lead being sensitive to organic acids, it corroded strongly. This is not new, but what is interesting here is that the two objects corroded in a very heterogeneous way. One lead came may be deformed and completely covered with bulky white efflorescences, and the one next to it shows no corrosion.

The "stokar" window, which is of interest here, was restored in 2008, just before it was put on display. The restoration consisted of replacing some of the lead came. Thus, while the object is dated to the 16th century, the replaced came were new when they entered the display case. In 2018, they were completely corroded. In comparison, the other stained glass panel, with older lead came, was placed in the same display case at the same time. For this second panel, the came are slightly corroded in 2018, but not as badly as those of the 'Stokar' panel. The metal chosen by the restorer reacted more strongly with the corrosive environment (the display case) than the historical metal.

Fig. 2: Corroded "modern" lead came on the "Stokar" stained glass panel with location of the sampling area,

Fig. 3: Detail of the corroded lead came,
