LEAD CAMES OF A STAINED GLASS WINDOW 52583 – PB SB ALLOY – UNKNOWN – SWITZERLAND

Artefact name	Lead comes of a stained glass window 52583
Authors	Alice Gerber. (Haute École Arc Neuchâtel, Neuchâtel, Neuchâtel, Switzerland)
Url	/artefacts/924/

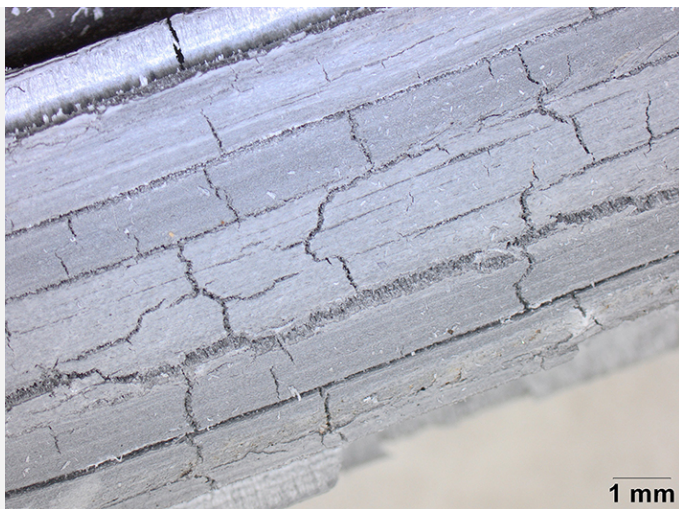
Fig. 3: Detail of the corroded lead came,

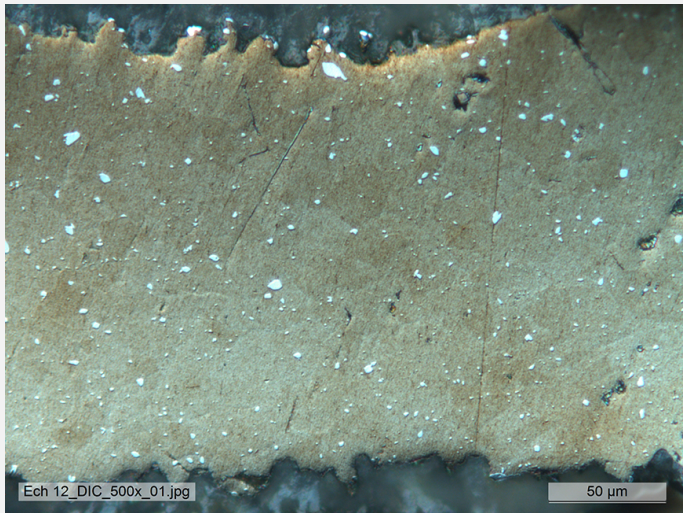
The lead alloy contains approximately 1.5% antimony. The grains of the metal are slightly visible, even without etching. The light-coloured dots in the alloy are Sb-rich inclusions (Fig. 7).

Fig. 7: Micrograph (detail of Fig. 5), unetched, dark field,
