LEAD CAMES OF A STAINED GLASS WINDOW 52583 – PB SB ALLOY – UNKNOWN – SWITZERLAND

Artefact name Lead comes of a stained glass window 52583

Authors Alice Gerber. (Haute École Arc Neuchâtel, Neuchâtel, Neuchâtel, Switzerland)

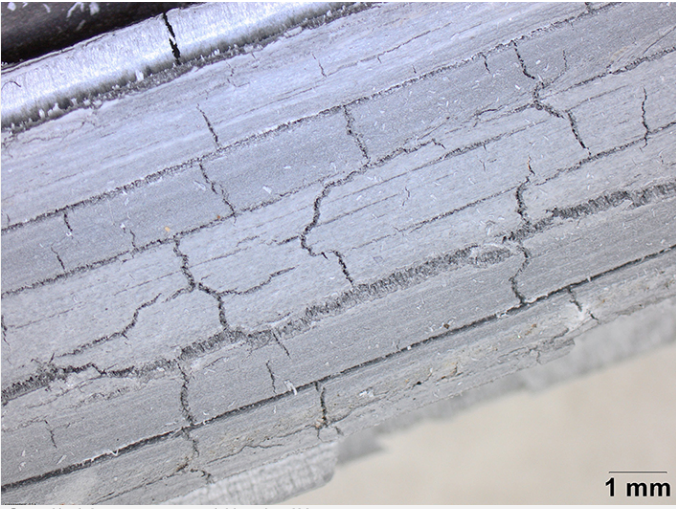
Fig. 3: Detail of the corroded lead came,
