# SACRIFICIAL KNIFE (TUMI) IVC 24745 – CU ALLOY – UNKNOWN – PERU

**Artefact name** Sacrificial knife (tumi) IVC 24745

**Authors** Christian. Degrigny (HE-Arc CR, Neuchâtel, Neuchâtel, Switzerland) & Marion. Billot (HE-Arc CR, Neuchâtel, Neuchâtel, Switzerland) & Valentin. Boissonnas (HE-Arc CR, Neuchâtel, Neuchâtel, Switzerland)

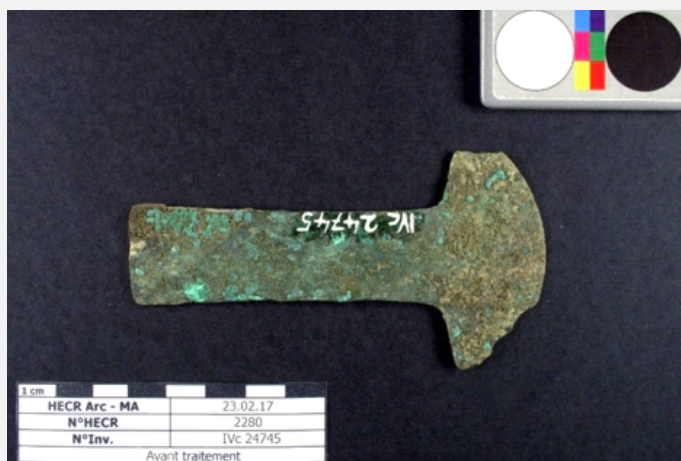
Fig. 1: Sacrificial knife,

<b>Description of the artefact</b>	Sacrificial knife (tumi) covered with green corrosion products and sediments. Semi circular flattened cutting edge. Trapezoidal handle with rectangular section. L = 105 mm; W handle = 25 mm; W blade = 55 mm; T = 1 mm; WT = 18,7 g
<b>Type of artefact</b>	Sacrificial knife (tumi in vernacular language)
<b>Origin</b>	Probably Cajamarca (Peru), Cajamarca, Cajamarca, Peru
<b>Recovering date</b>	Unknown
<b>Chronology category</b>	Unknown
<b>chronology tpq</b>	200 A.D. ▼
<b>chronology taq</b>	1300 A.D. ▼
<b>Chronology comment</b>	None

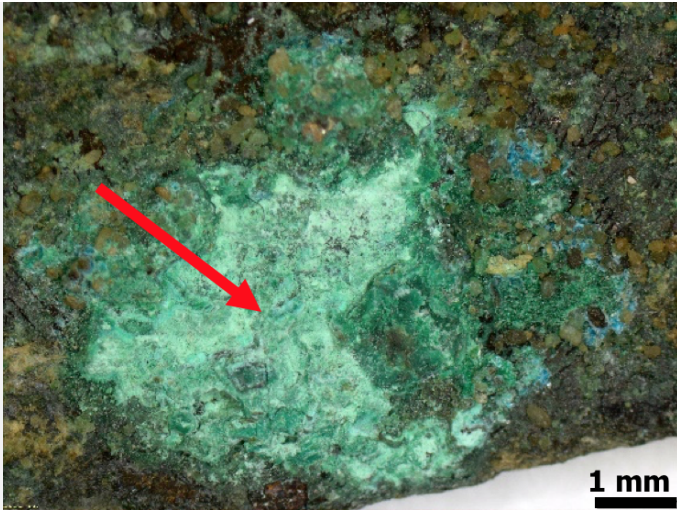
Fig. 4: Detail from Fig. 2 of the sampling area for XRF and XRD analysis,

<b>Description of sample</b>	Invasive sampling was not authorized by the museum. Only one powder sample was taken of the green corrosion product (Fig. 4).
<b>Alloy</b>	Cu Alloy
<b>Technology</b>	Cold worked (laminated)
<b>Lab number of sample</b>	1
<b>Sample location</b>	HE-Arc CR, Neuchâtel, Neuchâtel
<b>Responsible institution</b>	HE-Arc CR, Neuchâtel, Neuchâtel
<b>Date and aim of sampling</b>	02.04.2017, chemical and structural analyses

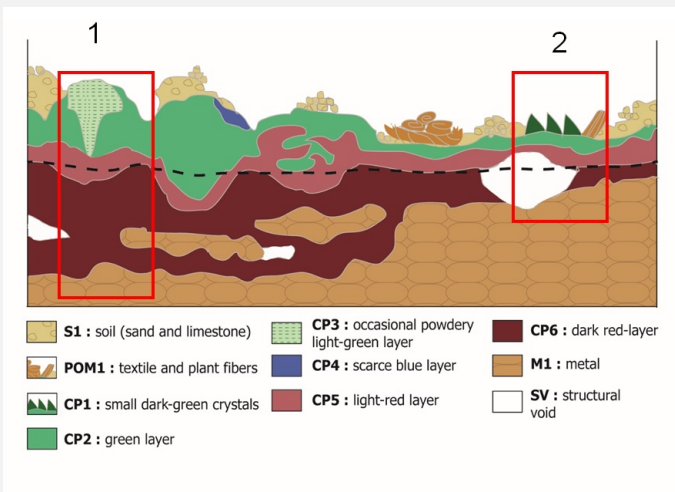
The schematic representation below gives an overview of the corrosion layers encountered on the tumi from a first visual macroscopic observation under binocular microscope.

Fig. 5: Stratigraphic representation of the sacrificial knife by macroscopic observation with indication of corrosion structures 1 and 2 used to build the MiCorr stratigraphy of Fig. 6,

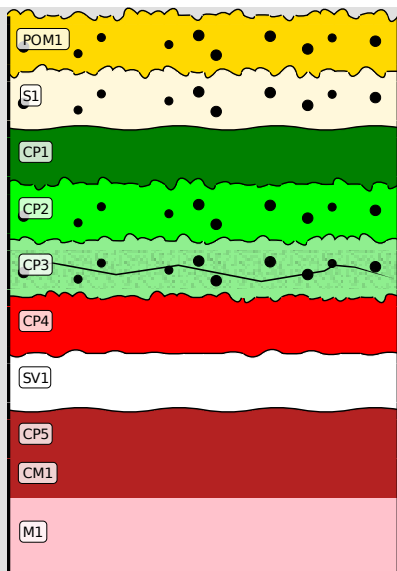
Fig. 6. Stratigraphic representation of the knife (combination of corrosion structures 1 and 2 of Fig. 5) under binocular using the MiCorr application. The characteristics of the strata are only accessible by clicking on the drawing that redirects you to the search tool by stratigraphy representation, Credit HE-Arc CR, M.Billot.

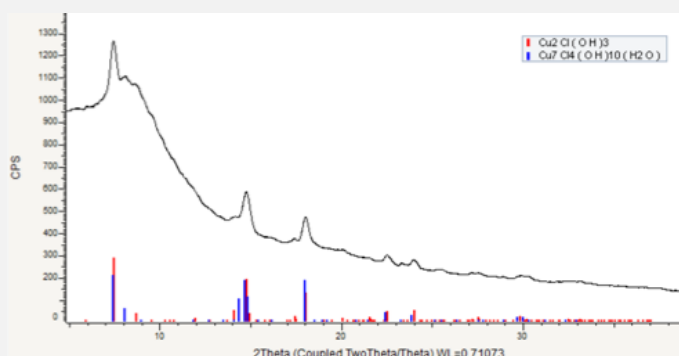
Results from XRF analyses of the non-cleaned metal surface (Table 1) indicate the presence of chlorine. The exogenous elements come from the landfill are mainly Si and Al, certainly associated to aluminosilicates. A sample was taken in the powdered light-green isolated layer (Figs. 2, 4 and 5). Chlorine, copper and oxygen was analysed by EDS-SEM. The presence of a high amount of Cl as well as Cu and O seems to indicate active corrosion (Fig. 8). XRD analysis confirmed the presence of paratacamite often associated to active corrosion (Fig. 9).

Fig. 9: XRD spectrum of a sample of the powdered light-green isolated layer (Fig. 4), Laboratory of Analytical Chemistry, Empa, HE-Arc,

Chlorine is found locally in the form of paratacamite.
