# CORRODED METAL SHEET FN 655.13.01 – FE ALLOY – MODERN TIMES – SWITZERLAND

**Artefact name** Corroded metal sheet FN 655.13.01

**Authors** Marianne. Senn (Empa, Dübendorf, Zurich, Switzerland) & Christian. Degryny (HE-Arc CR, Neuchâtel, Neuchâtel, Switzerland)

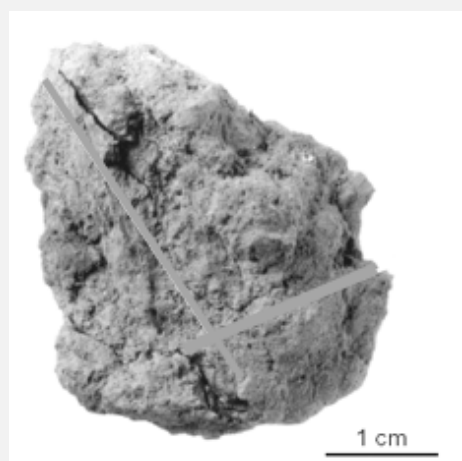
Fig. 1: Metal sheet (after Senn Bischofberger 2005, 137),

<b>Description of the artefact</b>	Metal (iron-based) sheet with middle rib. The shape is no longer discernible (Fig. 1). The metal is covered by a thick corrosion crust. Dimensions: L = 4.5cm; WT = 35g.
<b>Type of artefact</b>	Metal sheet
<b>Origin</b>	Steinmöri, Neftenbach / Dorf Neftenbach, Zurich, Switzerland
<b>Recovering date</b>	Excavation of the Roman villa, 1986-1990, phase S2, StblI.2 (2nd/3rd century AD)
<b>Chronology category</b>	Modern Times
<b>chronology tpq</b>	<input type="text" value="1900"/> A.D. ∨
<b>chronology taq</b>	<input type="text" value="2000"/> A.D. ∨

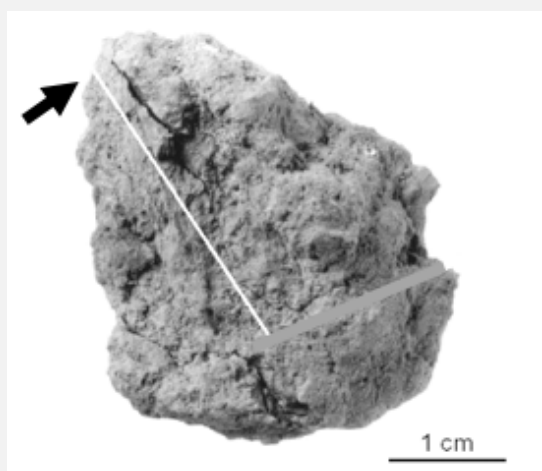
Fig. 2: Location of sampling area,

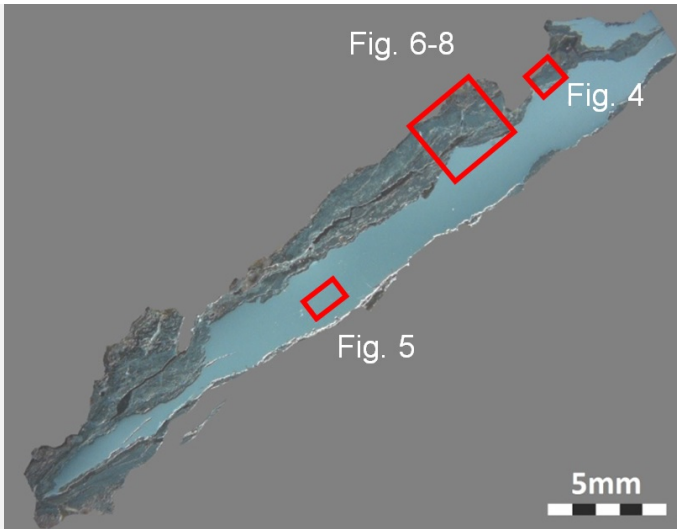
Fig. 3: Micrograph of the cross-section of the metal sheet showing the location of Figs. 4 to 8,

<b>Description of sample</b>	A longitudinal cut has been made through the sheet (Fig. 2). Large parts of the corrosion crust fell off during sampling (Fig. 3).
<b>Alloy</b>	Fe Alloy
<b>Technology</b>	Forged with final cold work
<b>Lab number of sample</b>	NEF 655
<b>Sample location</b>	HE-Arc CR, Neuchâtel, Neuchâtel
<b>Responsible institution</b>	Kantonsarchäologie, Dübendorf, Zurich
<b>Date and aim of sampling</b>	2000, metallography

The corrosion is massive and large parts of the outer corrosion layers have been lost during the sample preparation. The heavily cracked corrosion crust represents about one third of the thickness of the sample (Fig. 3) and is located on one side of the metal (the rest having been lost during the cutting process). It does not show well defined layers. Despite this, three areas can be distinguished (Figs. 6 and 7). Adhering to the metal (area 1), we find an orange-red-brown layer enriched in Cl (CP3 in Fig. 9, Fig. 8 and Table 3). The dark or violet middle area 2 is richer in Fe (CP2 in Fig. 9). The outer area 3 is red-brown (CP1 in Fig. 9) and strongly contaminated by soil material (rock fragment inclusion and elements like Si, Al, P etc.). This layer is enriched in O (Fig. 9).

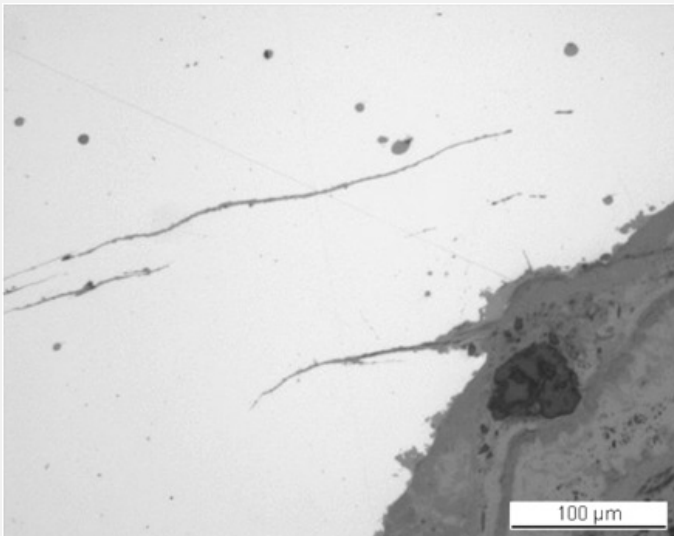
The remaining metal is an iron containing elevated (more than 1g/kg) concentrations of Co and Ni (Table 1), small round slag inclusions and cracks resulting from corrosion and deformation (Fig. 4). The composition of the round, elongated slag inclusions is similar to wüstite-FeO (Table 2). Iron reduced in the direct smelting process never contains such pure compounds and only FeO inclusions. In modern steels FeO occurs in low carbon alloys and Armco-iron (Schumann 1991, 474). After etching, the cross-section shows a heavily deformed ferritic microstructure from cold working (Fig. 6). The cracks have the same orientation as the deformation. The average hardness of the metal is HV1 195.

Fig. 4: Micrograph of metal sample from Fig. 3 (inverted picture, detail), unetched, bright field. In white the metal with round slag inclusions as well as cracks filled with corrosion products,

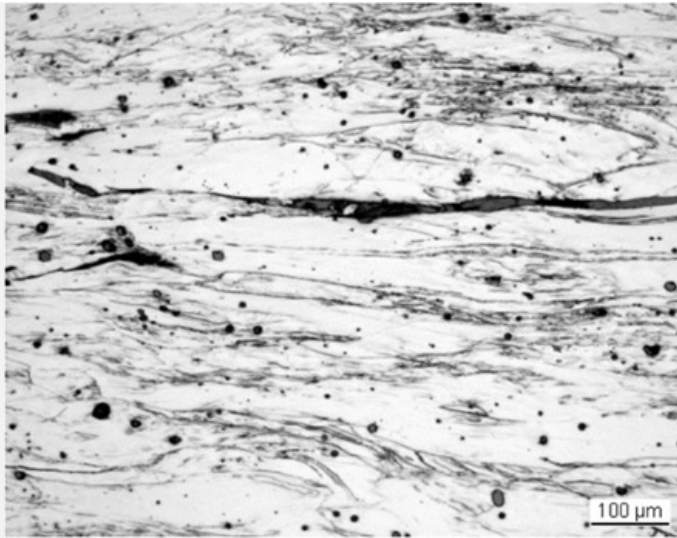
Fig. 5: Micrograph of metal sample from Fig. 3 (detail), etched, bright field. The heavily cold worked metal shows elongated grains with nearly invisible grain boundaries and cracks parallel to the grains,

<b>Microstructure</b>	Heavily deformed ferritic microstructure
<b>First metal element</b>	Fe
<b>Other metal elements</b>	Co, Ni

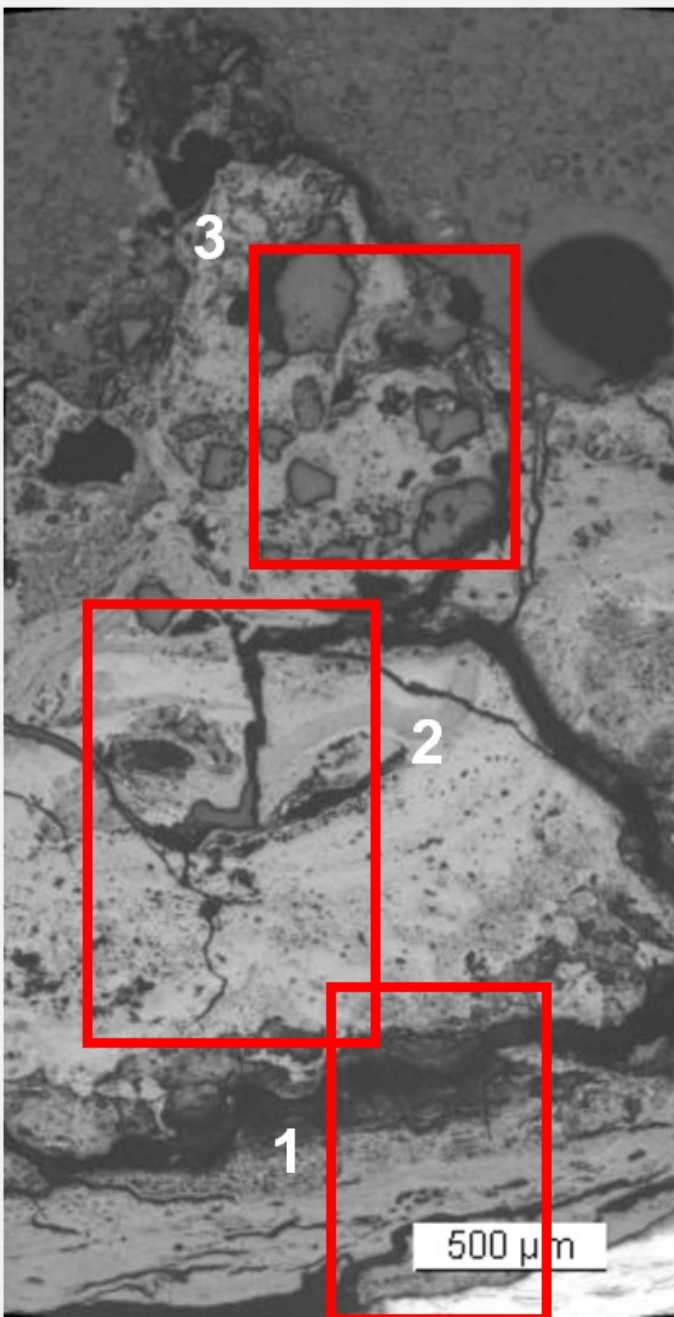
Fig. 6: Micrograph of the corrosion layer from Fig. 3 showing the metal - corrosion crust interface (detail, rotated by 45°) and corresponding to the stratigraphy of Fig. 9, unetched, bright field. The areas 1 (for CP3), 2 (for CP2) and 3 (for CP3) selected for elemental chemical distribution (Fig. 8) are marked by red rectangles,

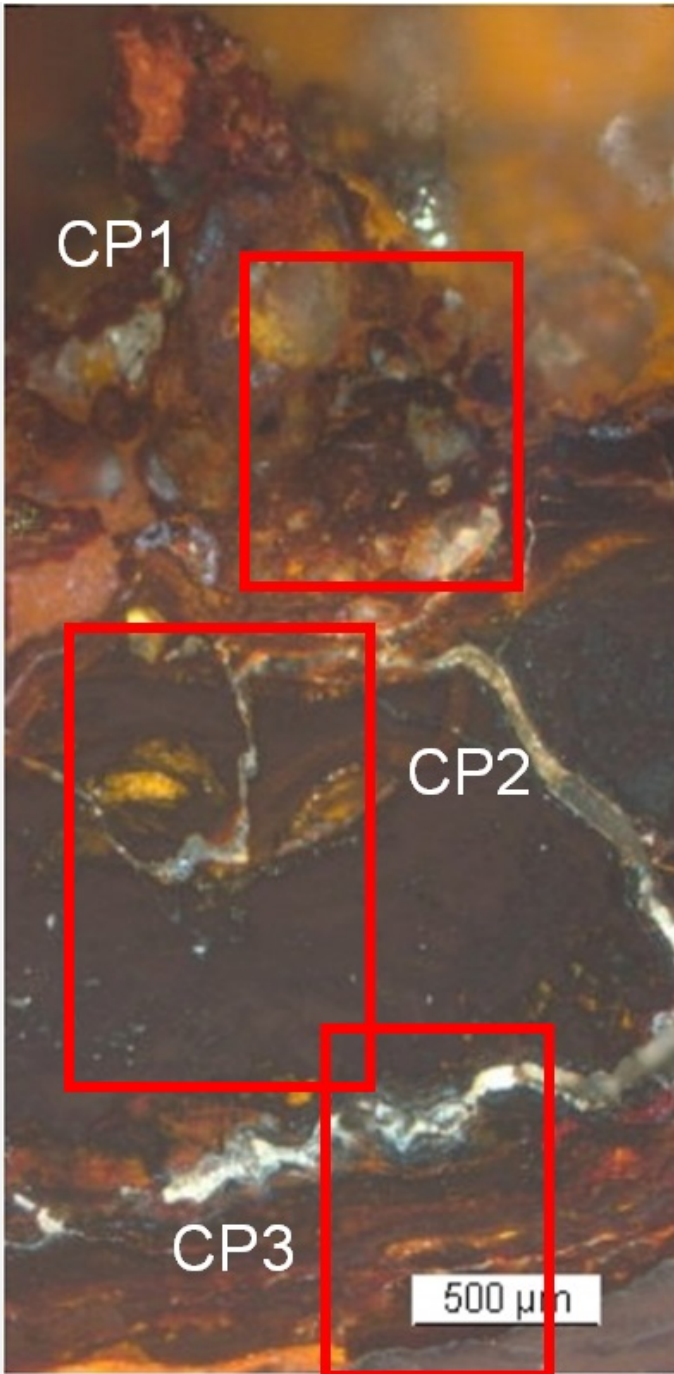
Fig. 7: Micrograph (same as Fig.6) and corresponding to the stratigraphy of Fig. 9, polarised light. The inner layer (CP3) is red-brown, area 2 is brown-violet (CP2) and the outer brown area contains rock fragment inclusions (CP1),

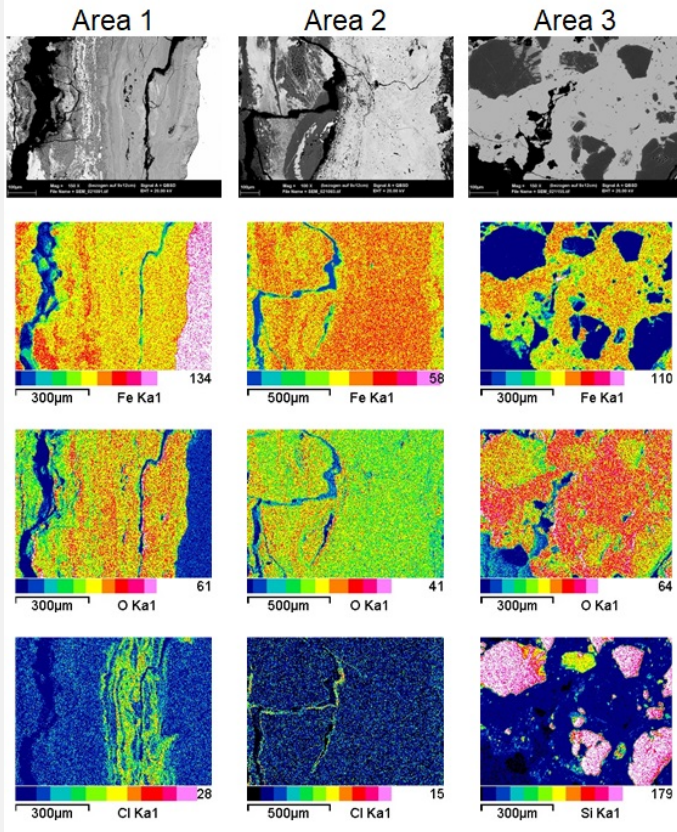
Fig. 8: SEM images, BSE-mode, and elemental chemical distribution of the selected areas from Figs. 6 and 7 (reversed picture rotated by 270°, details). First column: mapping on area 1 (CP3) where an inner layer enriched in Cl appears near the metal surface. 2nd column: area 2 (CP2) where iron oxides prevail. 3rd column: area 3 (CP1) where the outer O-rich layer includes rock fragments rich in Si. Method of examination: SEM/EDS, Lab. Anal. Chem. Empa,

This iron-based sheet is entirely cold worked and hard compared to an annealed metal. The corrosion is massive and masks the shape of the object. The presence of Cl adjacent to the metal surface indicates that the corrosion front is potentially active. The very thick top corrosion layers may have slowed down the corrosion. The object was mentioned as being Roman in Senn Bischofberger 2005, however the chemical composition of the slag inclusions shows that it is a product of the 20<sup>th</sup> century AD which has been accidentally introduced into a Roman layer.

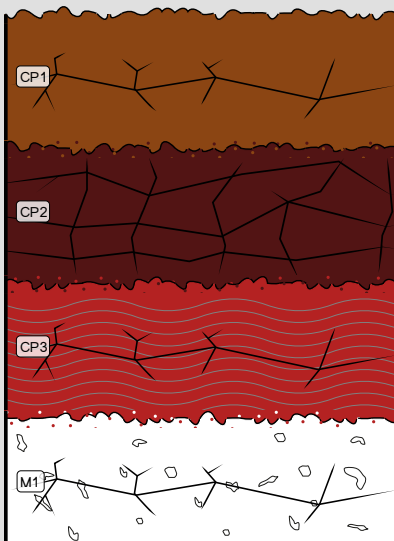
Fig. 9: Stratigraphic representation of the iron-based sheet in cross-section (dark field) using the MiCorr application. The characteristics of the strata are only accessible by clicking on the drawing that redirects you to the search tool by stratigraphy representation. This representation can be compared to Figs. 7, Credit HE-Arc CR.
