CORRODED METAL SHEET FN 655.13.01 – FE ALLOY – MODERN TIMES – SWITZERLAND

Artefact name Corroded metal sheet FN 655.13.01

Authors Marianne. Senn (Empa, Dübendorf, Zurich, Switzerland) & Christian. Degryny (HE-Arc CR, Neuchâtel, Neuchâtel, Switzerland)

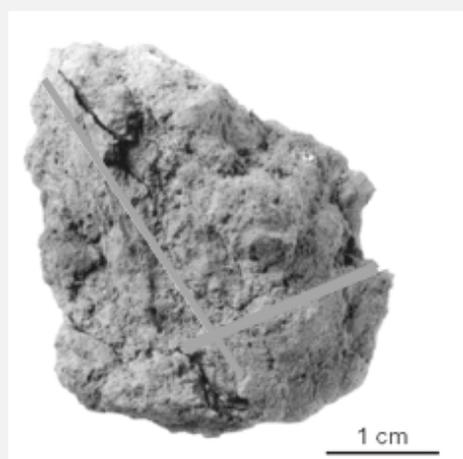
Fig. 1: Metal sheet (after Senn Bischofberger 2005, 137),

Description of the artefact	Metal (iron-based) sheet with middle rib. The shape is no longer discernible (Fig. 1). The metal is covered by a thick corrosion crust. Dimensions: L = 4.5cm; WT = 35g.
Type of artefact	Metal sheet
Origin	Steinmöri, Neftenbach / Dorf Neftenbach, Zurich, Switzerland
Recovering date	Excavation of the Roman villa, 1986-1990, phase S2, Stbll.2 (2nd/3rd century AD)
Chronology category	Modern Times
chronology tpq	<input type="text" value="1900"/> A.D. ∨
chronology taq	<input type="text" value="2000"/> A.D. ∨

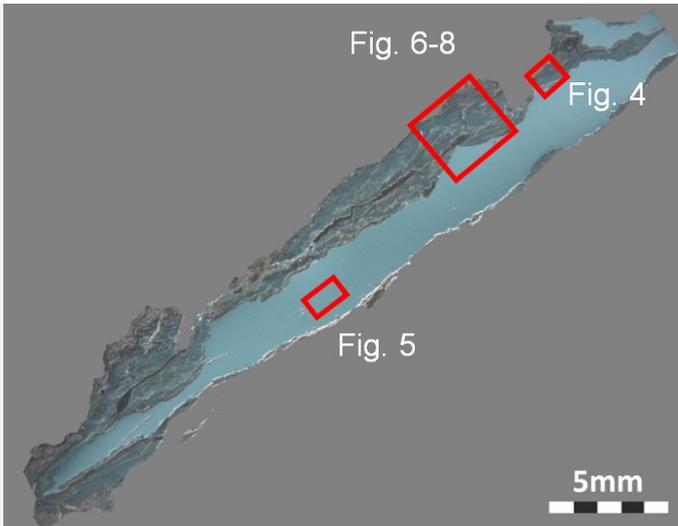
Fig. 3: Micrograph of the cross-section of the metal sheet showing the location of Figs. 4 to 8,

Description of sample	A longitudinal cut has been made through the sheet (Fig. 2). Large parts of the corrosion crust fell off during sampling (Fig. 3).
Alloy	Fe Alloy
Technology	Forged with final cold work
Lab number of sample	NEF 655
Sample location	HE-Arc CR, Neuchâtel, Neuchâtel
Responsible institution	Kantonsarchäologie, Dübendorf, Zurich
Date and aim of sampling	2000, metallography

The corrosion is massive and large parts of the outer corrosion layers have been lost during the sample preparation. The heavily cracked corrosion crust represents about one third of the thickness of the sample (Fig. 3) and is located on one side of the metal (the rest having been lost during the cutting process). It does not show well defined layers. Despite this, three areas can be distinguished (Figs. 6 and 7). Adhering to the metal (area 1), we find an orange-red-brown layer enriched in Cl (CP3 in Fig. 9, Fig. 8 and Table 3). The dark or violet middle area 2 is richer in Fe (CP2 in Fig. 9). The outer area 3 is red-brown (CP1 in Fig. 9) and strongly contaminated by soil material (rock fragment inclusion and elements like Si, Al, P etc.). This layer is enriched in O (Fig. 9).

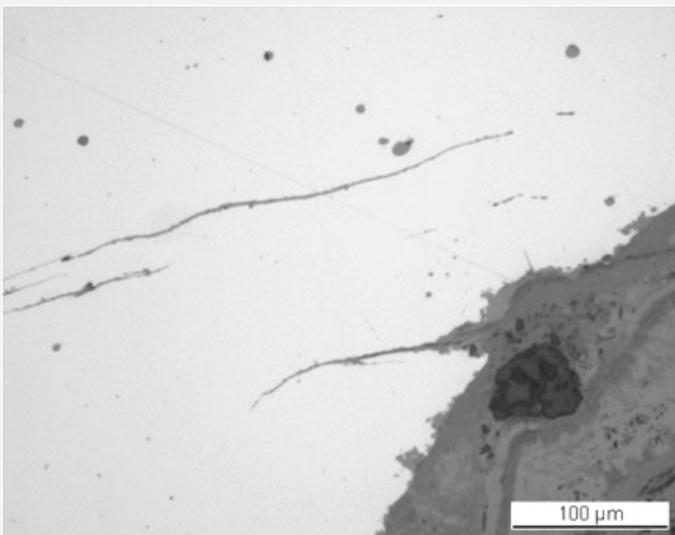
The remaining metal is an iron containing elevated (more than 1g/kg) concentrations of Co and Ni (Table 1), small round slag inclusions and cracks resulting from corrosion and deformation (Fig. 4). The composition of the round, elongated slag inclusions is similar to wüstite-FeO (Table 2). Iron reduced in the direct smelting process never contains such pure compounds and only FeO inclusions. In modern steels FeO occurs in low carbon alloys and Armco-iron (Schumann 1991, 474). After etching, the cross-section shows a heavily deformed ferritic microstructure from cold working (Fig. 6). The cracks have the same orientation as the deformation. The average hardness of the metal is HV1 195.

Fig. 4: Micrograph of metal sample from Fig. 3 (inverted picture, detail), unetched, bright field. In white the metal with round slag inclusions as well as cracks filled with corrosion products,

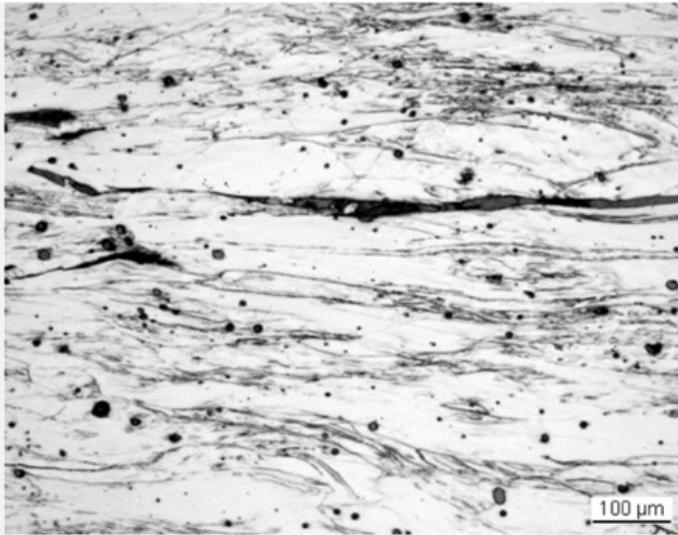
Fig. 5: Micrograph of metal sample from Fig. 3 (detail), etched, bright field. The heavily cold worked metal shows elongated grains with nearly invisible grain boundaries and cracks parallel to the grains,

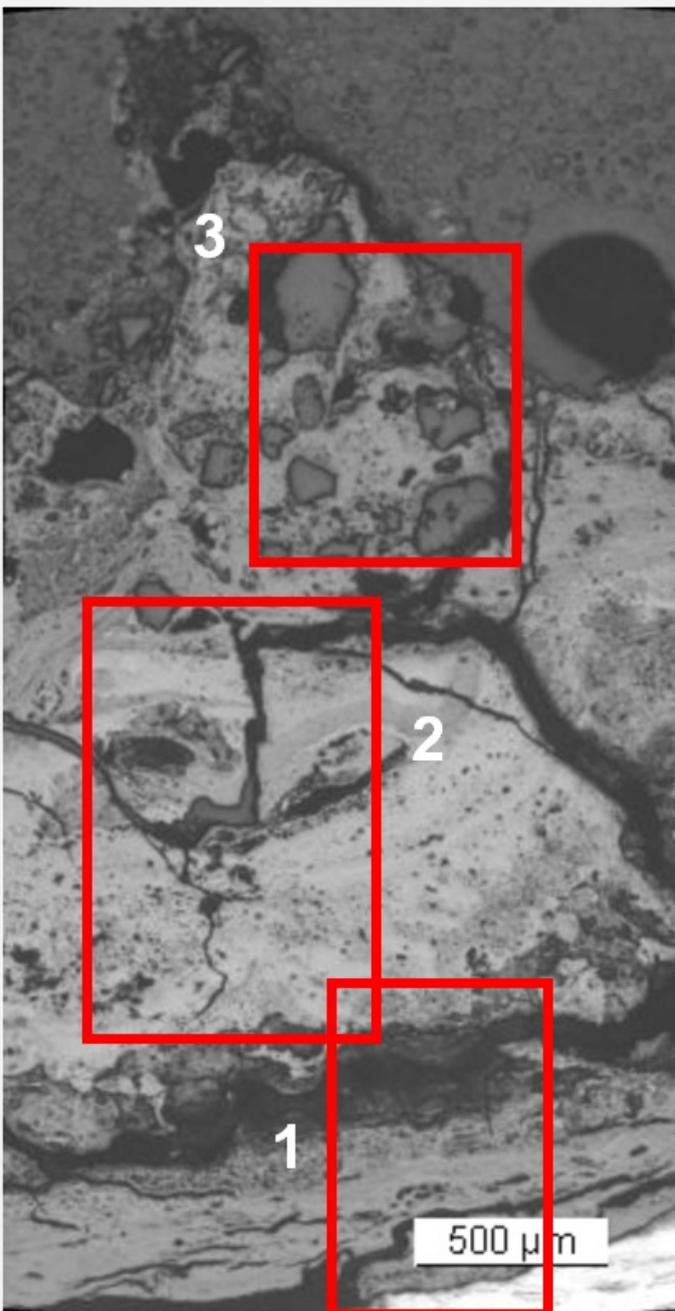
Fig. 6: Micrograph of the corrosion layer from Fig. 3 showing the metal - corrosion crust interface (detail, rotated by 45°) and corresponding to the stratigraphy of Fig. 9, unetched, bright field. The areas 1 (for CP3), 2 (for CP2) and 3 (for CP3) selected for elemental chemical distribution (Fig. 8) are marked by red rectangles,

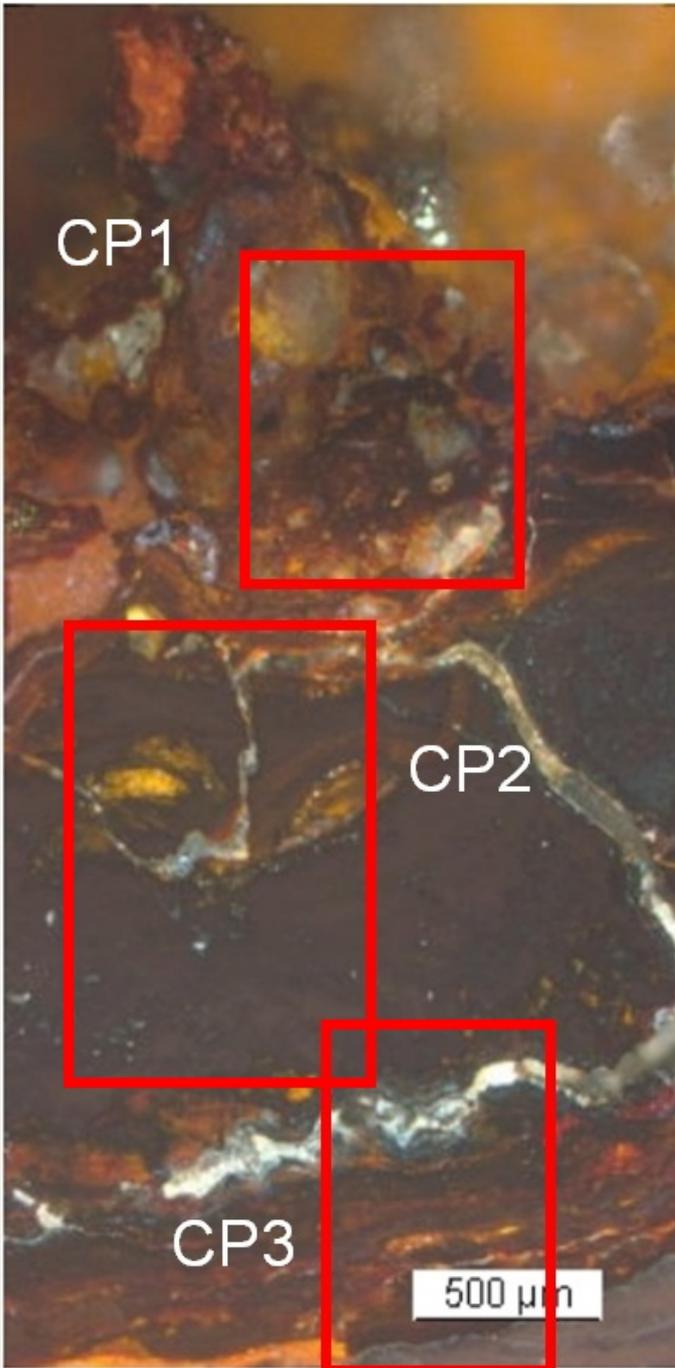
Fig. 7: Micrograph (same as Fig.6) and corresponding to the stratigraphy of Fig. 9, polarised light. The inner layer (CP3) is red-brown, area 2 is brown-violet (CP2) and the outer brown area contains rock fragment inclusions (CP1),

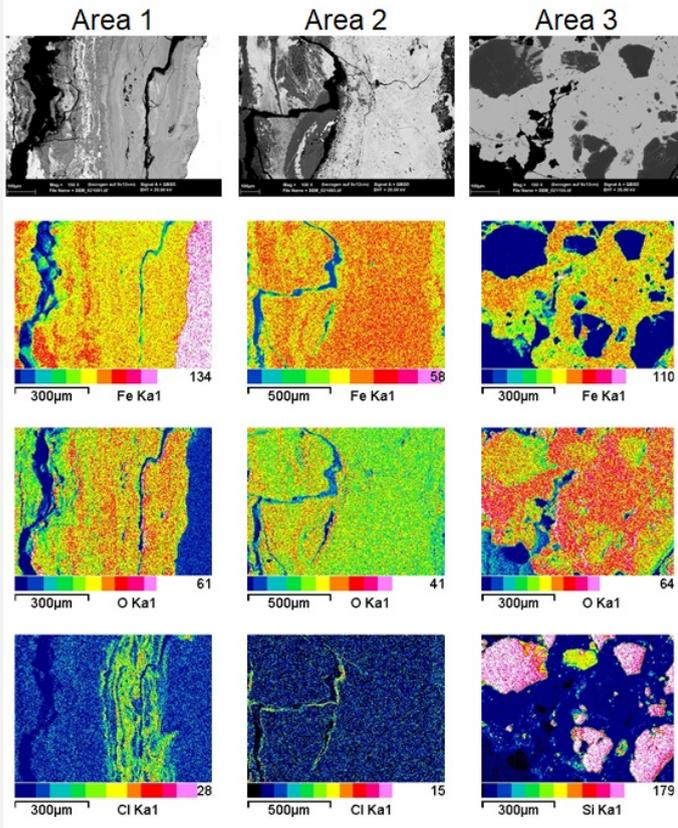
Fig. 8: SEM images, BSE-mode, and elemental chemical distribution of the selected areas from Figs. 6 and 7 (reversed picture rotated by 270°, details). First column: mapping on area 1 (CP3) where an inner layer enriched in Cl appears near the metal surface. 2nd column: area 2 (CP2) where iron oxides prevail. 3rd column: area 3 (CP1) where the outer O-rich layer includes rock fragments rich in Si. Method of examination: SEM/EDS, Lab. Anal. Chem. Empa,

This iron-based sheet is entirely cold worked and hard compared to an annealed metal. The corrosion is massive and masks the shape of the object. The presence of Cl adjacent to the metal surface indicates that the corrosion front is potentially active. The very thick top corrosion layers may have slowed down the corrosion. The object was mentioned as being Roman in Senn Bischofberger 2005, however the chemical composition of the slag inclusions shows that it is a product of the 20th century AD which has been accidentally introduced into a Roman layer.

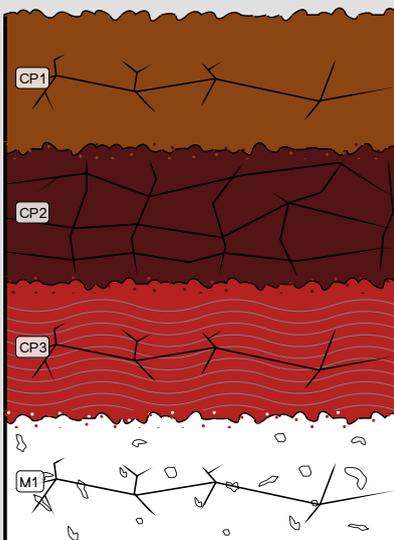
Fig. 9: Stratigraphic representation of the iron-based sheet in cross-section (dark field) using the MiCorr application. The characteristics of the strata are only accessible by clicking on the drawing that redirects you to the search tool by stratigraphy representation. This representation can be compared to Figs. 7, Credit HE-Arc CR.
