# CORRODED METAL SHEET FN 655.13.01 – FE ALLOY – MODERN TIMES – SWITZERLAND

Artefact name	Corroded metal sheet FN 655.13.01
Authors	Marianne. Senn (Empa, Dübendorf, Zurich, Switzerland) & Christian. Degriigny (HE-Arc CR, Neuchâtel, Neuchâtel, Switzerland)
Url	/artefacts/962/

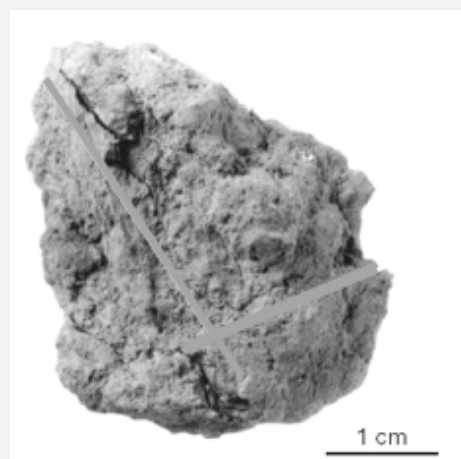
Fig. 1: Metal sheet (after Senn Bischofberger 2005, 137),

Description of the artefact	Metal (iron-based) sheet with middle rib. The shape is no longer discernible (Fig. 1). The metal is covered by a thick corrosion crust. Dimensions: L = 4.5cm; WT = 35g.
Type of artefact	Metal sheet
Origin	Steinmöri, Neftenbach / Dorf Neftenbach, Zurich, Switzerland
Recovering date	Excavation of the Roman villa, 1986-1990, phase S2, StbII.2 (2nd/3rd century AD)
Chronology category	Modern Times
chronology tpq	1900 A.D. ▼
chronology taq	2000 A.D. ▼
Chronology comment	Product of the 20th century AD introduced accidentally into a Roman layer

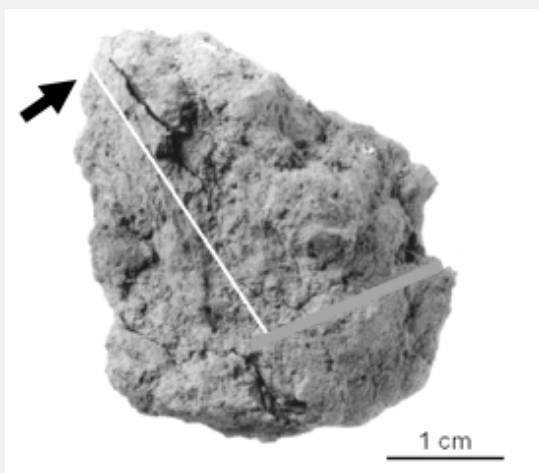
Fig. 2: Location of sampling area,

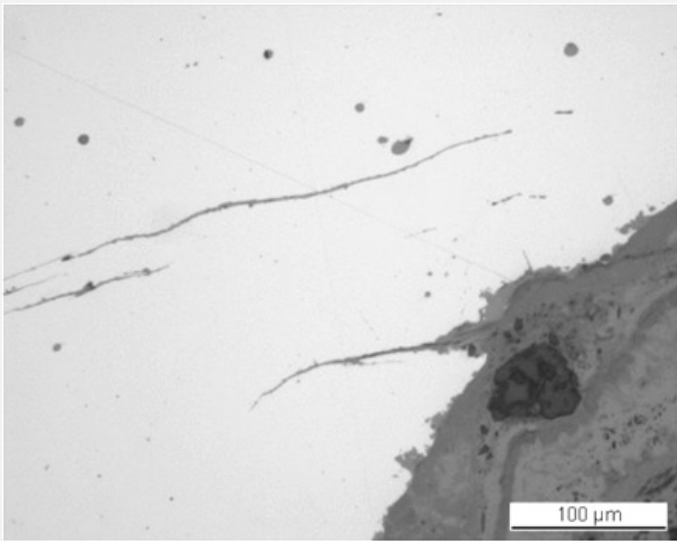
The remaining metal is an iron containing elevated (more than 1g/kg) concentrations of Co and Ni (Table 1), small round slag inclusions and cracks resulting from corrosion and deformation (Fig. 4). The composition of the round, elongated slag inclusions is similar to wüstite-FeO (Table 2). Iron reduced in the direct smelting process never contains such pure compounds and only FeO inclusions. In modern steels FeO occurs in low carbon alloys and Armco-iron (Schumann 1991, 474). After etching, the cross-section shows a heavily deformed ferritic microstructure from cold working (Fig. 6). The cracks have the same orientation as the deformation. The average hardness of the metal is HV1 195.

Fig. 4: Micrograph of metal sample from Fig. 3 (inverted picture, detail), unetched, bright field. In white the metal with round slag inclusions as well as cracks filled with corrosion products,

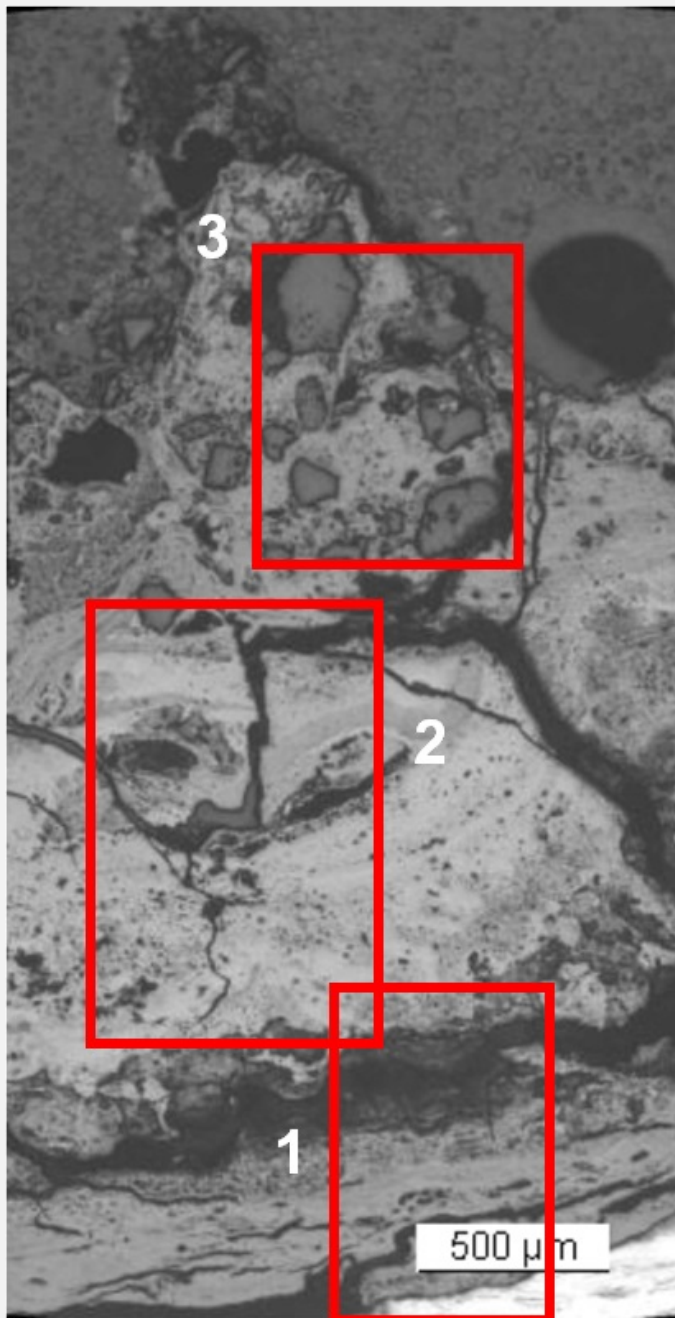
The corrosion is massive and large parts of the outer corrosion layers have been lost during the sample preparation. The heavily cracked corrosion crust represents about one third of the thickness of the sample (Fig. 3) and is located on one side of the metal (the rest having been lost during the cutting process). It does not show well defined layers. Despite this, three areas can be distinguished (Figs. 6 and 7). Adhering to the metal (area 1), we find an orange-red-brown layer enriched in Cl (CP3 in Fig. 9, Fig. 8 and Table 3). The dark or violet middle area 2 is richer in Fe (CP2 in Fig. 9). The outer area 3 is red-brown (CP1 in Fig. 9) and strongly contaminated by soil material (rock fragment inclusion and elements like Si, Al, P etc.). This layer is enriched in O (Fig. 9).

Fig. 6: Micrograph of the corrosion layer from Fig. 3 showing the metal - corrosion crust interface (detail, rotated by 45°) and corresponding to the stratigraphy of Fig. 9, unetched, bright field. The areas 1 (for CP3), 2 (for CP2) and 3 (for CP3) selected for elemental chemical distribution (Fig. 8) are marked by red rectangles,

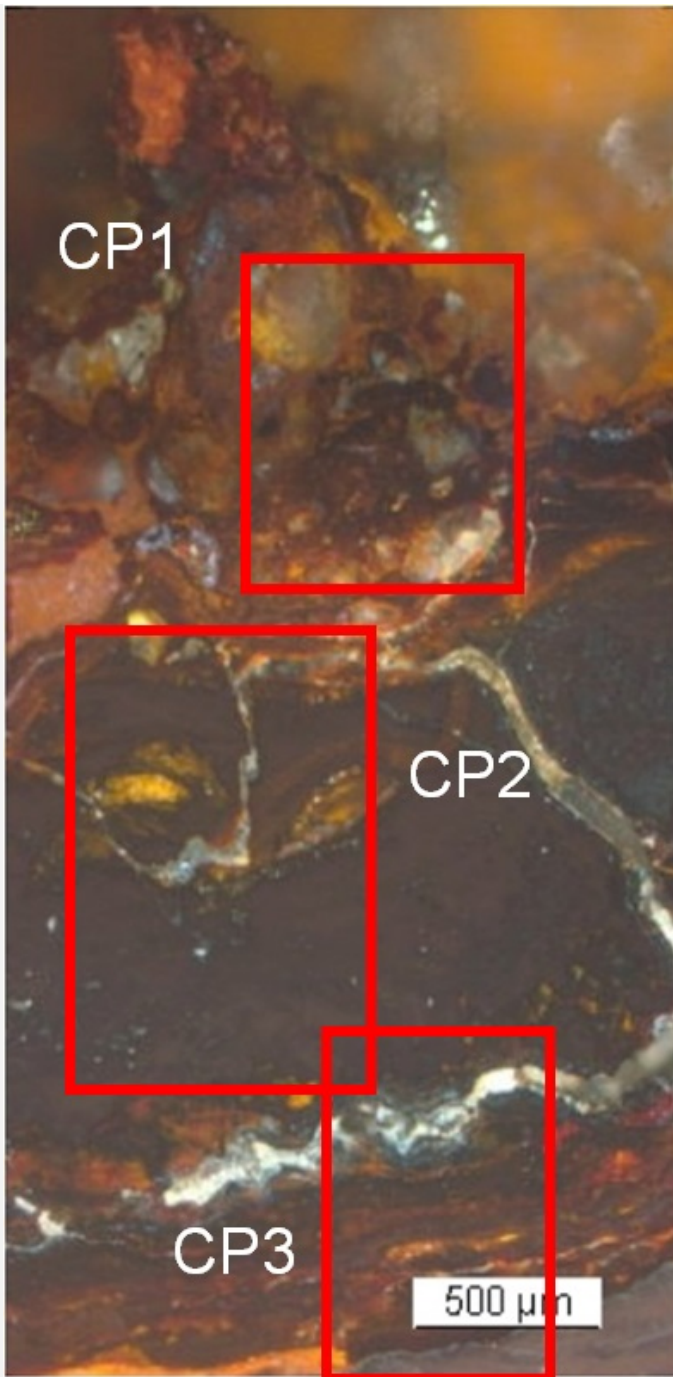
Fig. 7: Micrograph (same as Fig.6) and corresponding to the stratigraphy of Fig. 9, polarised light. The inner layer (CP3) is red-brown, area 2 is brown-violet (CP2) and the outer brown area contains rock fragment inclusions (CP1),

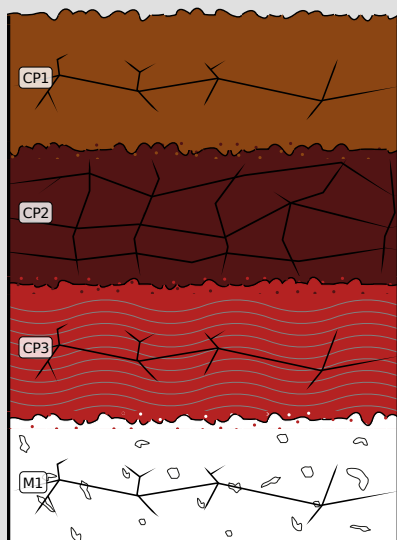
Fig. 9: Stratigraphic representation of the iron-based sheet in cross-section (dark field) using the MiCorr application. The characteristics of the strata are only accessible by clicking on the drawing that redirects you to the search tool by stratigraphy representation. This representation can be compared to Figs. 7, Credit HE-Arc CR.
