# CHISEL POINT DEV 995 1069 PR – EUTECTOID TO HYPEREUTECTOID STEEL – EARLY MEDIEVAL TIMES – SWITZERLAND

Artefact name	Chisel point DEV 995 1069 PR
Authors	Marianne. Senn (Empa, Dübendorf, Zurich, Switzerland) & Christian. Degriigny (HE-Arc CR, Neuchâtel, Neuchâtel, Switzerland)
Url	/artefacts/966/

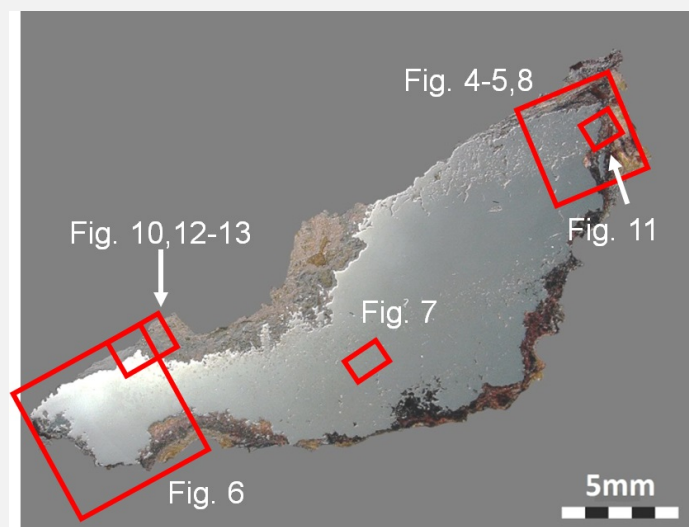
Fig. 3: Micrograph of the cross-section of the chisel point showing the location of Figs. 4 to 8 and 10 to 13,

<b>Description of sample</b>	A longitudinal cut from a chisel point (Figs. 2 and 3) after restoration. Dimensions: L = 30mm; W = 11mm (approximately).
<b>Alloy</b>	Eutectoid to hypereutectoid steel
<b>Technology</b>	Quench hardened
<b>Lab number of sample</b>	DEV1069
<b>Sample location</b>	HE-Arc CR, Neuchâtel, Neuchâtel
<b>Responsible institution</b>	Office de la Culture, Porrentruy, Jura
<b>Date and aim of sampling</b>	2000, metallography and chemical composition of the metal

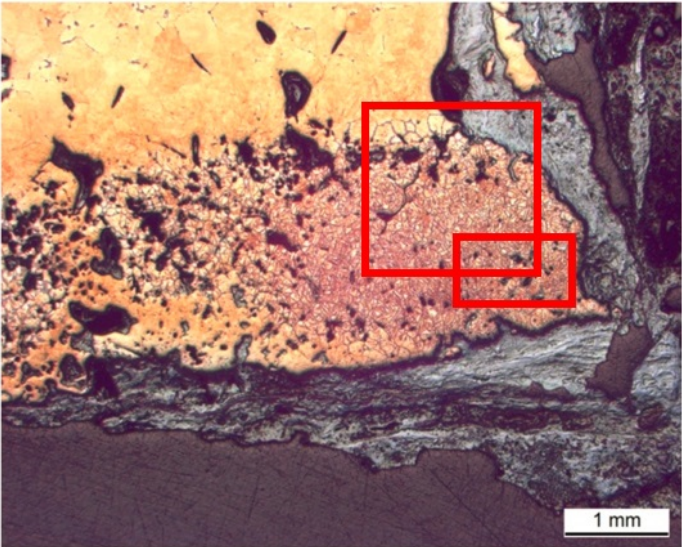
The remaining metal is a eutectoid to hypereutectoid steel (C 0.8-1 mass%) with cracks and porosity (Figs. 4 and 5). Its composition is given in Table 1 (except Fe). Of the trace elements, only Ni reaches a medium concentration (Ni 0.07 mass%). The composition and the high Ni/Co ratio are atypical for iron worked in smithies of the settlement at Develier-Courtételle JU, CH. The few slag inclusions and their chemical composition confirm this (Table 2). The slag is rich in CaO whereas the pisolithic or bean ore worked in the Central Jura smelting district is rich in Al<sub>2</sub>O<sub>3</sub>. The slag inclusions cannot be smithing slag because the artefact is formed from one piece of metal. The slag probably incorporated while refining the bloom or during the bloom smelting process. The ore from which this metal was smelted cannot yet be identified. Intergranular corrosion has developed, penetrating into the metal structure (Fig. 5). The etched metal shows a dominant martensitic structure, typical of quench hardened steel (Figs. 4, 6, 7 and 8). The characteristic forms of the martensite are non-organised needles (Fig. 7). In restricted areas bainite nodules occur (Figs. 6 and 7). In the centre of the point, hypereutectoid steel is composed of cementite in the grain boundaries and in needle like shapes within the grains (Fig. 9). Hypereutectoid regions also occur in the centre of the shaft and on its left surface (Fig. 4). Here the hypereutectoid steel is composed of martensite and cementite in the grain boundaries and in needle form within the grains (Figs. 5 and 8). Nevertheless, most of the chisel is dominated by eutectoid steel. The average hardness of the quench hardened steel is about HV1 690. In the bainite nodules the average hardness drops to about HV1 350, the martensite has an average hardness of HV1 750.

Fig. 4: Micrograph of the metal sample from Fig. 3 (inverted picture, detail), etched, bright field. The metal contains porosity and cracks (in black). The micrographs of Figs. 5 and 8 are marked by the top and bottom rectangles respectively,

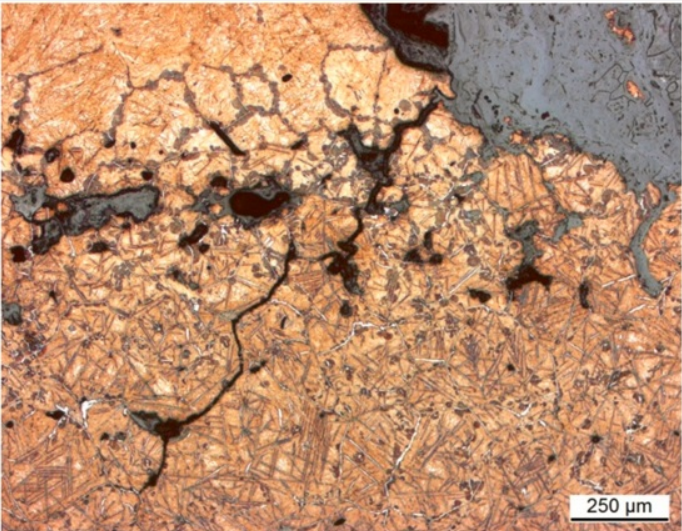
Fig. 5: Micrograph of the metal sample, detail from Fig. 4, etched, bright field. We observe martensite (in orange), cementite (in grey), porosity and intergranular cracks (in black) and corrosion,

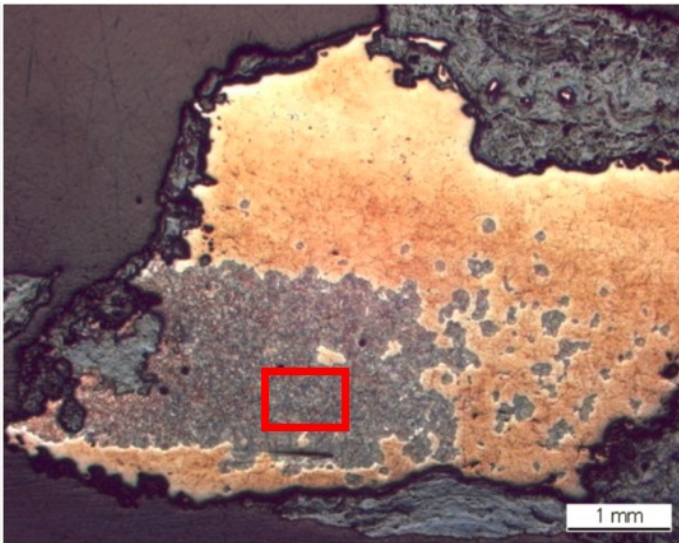
Fig. 6: Micrograph of the metal sample from Fig. 3 (inverted picture, detail), etched, bright field. We observe the metal with martensite (orange) and bainite nodules (blue). The micrograph of Fig. 9 is marked by a rectangle,

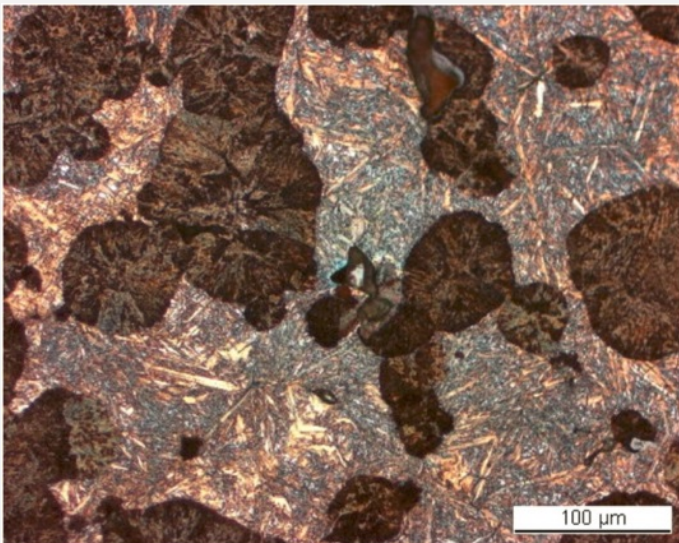
Fig. 7: Micrograph of the metal sample from Fig. 3 (detail), etched, bright field. We observe dark bainite nodules combined with martensite needles,

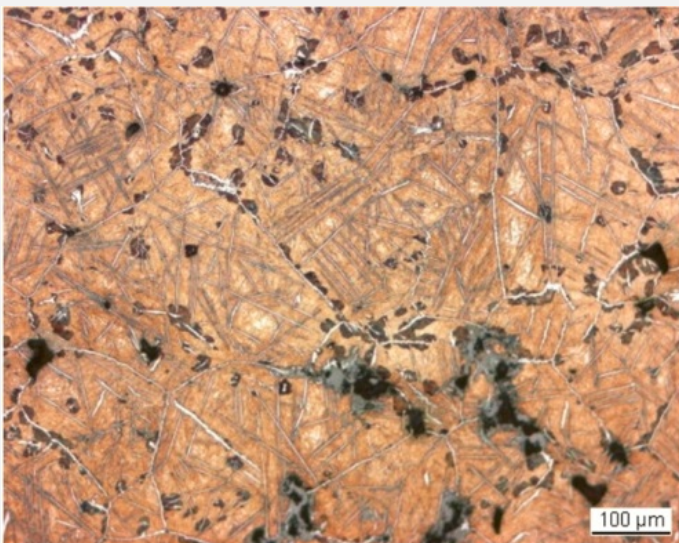
Fig. 8: Micrograph of the metal sample, detail from Fig. 4, etched, bright field. Hypereutectoid steel with a structure of cementite in white in the grain boundaries and in needle form combined with martensite (pink). Some bainite occurs around the grain boundaries,

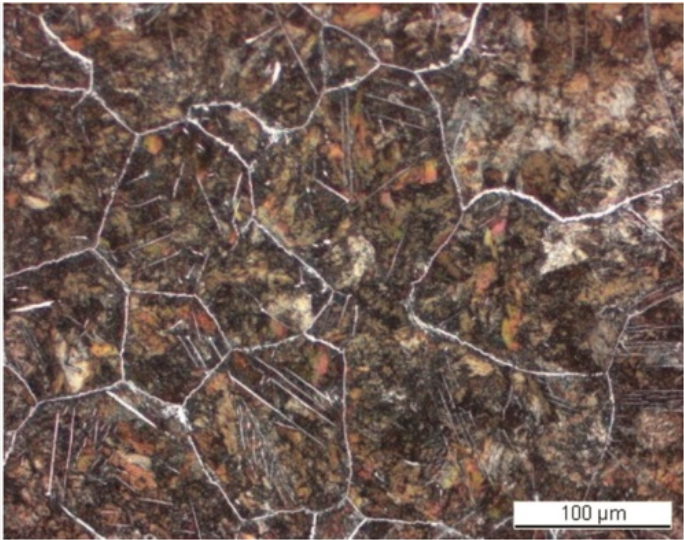
Fig. 9: Micrograph of the metal sample, detail from Fig. 6, etched, bright field. Hypereutectoid steel with a structure of cementite in white in the grain boundaries and in needle form combined with bainite (dark),

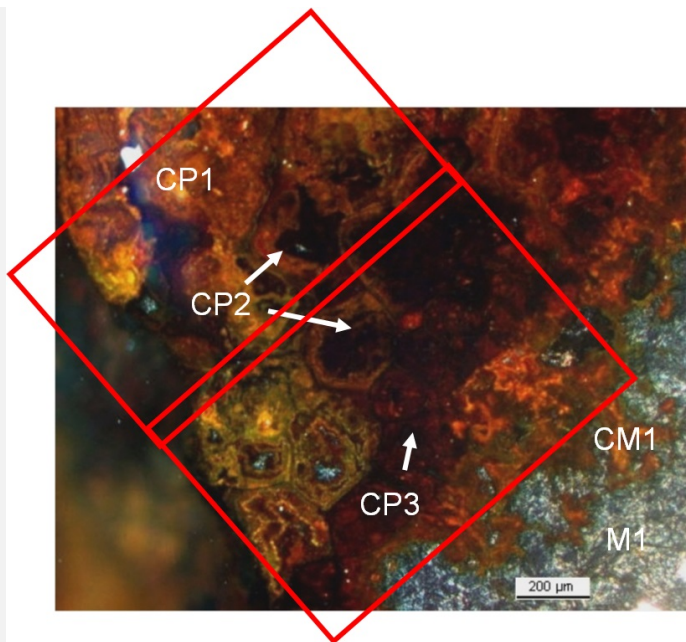
The metal is heavily corroded and the thickness of the corrosion crust is irregular, but averages about 0.5mm. The corrosion products enclose different ghost structures: the corrosion crust has preserved the shape of polygonal grains (Figs. 10 and 12) and cementite needles (Fig. 11). Under polarised light, the corrosion products at the metal - corrosion crust interface are dark-red and form an inner S-rich layer (CP3, Figs. 10 and 12). Cl occurs locally (CP3) and C is present in layers CP2 and CP3 (Fig. 12). The outer layer of the corrosion products (CP1) is orange and contains more O than the inner layer CP3 (Figs. 10 and 13).

Fig. 10: Micrograph showing the metal - corrosion crust interface from Fig. 3 (rotated by 270°, detail) and corresponding to the stratigraphy of Fig. 14, unetched, polarised light. Polygonal grains are visible as ghost structure in the corrosion crust. The selected areas for elemental chemical distribution (Figs. 12 and 13) are marked by two rectangles (bottom: Fig. 12 and top: Fig. 13),

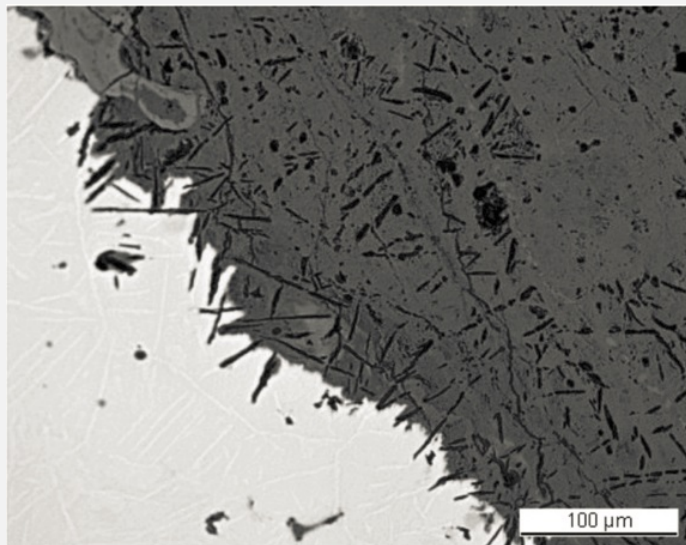
Fig. 11: Micrograph showing the metal - corrosion crust interface from Fig. 3 (detail), unetched, bright field. The cementite is visible as white needles in the metal and its ghost structure as black needles in the corrosion crust,

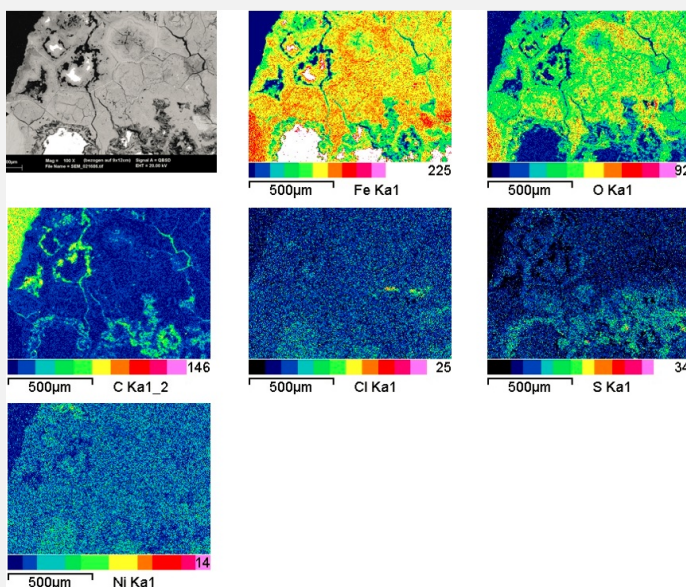
Fig. 12: SEM image, BSE-mode, and elemental chemical distribution of the selected area from Fig. 10 (rotated by 45°). Method of examination: SEM/EDS, Laboratory of Analytical Chemistry, Empa,

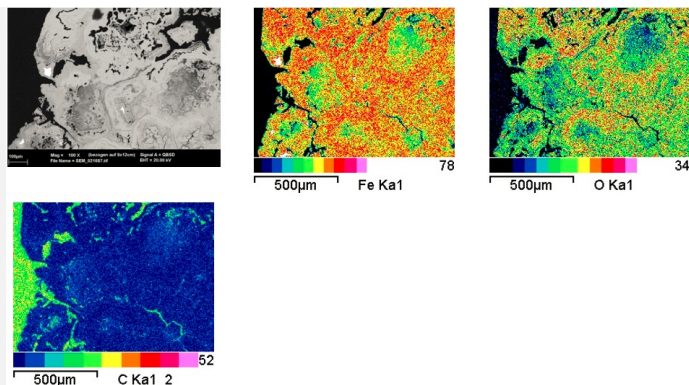
Fig. 13: SEM image, BSE-mode, and elemental chemical distribution of the selected area from Fig. 10 (rotated by 45°). Method of examination: SEM/EDS, Laboratory of Analytical Chemistry, Empa,

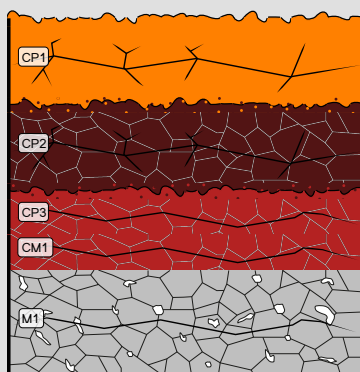
Fig. 14: Stratigraphic representation of the chisel point in cross-section (dark field) using the MiCorr application. The characteristics of the strata are only accessible by clicking on the drawing that redirects you to the search tool by stratigraphy representation. This representation can be compared to Fig. 10, Credit HE-Arc CR.
