CHISEL POINT DEV 995 1069 PR – EUTECTOID TO HYPEREUTECTOID STEEL – EARLY MEDIEVAL TIMES – SWITZERLAND

Artefact name	Chisel point DEV 995 1069 PR
Authors	Marianne. Senn (Empa, Dübendorf, Zurich, Switzerland) & Christian. Degriigny (HE-Arc CR, Neuchâtel, Neuchâtel, Switzerland)
Url	/artefacts/966/

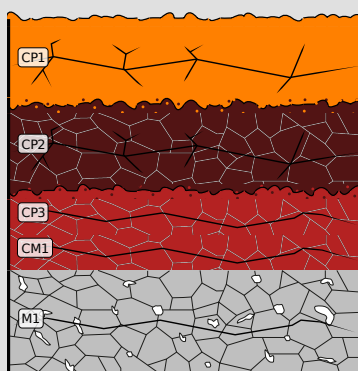
Fig. 14: Stratigraphic representation of the chisel point in cross-section (dark field) using the MiCorr application. The characteristics of the strata are only accessible by clicking on the drawing that redirects you to the search tool by stratigraphy representation. This representation can be compared to Fig. 10, Credit HE-Arc CR.
