SITULA EMT09-554.665 - TIN BRONZE - IRON AGE - SWITZERLAND

Artefact name	Situla EMT09-554.665
Authors	Christian. Degriigny (HE-Arc CR, Neuchâtel, Neuchâtel, Switzerland) & Marie-Jeanne. Scholl (HE-Arc CR, Neuchâtel, Neuchâtel, Switzerland) & Valentin. Boissonnas (HE-Arc CR, Neuchâtel, Neuchâtel, Switzerland)
Url	/artefacts/968/

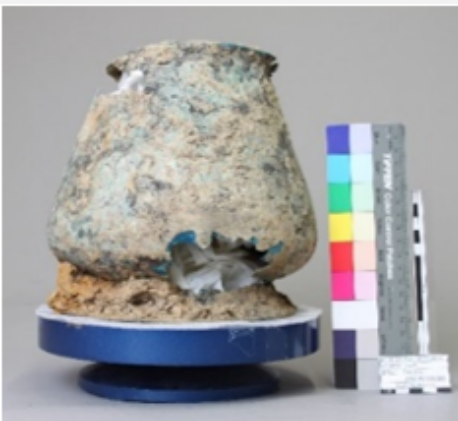
Fig. 1: Situla (Archeodunum (Gollion), 2009) inverted as found in situ,

Description of the artefact	Situla (Fig. 1) covered with blue-green corrosion products and sediments. Attached to two riveted iron loops is an iron handle terminating in two swan heads (not shown here). Dimensions of the main body: Hmax = 340mm, Ømax = 220mm.
Type of artefact	Situla
Origin	Mormont sanctuary, La Sarraz, Vaud, Switzerland
Recovering date	Excavated in 2011
Chronology category	Iron Age
chronology tpq	<input type="text" value="140"/> B.C. ▾
chronology taq	<input type="text" value="30"/> B.C. ▾
Chronology comment	La Tène D

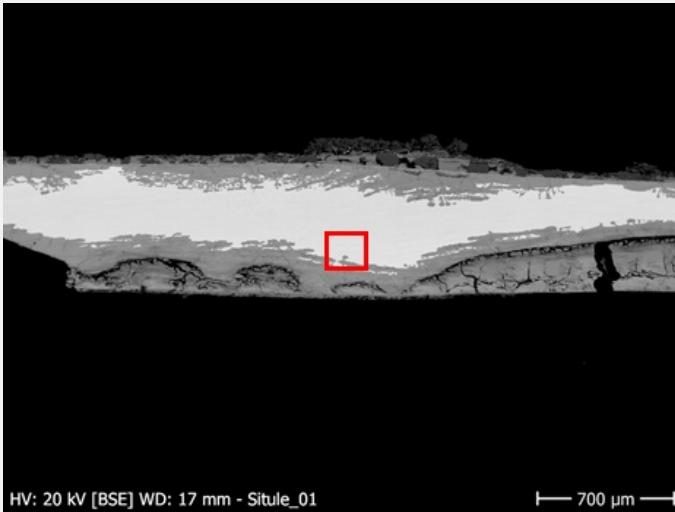
The remaining metal is a dense tin bronze (Fig. 5, Table 1), showing no inclusion. In bright field, the etched alloy shows a structure principally consisting of polygonal alpha phase grains (Fig. 6). Some of the grains include twin lines (Fig. 7). The presence of strain lines (slip lines) indicates a final cold work without annealing.

Elements	Cu	Sn
mass%	90	10

Fig. 5: SEM image, BSE-mode, of the metal sample from Fig. 4. Area of Fig. 6 is marked by a red square,

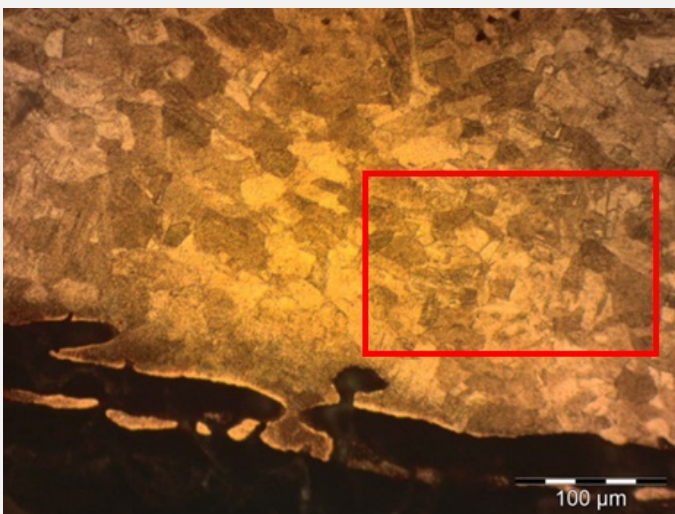
Fig. 6: Micrograph of the metal structure from Fig. 5 (detail), etched, bright field, 50x. The alpha phase of the alloy shows polygonal grains. Area of Fig. 7 is marked by a red rectangle,

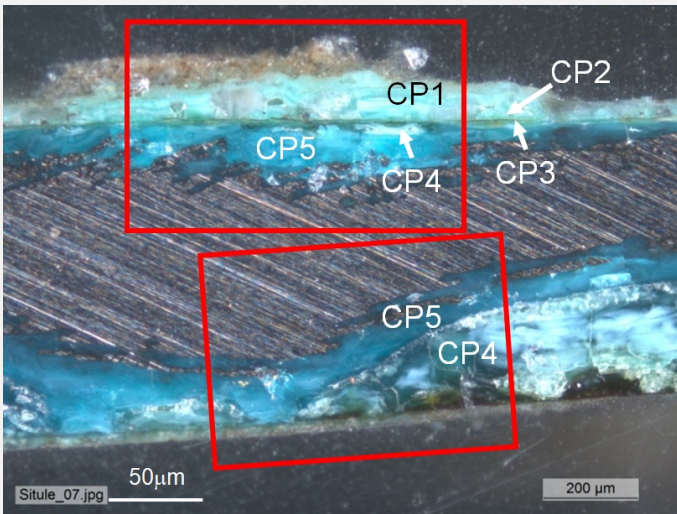
The corrosion crust is heterogeneous and has in places completely replaced the metal. The metal – corrosion products interface is irregular due to transgranular corrosion (Figs 5-6). In most cases, the corrosion crust can be divided in three main layers: first, an inner compact blue layer directly on the metal core (CP5, Figs. 8, 10 and 15 and CP3, Fig. 14). In areas of extensive corrosion this blue layer coexists with a friable light blue-green layer (CP4, Figs. 8, 10 and 15 and CP2, Fig. 14). Secondly, and depending on the area, either a very fine dark green (CP3, Figs. 8 and 15) or red corrosion layer (CP2, Figs. 10 and 15) marks the limit of the original surface. Finally, there is a fourth outer layer, consisting of friable and sometimes curly pale green corrosion products, interspersed with soil products (CP1, Figs. 8, 10 and 15). In heavily worked and fragile parts of the object a cleavage between the inner layers of blue and light blue-green corrosion is present, rendering the light blue-green corrosion vulnerable to loss (Fig. 9).

Fig. 8: Micrograph of the metal sample from Fig. 4, unetched, dark field, 50x. Areas of Fig. 9 (bottom, corresponding to the stratigraphy of Fig. 14) and Figs. 10 and 11 (top, corresponding to the stratigraphy of Fig. 15) are marked by a rectangle. Codes are those of Fig. 15,

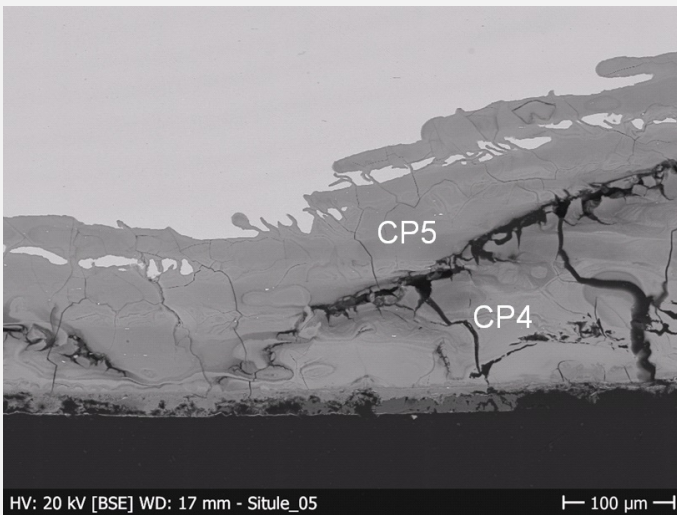
Fig. 9: SEM image, BSE-mode of the metal sample from Fig. 8 (detail) showing cleavage between the inner blue (CP5) and green (CP4) layers of Fig. 15,

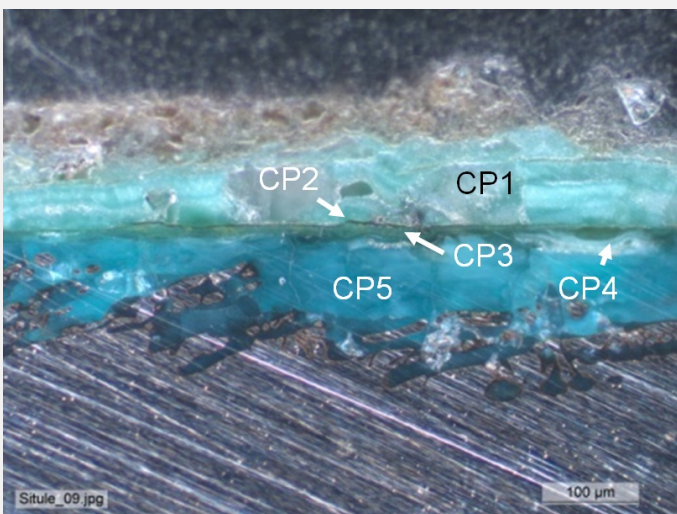
The limit of the original surface is well defined (interface of CP1 and CP2) but due to the fragility of the inner corrosion layers it was difficult to uncover.

Table 2: Chemical composition of the corrosion crust from Fig. 10. SEM-EDS, Lab of Electronic Microscopy and Microanalysis, IMA (Néode) (+++: high concentration, ++ medium concentration, + low concentration, nd: not-detected).

Fig. 10: Micrograph of the metal / corrosion interface (detail of Fig. 8) unetched, dark field, 100x. The outer layer (CP1 of Fig. 15) incorporates soil material and the thin dark layer (CP2 of Fig. 15) highlights the limit of the original surface,

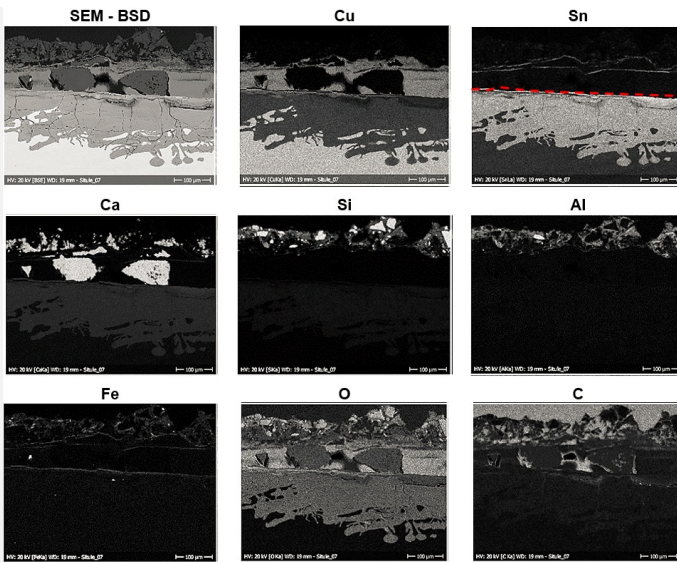
The inner layers (CP3-CP5) are Sn and O-rich and depleted in Cu (Table 2). The outer layers (CP1 and CP2) are Cu and O-rich, contain no Sn, and are contaminated with Ca, Si, Al and Fe coming from the soil (Fig. 11). The colour of the corrosion crust varies according to the content of Sn (the more Sn, the darker green or blue the corrosion). FTIR on the inner blue (CP5 and Fig. 12) and outer green (CP1 and Fig. 13) layers were difficult to interpret. Only malachite could be identified in both cases. XRD spectra could not be interpreted because of the deficiency of peaks.

Fig. 11: SEM image, SE-mode, and elemental chemical distribution of Fig. 10. In red: the limit of the original surface highlighted by the enriched tin layer. Method of examination: SEM-EDS, Lab of Electronic Microscopy and Microanalysis, IMA (Néode), HEI Arc,

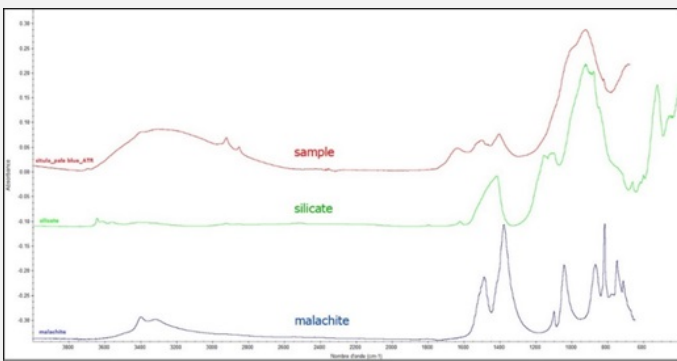
Fig. 12: FTIR spectrum (ATR mode) of the inner blue layer (CP5) compared to the silicate and malachite standard spectrum. Method of analysis: FTIR spectroscopy, HE- Arc CR,

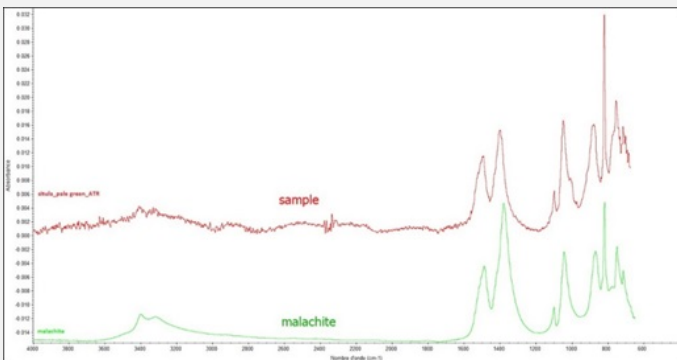
Fig. 13: FTIR spectrum (ATR mode) of the outer green layer (CP1) compared to the malachite standard spectrum. Method of analysis: FTIR spectroscopy, HE-Arc CR,

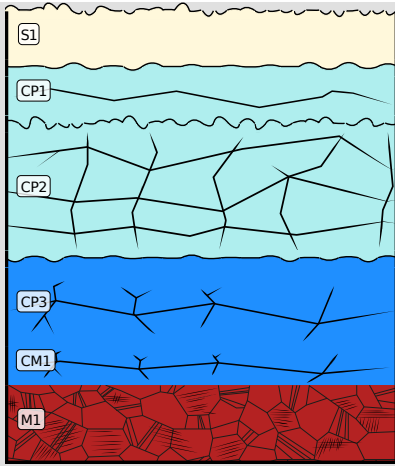
There are 2 stratigraphies (Fig. 14 corresponding to the interior face of the situla and Fig. 15 to its exterior face). The strata are similar in composition but their coding is different: CP1 to CP3 in Fig. 14 correspond to CP3 to CP5 in Fig. 15. Since the stratigraphy of Fig. 15 is more complete, the composition of each of its strata is given below.

Fig. 14: Stratigraphic representation of the sample taken from the detached fragment of the situla in cross-section (dark field) using the MiCorr application. The characteristics

of the strata are only accessible by clicking on the drawing that redirects you to the search tool by stratigraphy representation. This representation shows the interior face and can be compared to Fig. 8 (bottom red rectangle), Credit HE-Arc CR, M-J.Scholl.

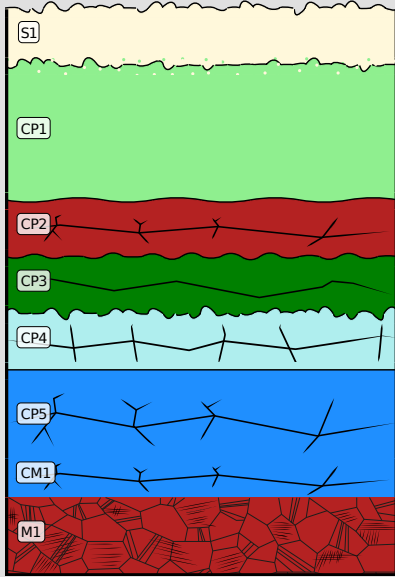
Fig. 15: Stratigraphic representation of the sample taken from the detached fragment of the situla in cross-section (dark field) using the MiCorr application. The characteristics of the strata are only accessible by clicking on the drawing that redirects you to the search tool by stratigraphy representation. This representation shows the exterior face and can be compared to Fig. 8 (top red rectangle), Credit HE-Arc CR, M-J.Scholl.
