# SITULA EMT09-554.665 - TIN BRONZE - IRON AGE - SWITZERLAND

Artefact name	Situla EMT09-554.665
Authors	Christian. Degriigny (HE-Arc CR, Neuchâtel, Neuchâtel, Switzerland) & Marie-Jeanne. Scholl (HE-Arc CR, Neuchâtel, Neuchâtel, Switzerland) & Valentin. Boissonnas (HE-Arc CR, Neuchâtel, Neuchâtel, Switzerland)
Url	/artefacts/968/

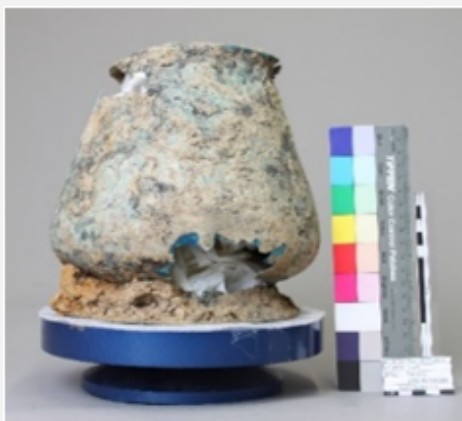
Fig. 1: Situla (Archeodunum (Gollion), 2009) inverted as found in situ,

Description of the artefact	Situla (Fig. 1) covered with blue-green corrosion products and sediments. Attached to two riveted iron loops is an iron handle terminating in two swan heads (not shown here). Dimensions of the main body: Hmax = 340mm, Ømax = 220mm.		
Type of artefact	Situla		
Origin	Mormont sanctuary, La Sarraz, Vaud, Switzerland		
Recovering date	Excavated in 2011		
Chronology category	Iron Age		
chronology tpq	<input type="text" value="140"/>	<input type="text" value="B.C. v"/>	
chronology taq	<input type="text" value="30"/>	<input type="text" value="B.C. v"/>	
Chronology comment	La Tène D

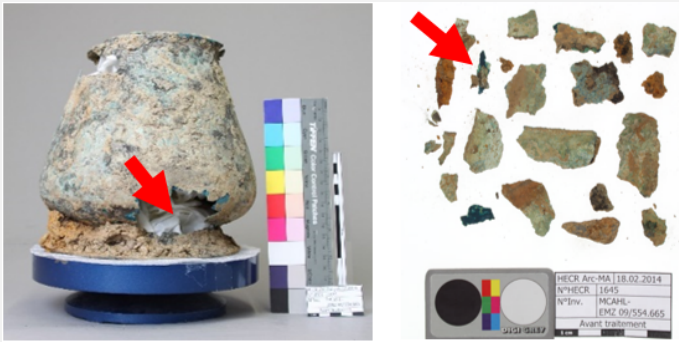
Fig. 2: Location of sampling area and sample selected from detached fragments,

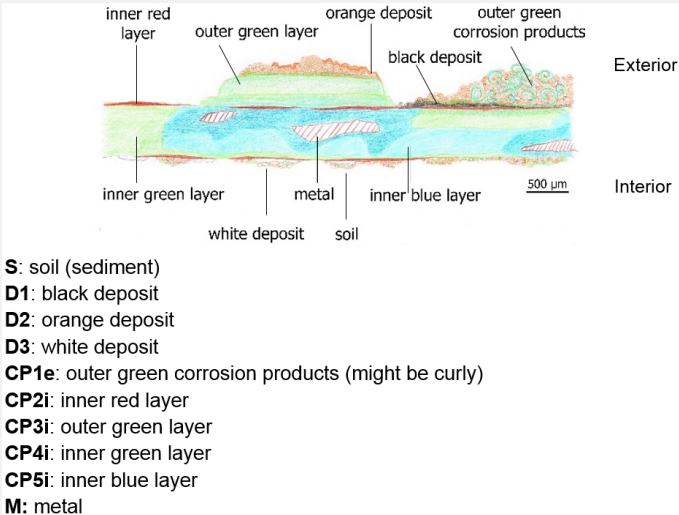
The schematic representation below gives an overview of the corrosion layers encountered on the situla from a first visual macroscopic observation (additional e and i within the coding correspond to strata in contact with the environment (e) and internal strata (i)).

Fig. 3: Stratigraphic representation of the situla by macroscopic observation,

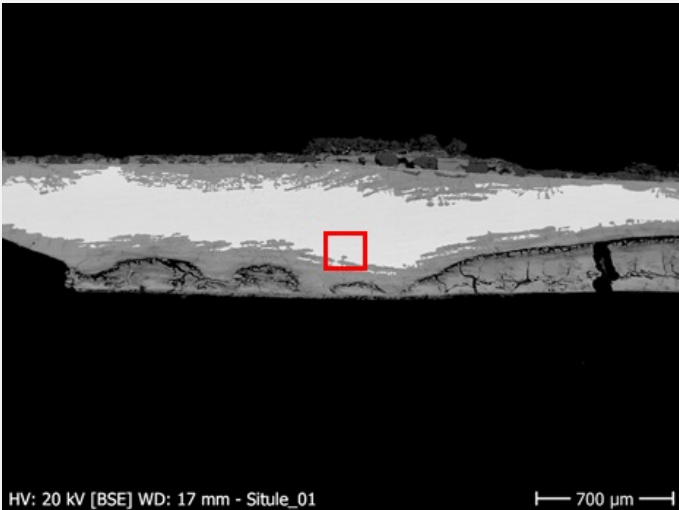
The remaining metal is a dense tin bronze (Fig. 5, Table 1), showing no inclusion. In bright field, the etched alloy shows a structure principally consisting of polygonal alpha phase grains (Fig. 6). Some of the grains include twin lines (Fig. 7). The presence of strain lines (slip lines) indicates a final cold work without annealing.

Fig. 5: SEM image, BSE-mode, of the metal sample from Fig. 4. Area of Fig. 6 is marked by a red square,

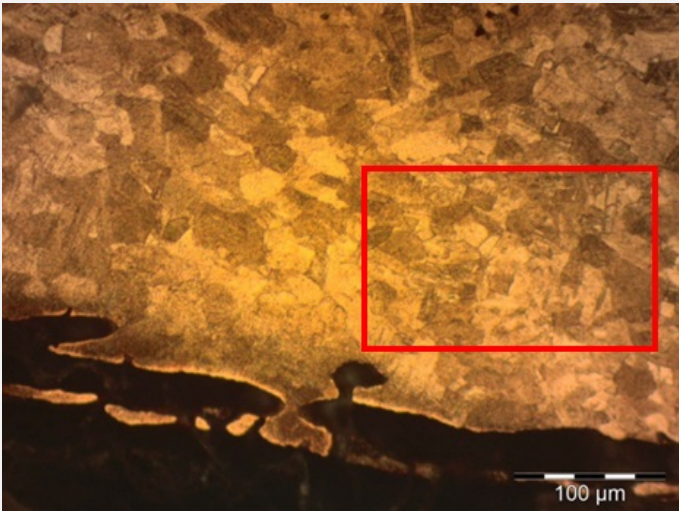
Fig. 6: Micrograph of the metal structure from Fig. 5 (detail), etched, bright field, 50x. The alpha phase of the alloy shows polygonal grains. Area of Fig. 7 is marked by a red rectangle,

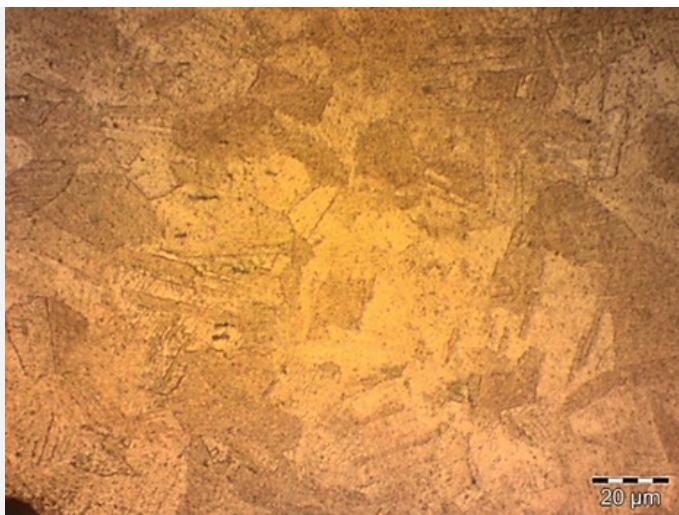
Fig. 7: Micrograph of the selected area of Fig. 6, etched, bright field, 500x. The grains show both twin and strain lines,

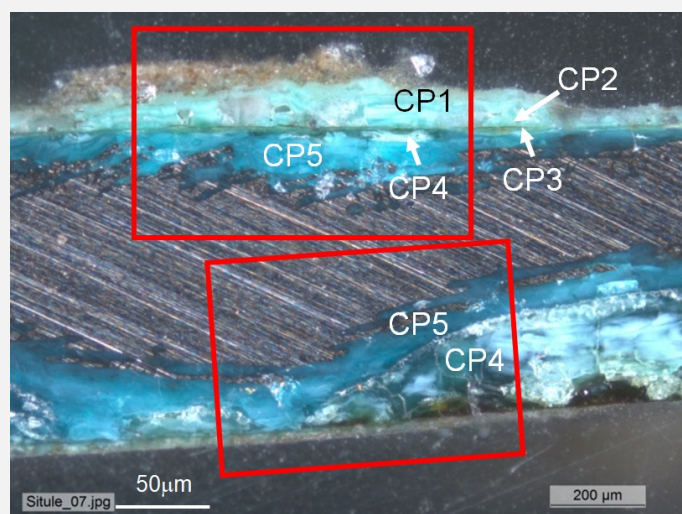
Fig. 8: Micrograph of the metal sample from Fig. 4, unetched, dark field, 50x. Areas of Fig. 9 (bottom, corresponding to the stratigraphy of Fig. 14) and Figs. 10 and 11 (top, corresponding to the stratigraphy of Fig. 15) are marked by a rectangle. Codes are those of Fig. 15,

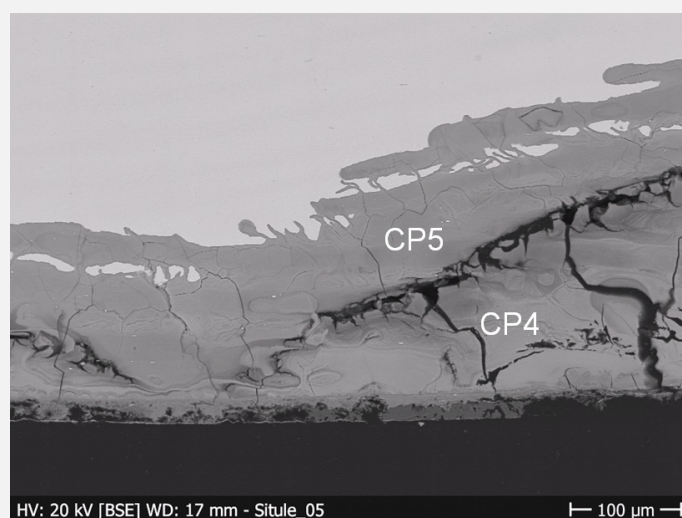
The corrosion crust is heterogeneous and has in places completely replaced the metal. The metal – corrosion products interface is irregular due to transgranular corrosion (Figs 5-6). In most cases, the corrosion crust can be divided in three main layers: first, an inner compact blue layer directly on the metal core (CP5, Figs. 8, 10 and 15 and CP3, Fig. 14). In areas of extensive corrosion this blue layer coexists with a friable light blue-green layer (CP4, Figs. 8, 10 and 15 and CP2, Fig. 14). Secondly, and depending on the area, either a very fine dark green (CP3, Figs. 8 and 15) or red corrosion layer (CP2, Figs. 10 and 15) marks the limit of the original surface. Finally, there is a fourth outer layer, consisting of friable and sometimes curly pale green corrosion products, interspersed with soil products (CP1, Figs. 8, 10 and 15). In heavily worked and fragile parts of the object a cleavage between the inner layers of blue and light blue-green corrosion is present, rendering the light blue-green corrosion vulnerable to loss (Fig. 9).

Fig. 9: SEM image, BSE-mode of the metal sample from Fig. 8 (detail) showing cleavage between the inner blue (CP5) and green (CP4) layers of Fig. 15,

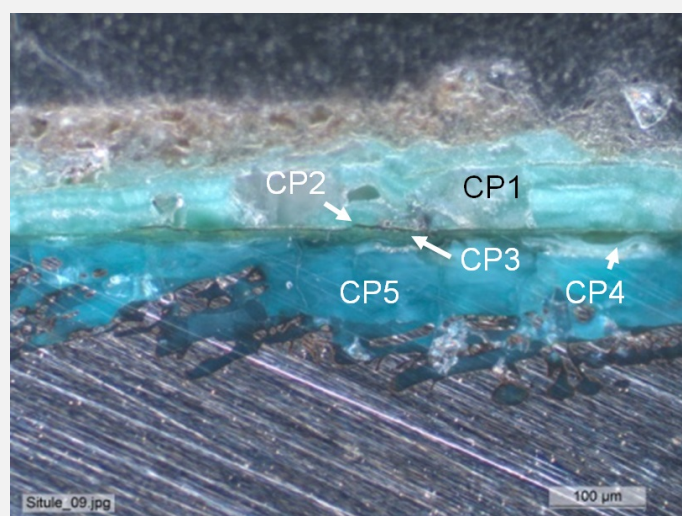
The limit of the original surface is well defined (interface of CP1 and CP2) but due to the fragility of the inner corrosion layers it was difficult to uncover.

Fig. 10: Micrograph of the metal / corrosion interface (detail of Fig. 8) unetched, dark field, 100x. The outer layer (CP1 of Fig. 15) incorporates soil material and the thin dark layer (CP2 of Fig. 15) highlights the limit of the original surface,

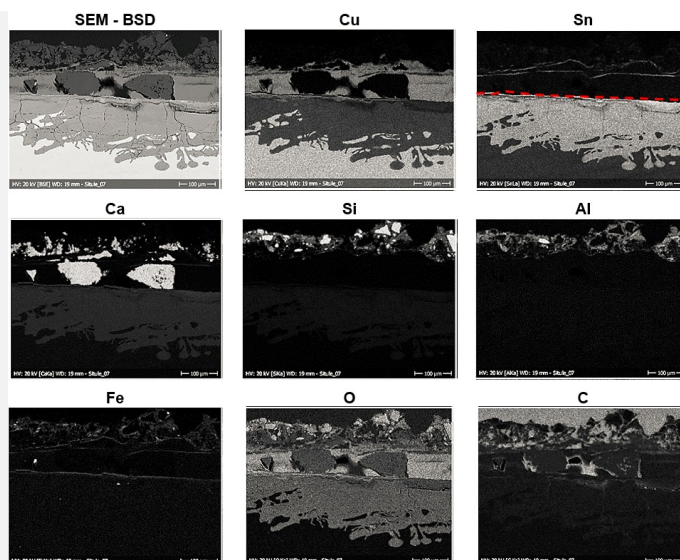
The inner layers (CP3-CP5) are Sn and O-rich and depleted in Cu (Table 2). The outer layers (CP1 and CP2) are Cu and O-rich, contain no Sn, and are contaminated with Ca, Si, Al and Fe coming from the soil (Fig. 11). The colour of the corrosion crust varies according to the content of Sn (the more Sn, the darker green or blue the corrosion). FTIR on the inner blue (CP5 and Fig. 12) and outer green (CP1 and Fig. 13) layers were difficult to interpret. Only malachite could be identified in both cases. XRD spectra could not be interpreted because of the deficiency of peaks.

Fig. 11: SEM image, SE-mode, and elemental chemical distribution of Fig. 10. In red: the limit of the original surface highlighted by the enriched tin layer. Method of examination: SEM-EDS, Lab of Electronic Microscopy and Microanalysis, IMA (Néode), HEI Arc,

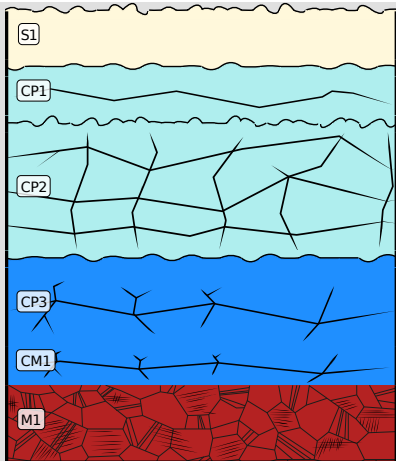
There are 2 stratigraphies (Fig. 14 corresponding to the interior face of the situla and Fig. 15 to its exterior face). The strata are similar in composition but their coding is different: CP1 to CP3 in Fig. 14 correspond to CP3 to CP5 in Fig. 15. Since the stratigraphy of Fig. 15 is more complete, the composition of each of its strata is given below.

Fig. 14: Stratigraphic representation of the sample taken from the detached fragment of the situla in cross-section (dark field) using the MiCorr application. The characteristics

of the strata are only accessible by clicking on the drawing that redirects you to the search tool by stratigraphy representation. This representation shows the interior face and can be compared to Fig. 8 (bottom red rectangle), Credit HE-Arc CR, M-J.Scholl.

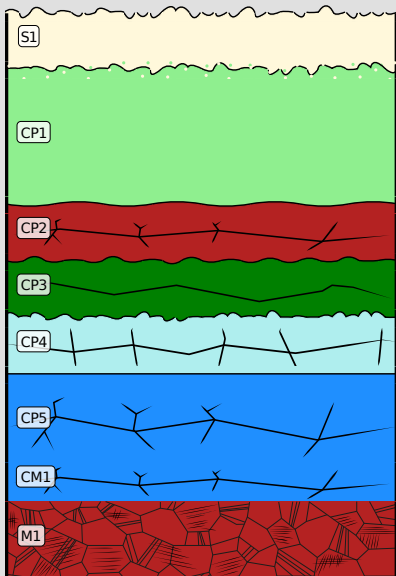
Fig. 15: Stratigraphic representation of the sample taken from the detached fragment of the situla in cross-section (dark field) using the MiCorr application. The characteristics of the strata are only accessible by clicking on the drawing that redirects you to the search tool by stratigraphy representation. This representation shows the exterior face and can be compared to Fig. 8 (top red rectangle), Credit HE-Arc CR, M-J.Scholl.

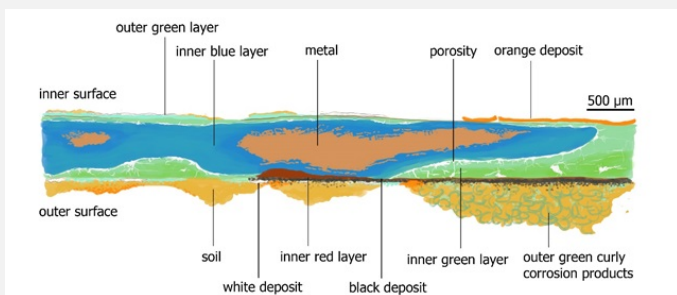
Fig. 16: Improved stratigraphic representation of the situla from visual observations and analyses,

Strata	Composition
Soil (S)	Ca, Si, Al, Fe
Black deposit (D1)	C
Orange deposit (D2)	Ferrous oxides
White deposit (D3)	Ca
Outer green curly corrosion product (CP1e)	Copper carbonates (curly malachite)
Inner red (CP2i)	Copper oxide (cuprite ?)
Outer green layer (CP3i)	Copper carbonates (malachite)
Inner green layer (CP4i)	Copper carbonates (?) + Sn
Inner blue layer (CP5i)	Copper carbonates (?) + Sn
Remnant metal phase (M)	Bronze (90%Cu, 10% Sn)
