SITULA EMT09-554.665 - TIN BRONZE - IRON AGE - SWITZERLAND

Artefact name	Situla EMT09-554.665
Authors	Christian. Degriigny (HE-Arc CR, Neuchâtel, Neuchâtel, Switzerland) & Marie-Jeanne. Scholl (HE-Arc CR, Neuchâtel, Neuchâtel, Switzerland) & Valentin. Boissonnas (HE-Arc CR, Neuchâtel, Neuchâtel, Switzerland)
Url	/artefacts/968/

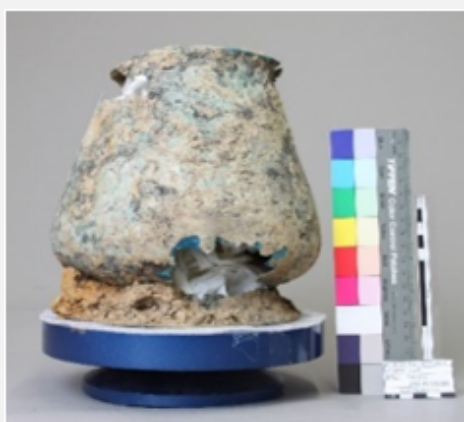
Fig. 1: Situla (Archeodunum (Gollion), 2009) inverted as found in situ,

Description of the artefact	Situla (Fig. 1) covered with blue-green corrosion products and sediments. Attached to two riveted iron loops is an iron handle terminating in two swan heads (not shown here). Dimensions of the main body: Hmax = 340mm, Ømax = 220mm.
Type of artefact	Situla
Origin	Mormont sanctuary, La Sarraz, Vaud, Switzerland
Recovering date	Excavated in 2011
Chronology category	Iron Age
chronology tpq	<input type="text" value="140"/> B.C. ▼
chronology taq	<input type="text" value="30"/> B.C. ▼
Chronology comment	La Tène D

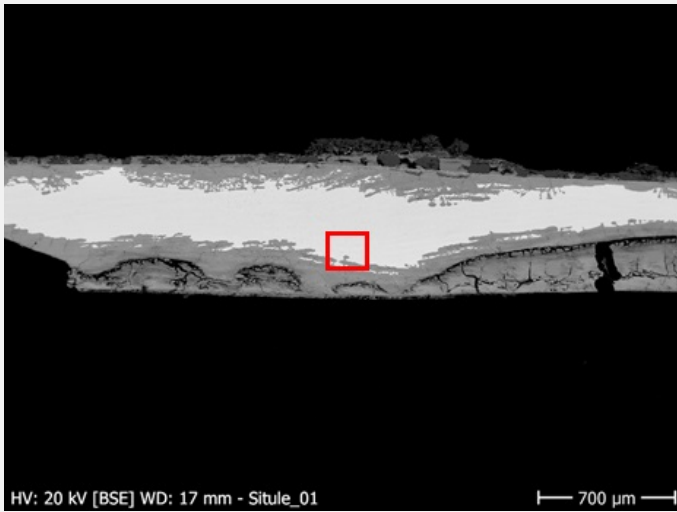
The remaining metal is a dense tin bronze (Fig. 5, Table 1), showing no inclusion. In bright field, the etched alloy shows a structure principally consisting of polygonal alpha phase grains (Fig. 6). Some of the grains include twin lines (Fig. 7). The presence of strain lines (slip lines) indicates a final cold work without annealing.

Fig. 5: SEM image, BSE-mode, of the metal sample from Fig. 4. Area of Fig. 6 is marked by a red square,

The corrosion crust is heterogeneous and has in places completely replaced the metal. The metal – corrosion products interface is irregular due to transgranular corrosion (Figs 5-6). In most cases, the corrosion crust can be divided in three main layers: first, an inner compact blue layer directly on the metal core (CP5, Figs. 8, 10 and 15 and CP3, Fig. 14). In areas of extensive corrosion this blue layer coexists with a friable light blue-green layer (CP4, Figs. 8, 10 and 15 and CP2, Fig. 14). Secondly, and depending on the area, either a very fine dark green (CP3, Figs. 8 and 15) or red corrosion layer (CP2, Figs. 10 and 15) marks the limit of the original surface. Finally, there is a fourth outer layer, consisting of friable and sometimes curly pale green corrosion products, interspersed with soil products (CP1, Figs. 8, 10 and 15). In heavily worked and fragile parts of the object a cleavage between the inner layers of blue and light blue-green corrosion is present, rendering the light blue-green corrosion vulnerable to loss (Fig. 9).

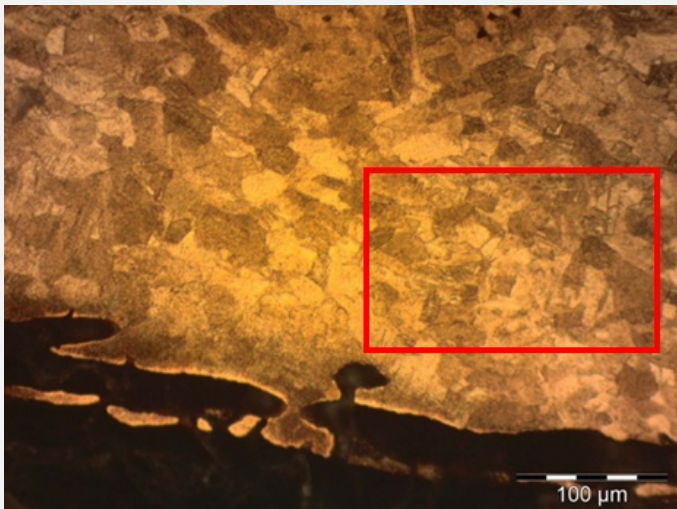
Fig. 6: Micrograph of the metal structure from Fig. 5 (detail), etched, bright field, 50x. The alpha phase of the alloy shows polygonal grains. Area of Fig. 7 is marked by a red rectangle,

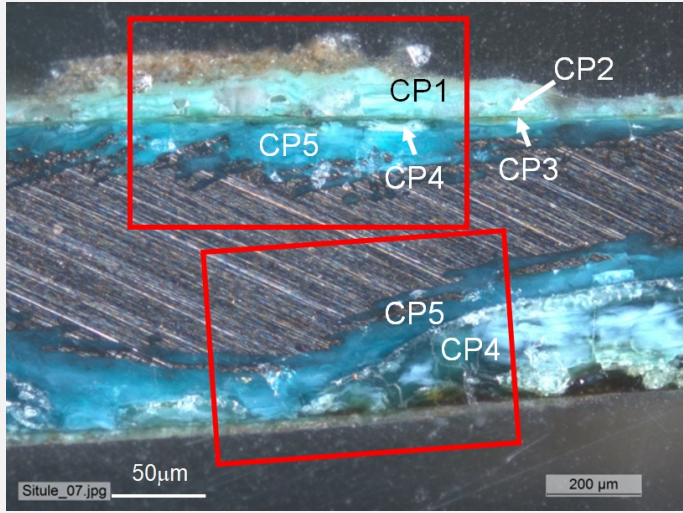
Fig. 8: Micrograph of the metal sample from Fig. 4, unetched, dark field, 50x. Areas of Fig. 9 (bottom, corresponding to the stratigraphy of Fig. 14) and Figs. 10 and 11 (top, corresponding to the stratigraphy of Fig. 15) are marked by a rectangle. Codes are those of Fig. 15,

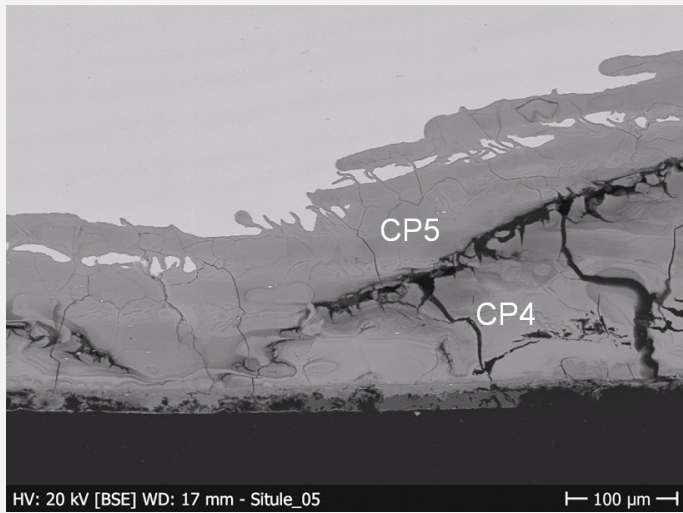
Fig. 9: SEM image, BSE-mode of the metal sample from Fig. 8 (detail) showing cleavage between the inner blue (CP5) and green (CP4) layers of Fig. 15,

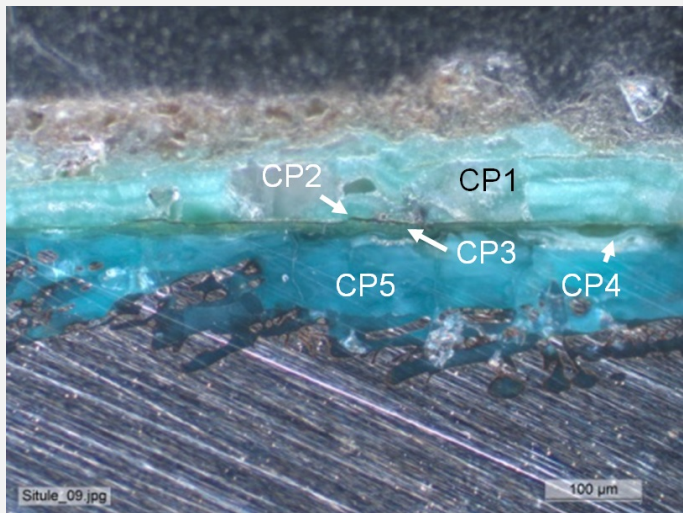
Table 2: Chemical composition of the corrosion crust from Fig. 10. SEM-EDS, Lab of Electronic Microscopy and Microanalysis, IMA (Néode) (+++: high concentration, ++ medium concentration, + low concentration, nd: not-detected).

Fig. 10: Micrograph of the metal / corrosion interface (detail of Fig. 8) unetched, dark field, 100x. The outer layer (CP1 of Fig. 15) incorporates soil material and the thin dark layer (CP2 of Fig. 15) highlights the limit of the original surface,

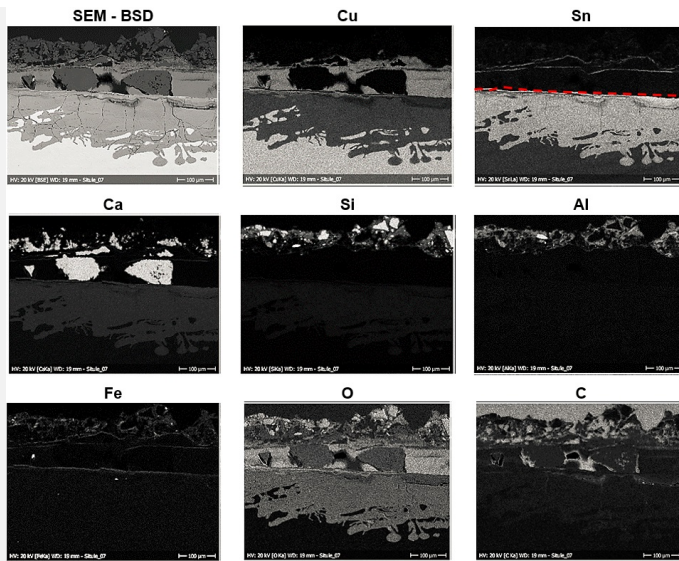
The inner layers (CP3-CP5) are Sn and O-rich and depleted in Cu (Table 2). The outer layers (CP1 and CP2) are Cu and O-rich, contain no Sn, and are contaminated with Ca, Si, Al and Fe coming from the soil (Fig. 11). The colour of the corrosion crust varies according to the content of Sn (the more Sn, the darker green or blue the corrosion). FTIR on the inner blue (CP5 and Fig. 12) and outer green (CP1 and Fig. 13) layers were difficult to interpret. Only malachite could be identified in both cases. XRD spectra could not be interpreted because of the deficiency of peaks.

Fig. 11: SEM image, SE-mode, and elemental chemical distribution of Fig. 10. In red: the limit of the original surface highlighted by the enriched tin layer. Method of examination: SEM-EDS, Lab of Electronic Microscopy and Microanalysis, IMA (Néode), HEI Arc,

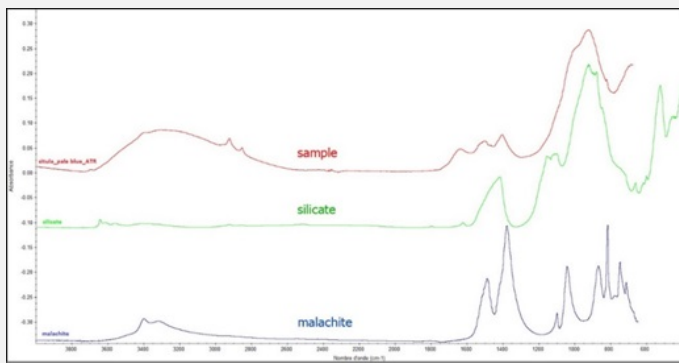
Fig. 12: FTIR spectrum (ATR mode) of the inner blue layer (CP5) compared to the silicate and malachite standard spectrum. Method of analysis: FTIR spectroscopy, HE- Arc CR,

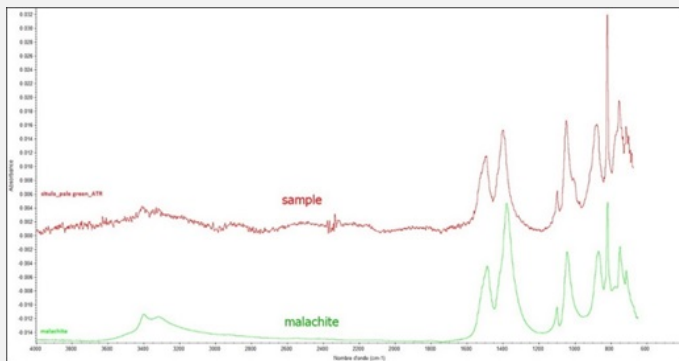
Fig. 13: FTIR spectrum (ATR mode) of the outer green layer (CP1) compared to the malachite standard spectrum. Method of analysis: FTIR spectroscopy, HE-Arc CR,

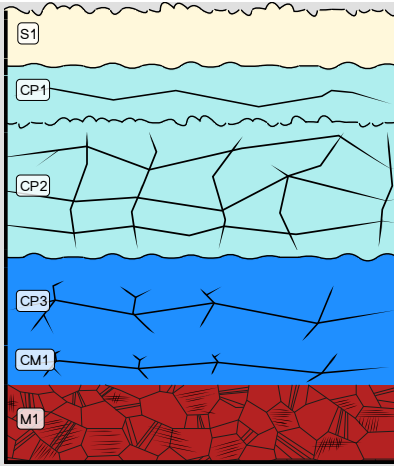
There are 2 stratigraphies (Fig. 14 corresponding to the interior face of the situla and Fig. 15 to its exterior face). The strata are similar in composition but their coding is different: CP1 to CP3 in Fig. 14 correspond to CP3 to CP5 in Fig. 15. Since the stratigraphy of Fig. 15 is more complete, the composition of each of its strata is given below.

Fig. 14: Stratigraphic representation of the sample taken from the detached fragment of the situla in cross-section (dark field) using the MiCorr application. The characteristics of the strata are only accessible by clicking on the drawing that redirects you to the search tool by stratigraphy representation. This representation shows the interior face and can be compared to Fig. 8 (bottom red rectangle), Credit HE-Arc CR, M-J.Scholl.

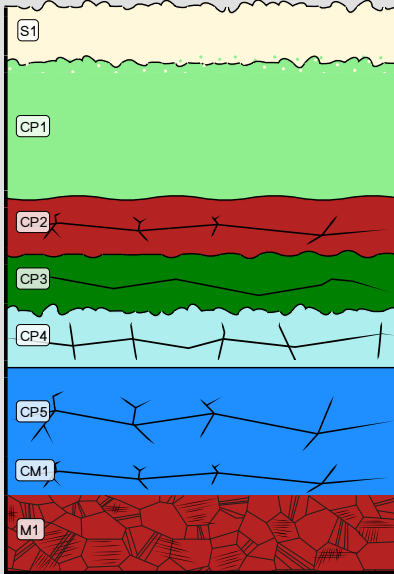
Fig. 15: Stratigraphic representation of the sample taken from the detached fragment of the situla in cross-section (dark field) using the MiCorr application. The characteristics of the strata are only accessible by clicking on the drawing that redirects you to the search tool by stratigraphy representation. This representation shows the exterior face and can be compared to Fig. 8 (top red rectangle), Credit HE-Arc CR, M-J.Scholl.

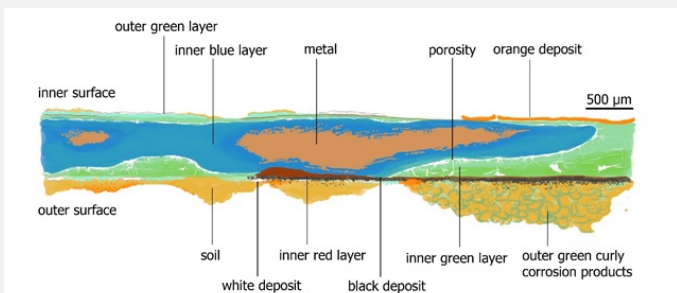
The schematic representation of corrosion layers of Fig. 3 integrating additional information (e and i within the coding correspond to strata in contact with the environment (e) and internal strata (i) based on the analyses carried out is given in Fig. 16.

Fig. 16: Improved stratigraphic representation of the situla from visual observations and analyses,

Strata	Composition
Soil (S)	Ca, Si, Al, Fe
Black deposit (D1)	C
Orange deposit (D2)	Ferrous oxides
White deposit (D3)	Ca
Outer green curly corrosion product (CP1e)	Copper carbonates (curly malachite)
Inner red (CP2i)	Copper oxide (cuprite ?)
Outer green layer (CP3i)	Copper carbonates (malachite)
Inner green layer (CP4i)	Copper carbonates (?) + Sn
Inner blue layer (CP5i)	Copper carbonates (?) + Sn
Remnant metal phase (M)	Bronze (90%Cu, 10% Sn)
