# SACRIFICIAL ANODE VHS-8339 – ZN ALLOY – MODERN TIMES

**Artefact name** Sacrificial anode VHS-8339

**Authors** Marianne. Senn (Empa, Dübendorf, Zurich, Switzerland) & Christian. Degrigny (HE-Arc CR, Neuchâtel, Neuchâtel, Switzerland)

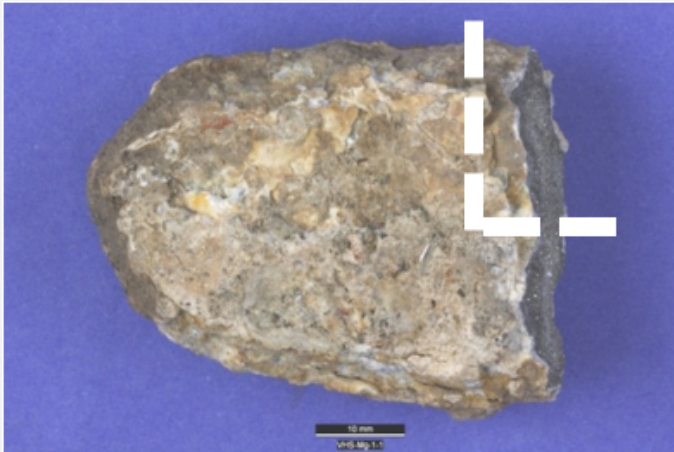
Fig. 2: Location of sampling area,

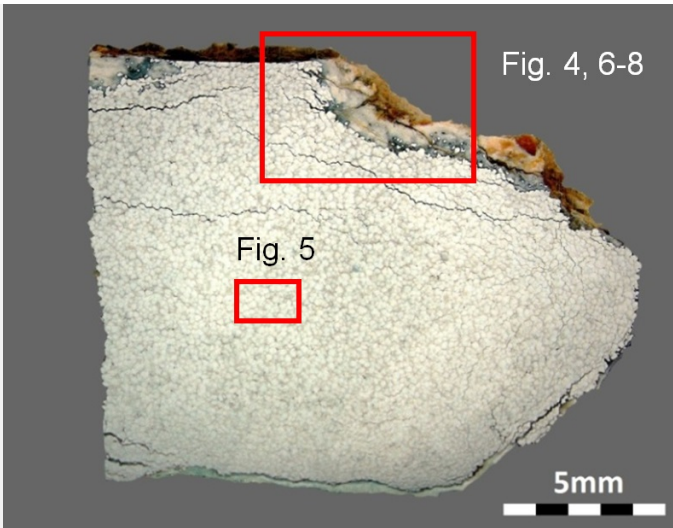
Fig. 3: Micrograph of the cross-section of the fragment sampled from the sacrificial anode showing the location of Figs. 4 to 8,

<b>Description of sample</b>	The sample (Fig. 3) shows a cross-section from the fragment of the sacrificial anode (Fig. 2). It has a silvery appearance. The thickness of the corrosion crust is variable. Dimensions: L = 17mm; W = 14mm.
<b>Alloy</b>	Zn Alloy
<b>Technology</b>	Cast and annealed
<b>Lab number of sample</b>	VHS-Mq-1
<b>Sample location</b>	HE-Arc CR, Neuchâtel, Neuchâtel
<b>Responsible institution</b>	Swiss Museum of Transport, Luzern, Lucerne
<b>Date and aim of sampling</b>	07/09/2009 metallography

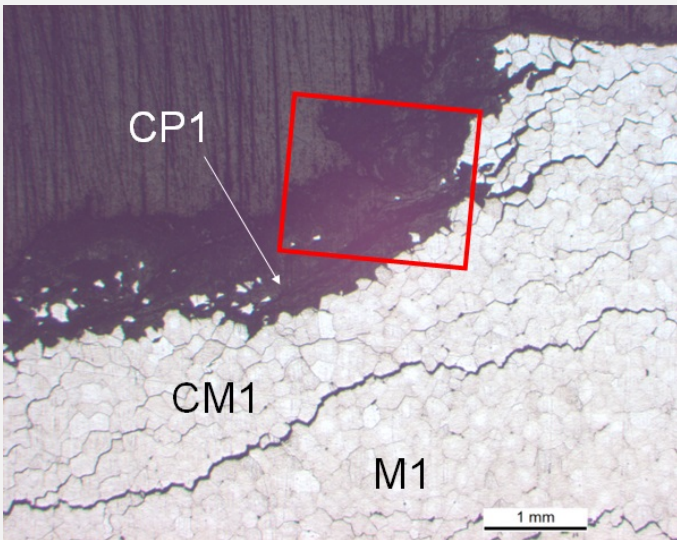
The remaining metal is an almost pure zinc alloy (Table 1). The oxygen content is not from the original alloy, but is due to secondary corrosion. The metal grains are visible without etching and present a polygonal structure (Figs. 4 and 5). The structure is recrystallized after annealing. The recrystallization of zinc alloys begins at room temperature.

Fig. 4: Micrograph of the metal sample from Fig. 3 (reversed picture, detail), unetched, bright field. Extensive intergranular corrosion is visible. The rectangle marks Fig. 6,

Extensive intergranular corrosion / cracking has developed in the metal structure (Figs. 4, 5). The metal is covered by a corrosion crust that is hardly visible in bright field and which contains remnant metal (Fig. 4). On most of the sample the corrosion crust is uniform. In areas we see cracks (Fig. 6) appearing as brown lines separating the corrosion crust (Fig. 7). In bright field the corrosion crust appears grey containing dark-grey zones (Fig. 6). Under polarized light, the corrosion crust appears white with darker parts including remnant metal (Fig. 7). It contains Zn and O as well as S along some cracks (Table 2 and Fig. 8).

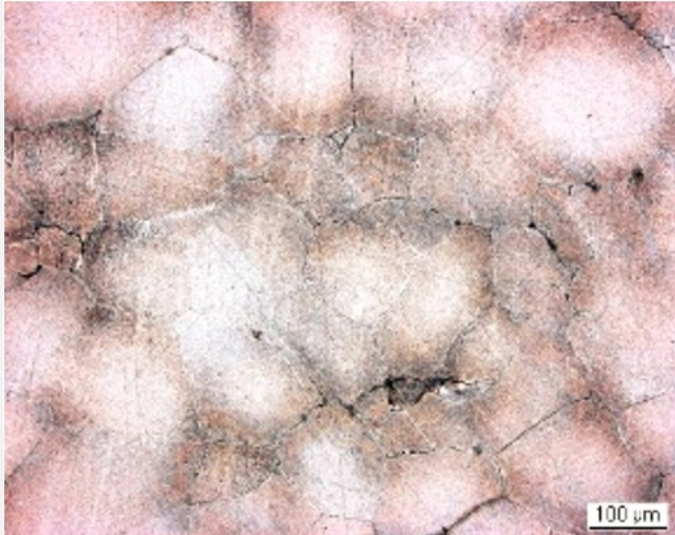
Fig. 5: Micrograph of the metal sample from Fig. 3 (detail), etched,

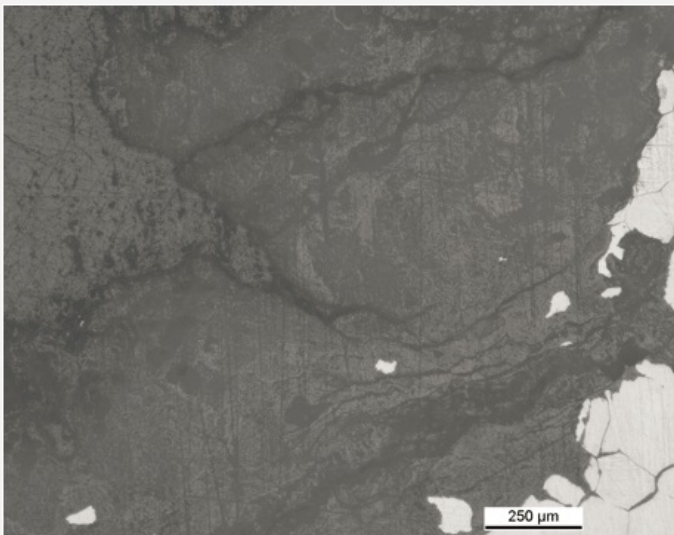
Table 2. Chemical composition (mass %) of the corrosion layer from Figs. 6 and 8. Method of analysis: SEM/EDS, Laboratory of Analytical Chemistry, Empa.

Fig. 6: Micrograph showing the metal - corrosion products interface from Fig. 5 (detail), unetched, bright field,

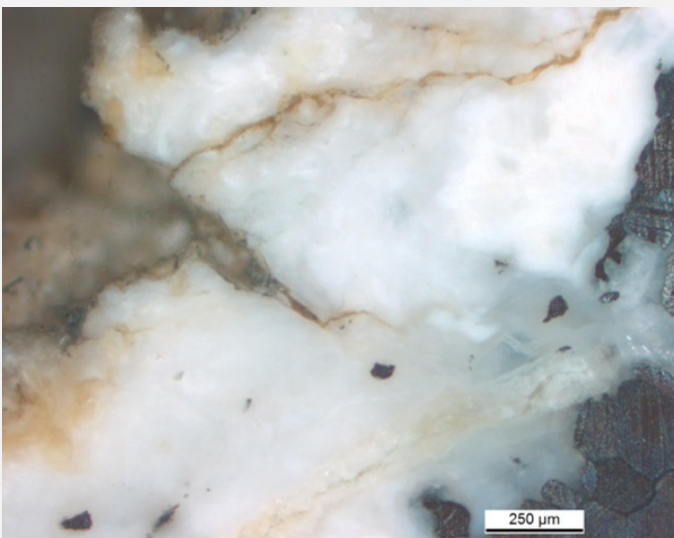
Fig. 7: Micrograph (same as Fig. 6) corresponding to the stratigraphy of Fig. 4, unetched, polarised light. We observe in dark-grey the metal, in white the corrosion crust separated by brown cracks including remnant metal,

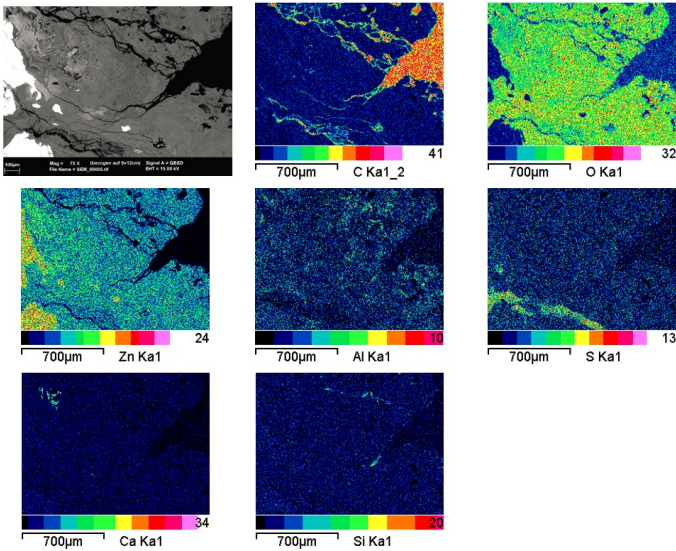
Fig. 8: SEM image, BSE-mode, and elemental chemical distribution of most of the area of Fig. 6 (reversed picture).

Method of examination: SEM/EDS, Laboratory of Analytical Chemistry, Empa,
