SACRIFICIAL ANODE VHS-8339 – ZN ALLOY – MODERN TIMES

Artefact name	Sacrificial anode VHS-8339
Authors	Marianne. Senn (Empa, Dübendorf, Zurich, Switzerland) & Christian. Degriigny (HE-Arc CR, Neuchâtel, Neuchâtel, Switzerland)
Url	/artefacts/970/

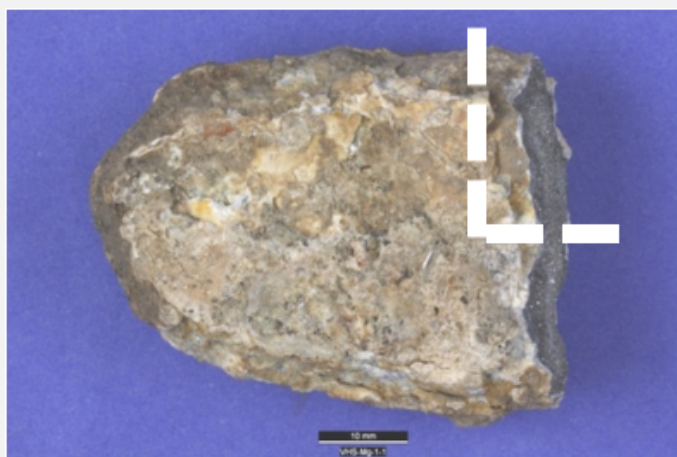
Fig. 2: Location of sampling area,

Description of sample	The sample (Fig. 3) shows a cross-section from the fragment of the sacrificial anode (Fig. 2). It has a silvery appearance. The thickness of the corrosion crust is variable. Dimensions: L = 17mm; W = 14mm.
Alloy	Zn Alloy
Technology	Cast and annealed
Lab number of sample	VHS-Mq-1
Sample location	HE-Arc CR, Neuchâtel, Neuchâtel
Responsible institution	Swiss Museum of Transport, Luzern, Lucerne
Date and aim of sampling	07/09/2009 metallography

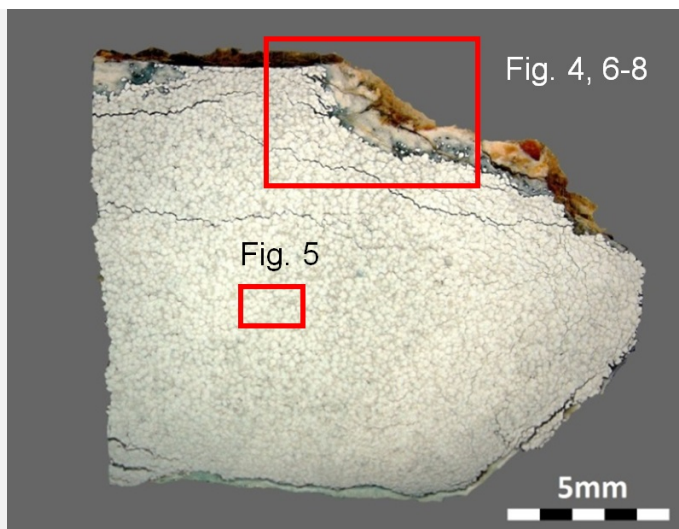
Fig. 3: Micrograph of the cross-section of the fragment sampled from the sacrificial anode showing the location of Figs. 4 to 8,

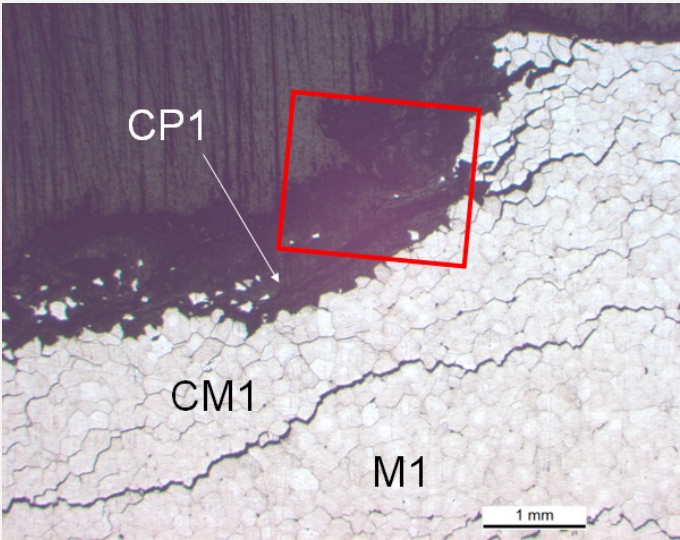
The remaining metal is an almost pure zinc alloy (Table 1). The oxygen content is not from the original alloy, but is due to secondary corrosion. The metal grains are visible without etching and present a polygonal structure (Figs. 4 and 5). The structure is recrystallised after annealing. The recrystallization of zinc alloys begins at room temperature.

Fig. 4: Micrograph of the metal sample from Fig. 3 (reversed picture, detail), unetched, bright field. Extensive intergranular corrosion is visible. The rectangle marks Fig. 6,

Extensive intergranular corrosion / cracking has developed in the metal structure (Figs. 4, 5). The metal is covered by a corrosion crust that is hardly visible in bright field and which contains remnant metal (Fig. 4). On most of the sample the corrosion crust is uniform. In areas we see cracks (Fig. 6) appearing as brown lines separating the corrosion crust (Fig. 7). In bright field the corrosion crust appears grey containing dark-grey zones (Fig. 6). Under polarized light, the corrosion crust appears white with darker parts including remnant metal (Fig. 7). It contains Zn and O as well as S along some cracks (Table 2 and Fig. 8).

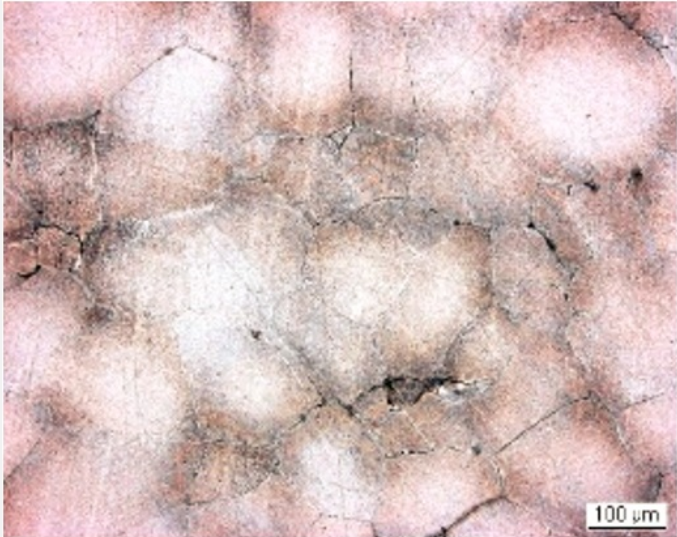
Fig. 5: Micrograph of the metal sample from Fig. 3 (detail), etched,

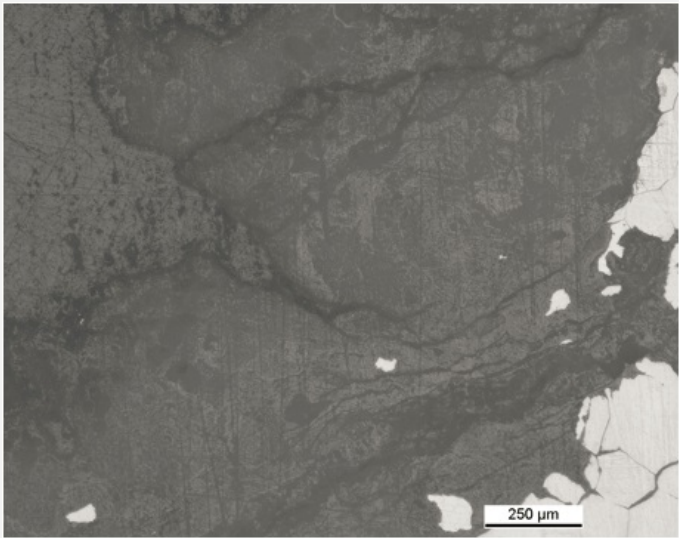
Table 2. Chemical composition (mass %) of the corrosion layer from Figs. 6 and 8. Method of analysis: SEM/EDS, Laboratory of Analytical Chemistry, Empa.

Fig. 6: Micrograph showing the metal - corrosion products interface from Fig. 5 (detail), unetched, bright field,

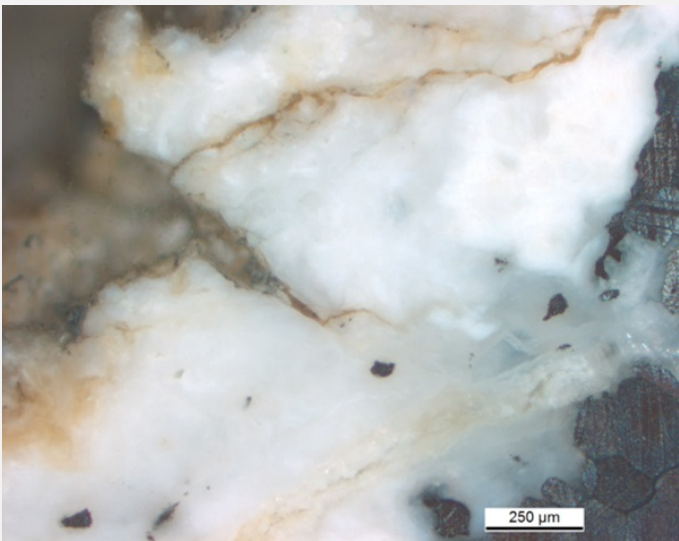
Fig. 7: Micrograph (same as Fig. 6) corresponding to the stratigraphy of Fig. 4, unetched, polarised light. We observe in dark-grey the metal, in white the corrosion crust separated by brown cracks including remnant metal,

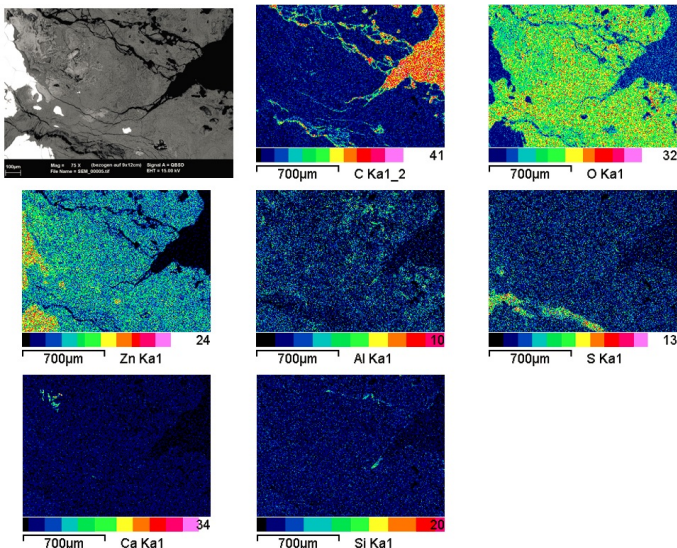
Fig. 8: SEM image, BSE-mode, and elemental chemical distribution of most of the area of Fig. 6 (reversed picture).
