# ARMATURE FROM A CLOCK MOVEMENT MIH IV-212 – ZN AL SN CU ALLOY – MODERN TIMES

**Artefact name** Armature from a clock movement MIH IV-212

**Authors** Marianne. Senn (Empa, Dübendorf, Zurich, Switzerland) & Christian. Degrygn (HE-Arc CR, Neuchâtel, Neuchâtel, Switzerland)

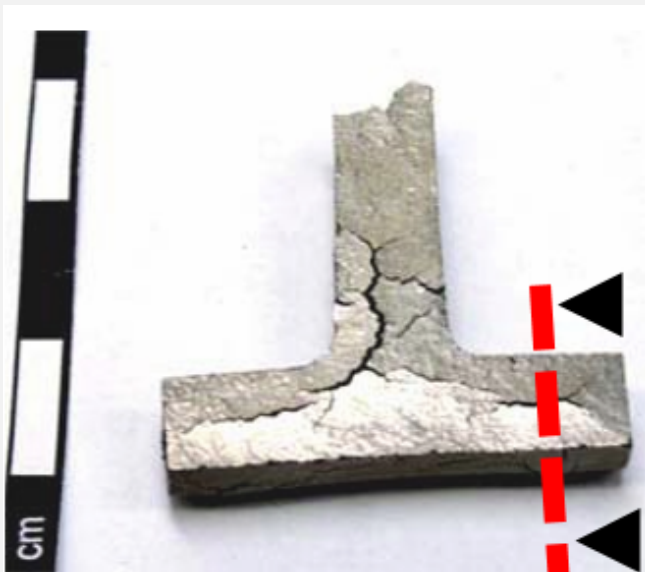
Fig. 2: Location of sampling area on one of the two broken elements of the armature,

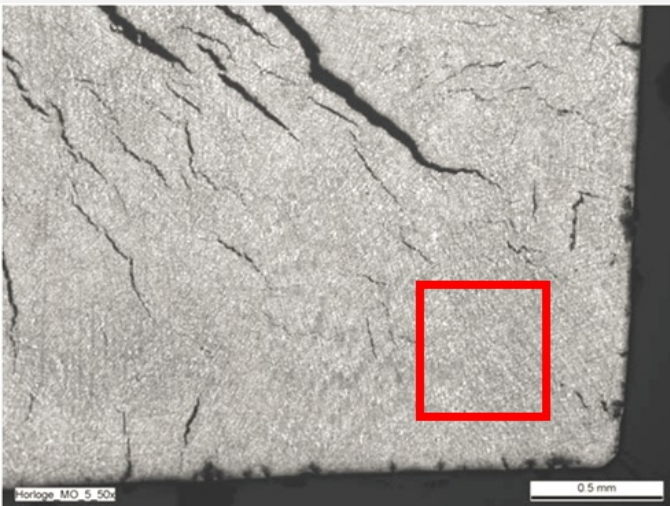
The metal is a Zn-Al-Sn-Cu alloy (Table 1) with an average hardness of HV1 105. A fine dendritic structure is observed (Fig. 4) which consists of clearly separated Zn, Al-Cu and Sn-rich phases (Figs. 5 and 6). Pb is associated with Sn but also forms tiny nodules.

Fig. 4: Micrograph of the metal sample from Fig. 3 (inverted picture, rotated by 270°, detail), unetched, bright field. A dendritic structure is visible. The micrograph of Fig. 5 is marked by a square,

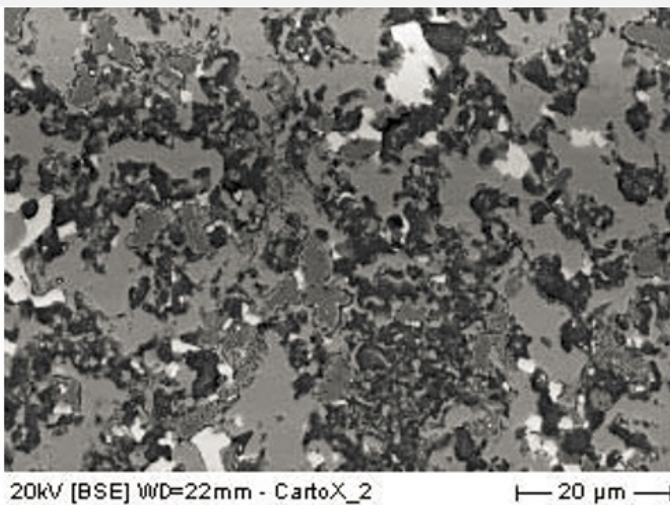
Fig. 5: SEM image, BSE-mode, detail from Fig. 4 (detail), unetched, bright field. Three phases appear: in light-grey the Zn-rich phase, in dark-grey the Al and Cu-rich phase and in white the Sn-rich phase,

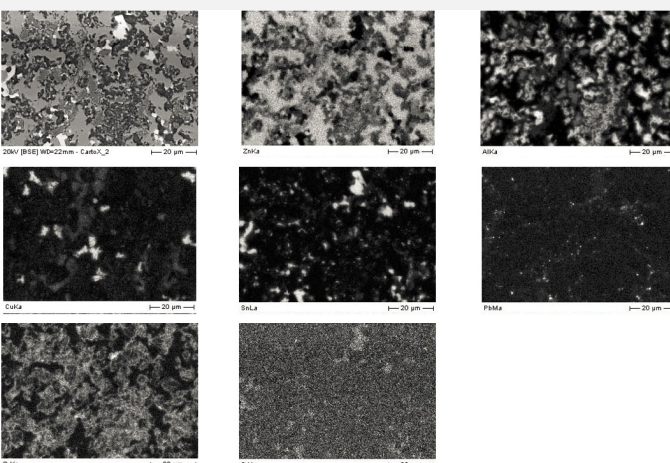
Fig. 6: SEM image, BSE-mode, and elemental chemical distribution of the selected area from Fig. 5. Method of examination: SEM/EDS, Lab of Electronic Microscopy and microanalysis, IMA (Néode), HEI Arc,

The Zn-rich phase is heavily oxidised internally (Fig. 6). The corrosion has developed throughout the entire metal body, generating cracks (Figs. 7 and 8). The cracks are Zn, O and C-rich (Fig. 9) and could be composed of zinc carbonate.
